EROSION CONTROL AND ABATEMENT PRACTICES FOR COUNTY ROAD SYSTEMS

Final Report
FY 1995 319(h)
EPA (CFDA 66.460)
TASK #900: OCC TASK #73

Gerald A. Miller

July 2001

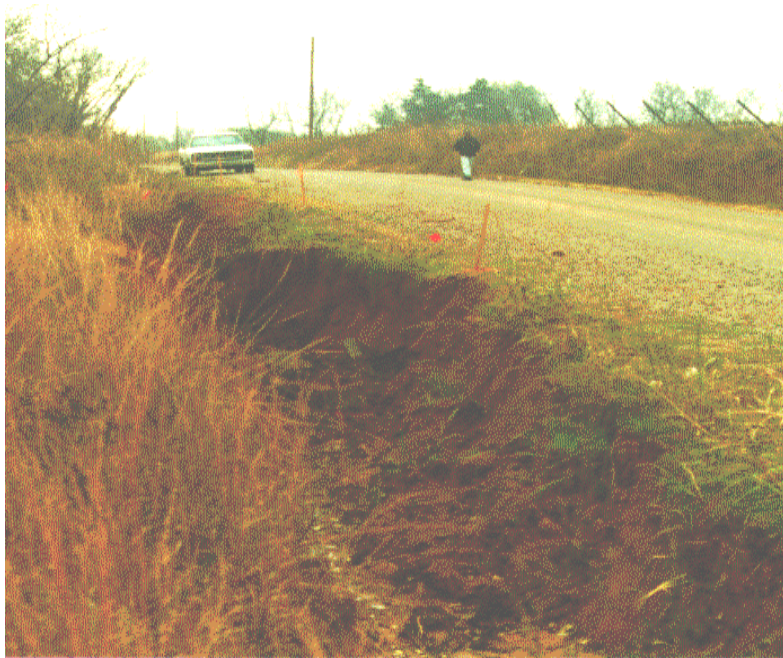
Excessive erosion in bar ditches can undermine and collapse the shoulder and portions of the roadway, resulting in a serious threat to motorists. An example of the type of damage that can occur during a storm event is depicted in Figure 1.1. In addition to the impacts in actively eroding areas, the sediment deposited downstream, such as shown in Figure 1.2, can create serious problems. Overflow of sediment-clogged drainage channels results in flooding and washouts that can render the road unsafe and impassible. Beside the obvious impacts on safety, construction delays while remedying these problems can pose a nuisance to local travelers.

Figure 1.1 Severe Erosion Damage Along the Shoulder of a County Road (looking north at Site 1).

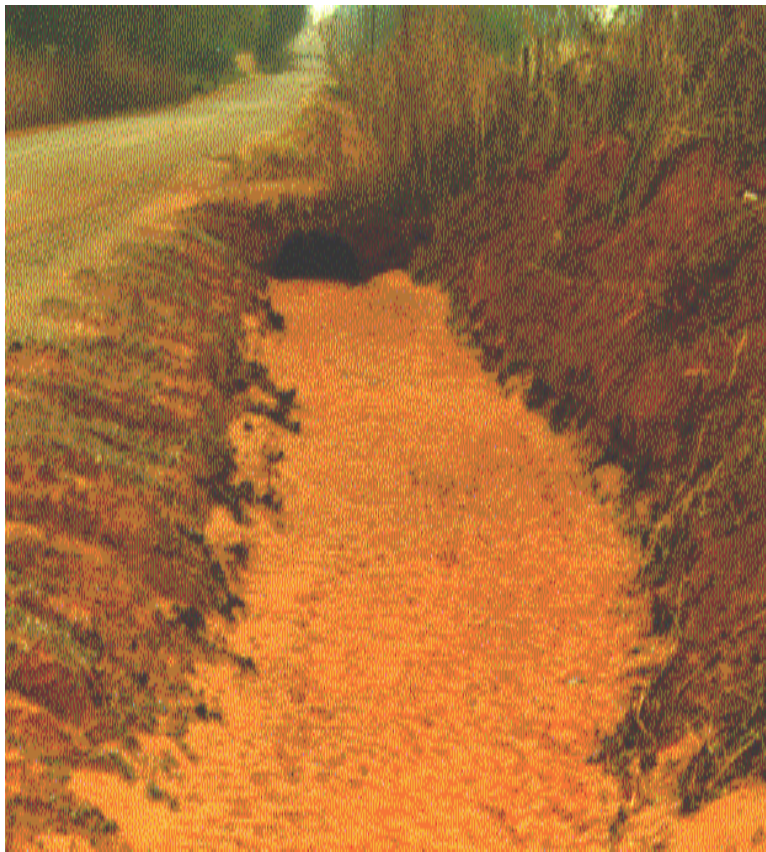
Figure 1.2 Sediment Deposition in a Culvert Along a County Road due to Upstream Erosion (location is south of Site 1).

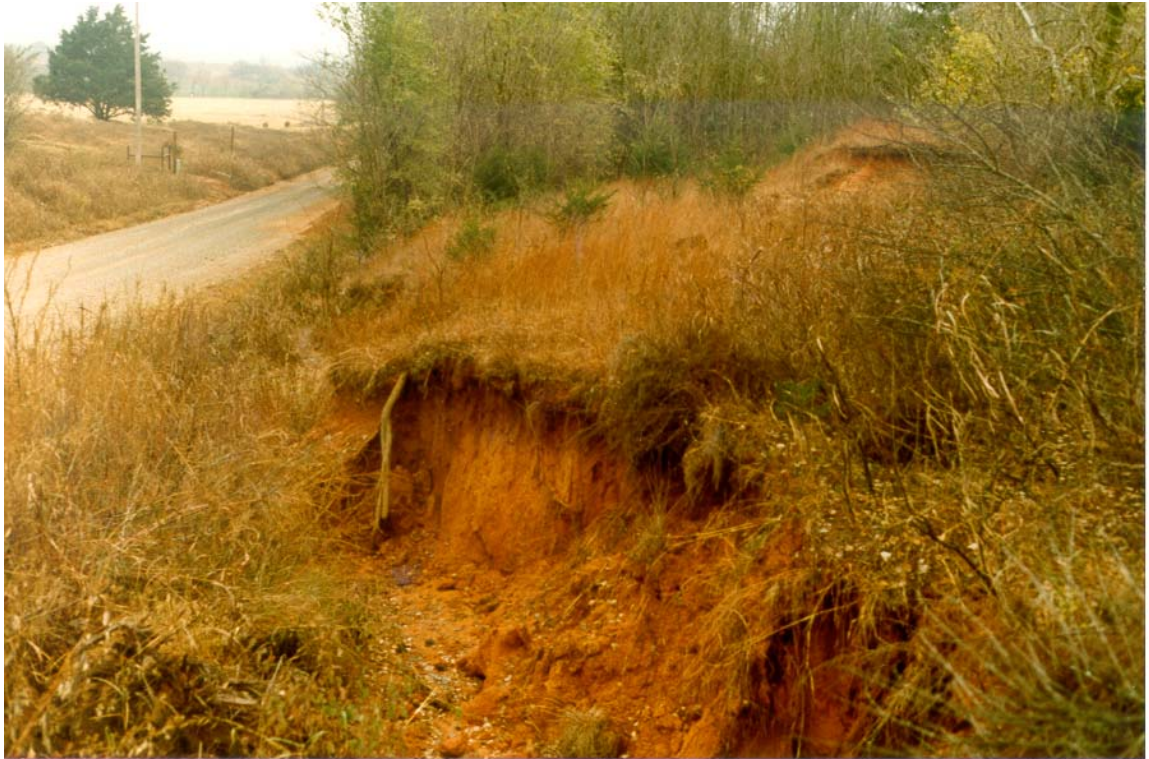
Figure 2.2 View of Site #1 Looking South Prior to Erosion Control.

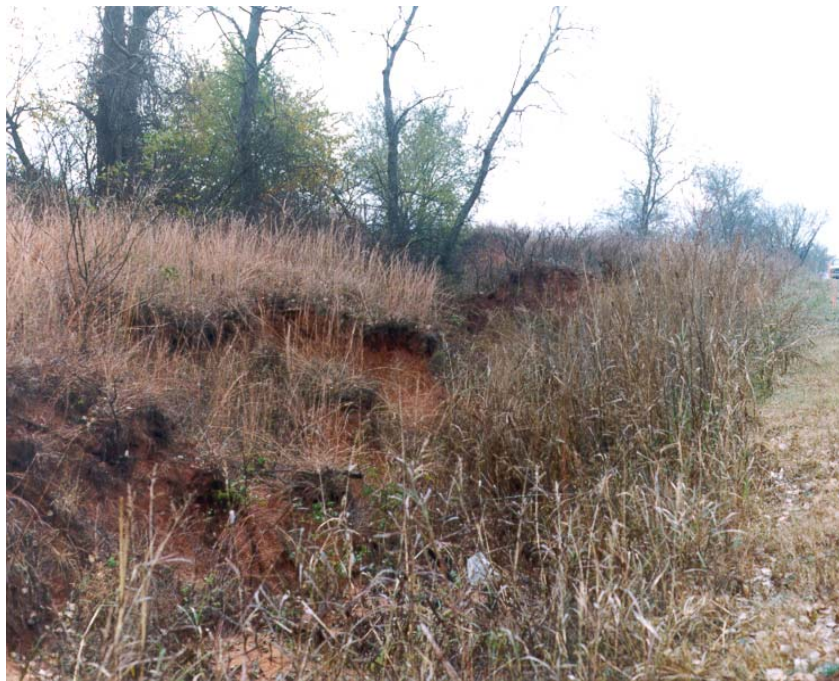
Figure 2.3 View of Site #1 Looking North Prior to Erosion Control.

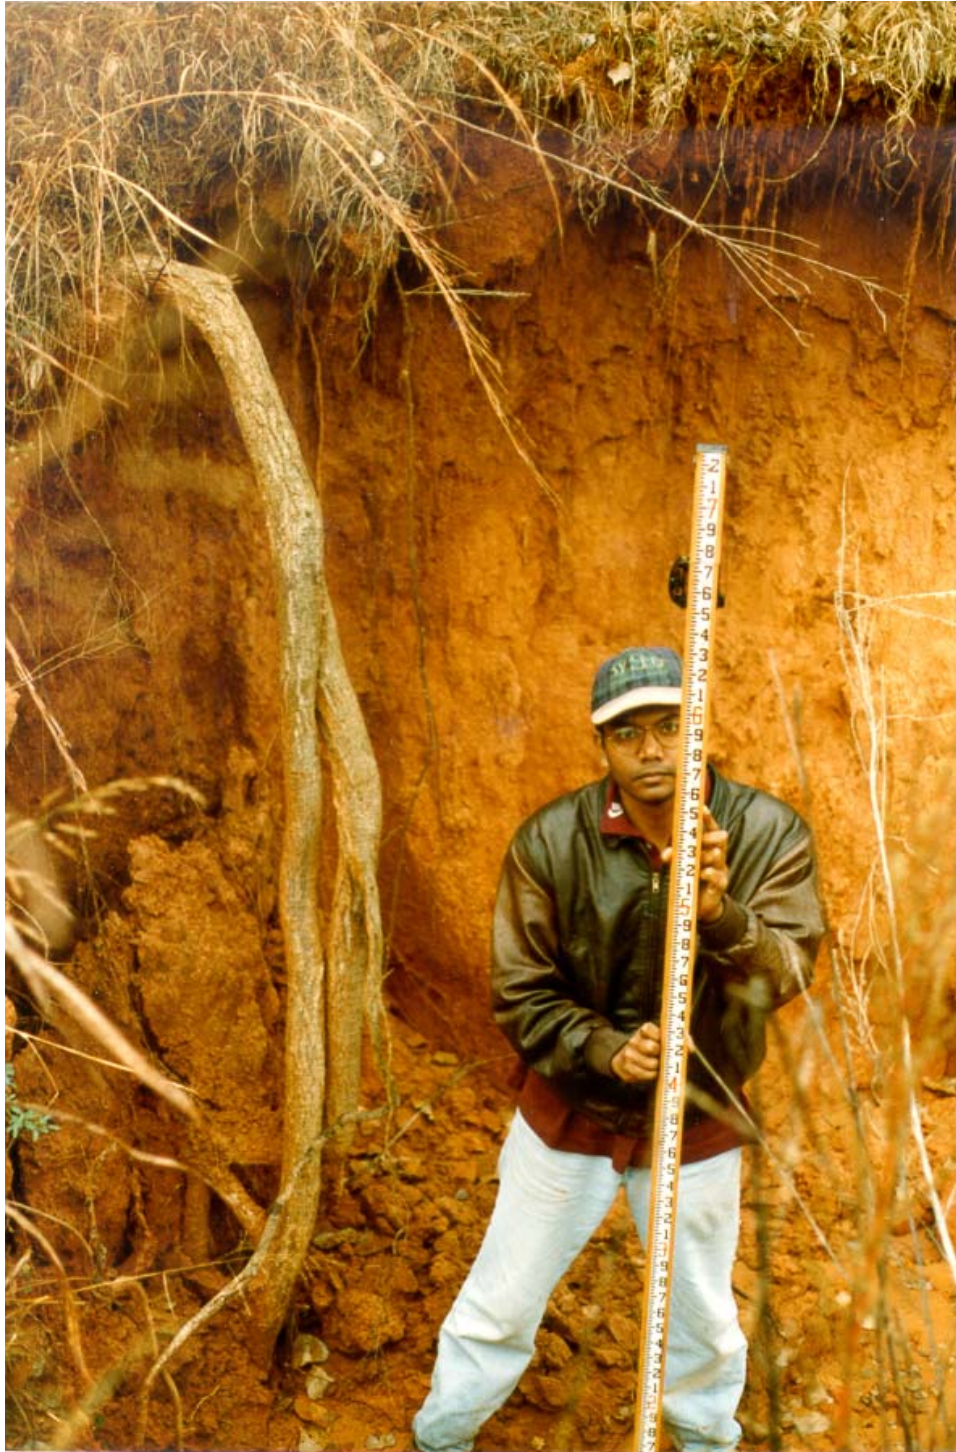
Figure 2.4 View of Gully at Site #1 Prior to Erosion Control (west side of road).

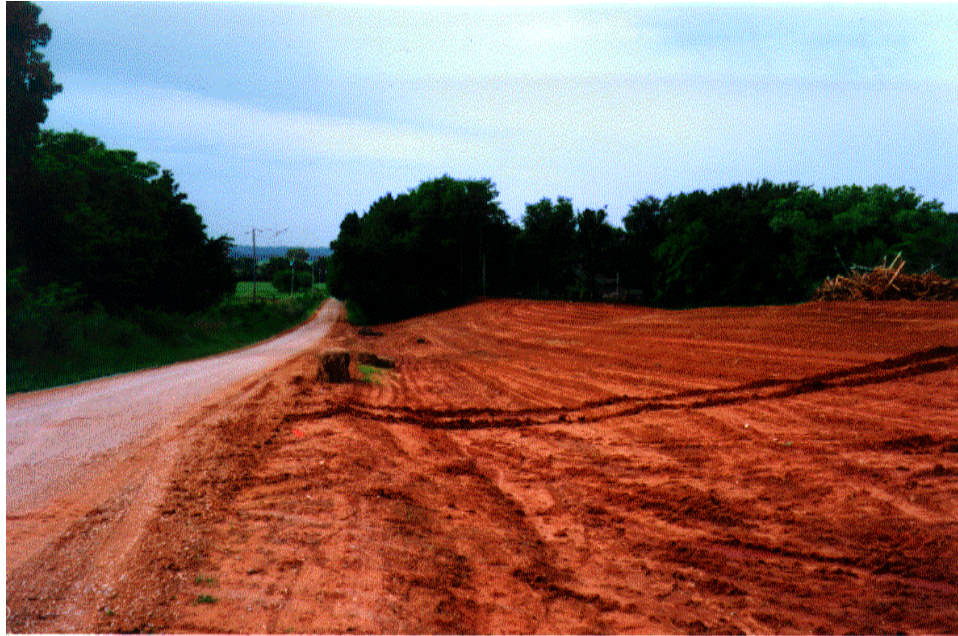
Figure 3.1 View of Site 1 Looking South after Earthwork and Grading.

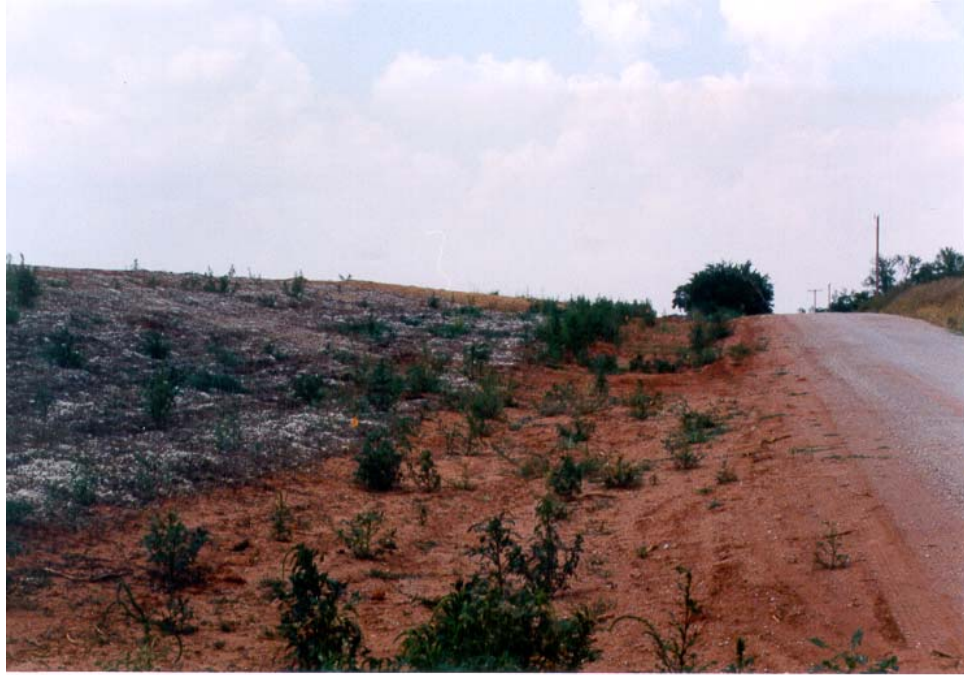
Figure 3.3 Cotton Burr Mulch at Site 1 with Limited Vegetation.

Both types of mulch proved to be effective in protecting the slopes while vegetation was established. In fact, following the completion of construction at Site 1 during spring and early summer of 1998, it took about two years to fully establish vegetation due to drought conditions that prevailed after during the summer and fall of 1998. Some effort was made by the commissioner to periodically water the site using a water truck, particularly in the drainage channel area, but these efforts did not seem effective. Nevertheless, while the site was exposed to the elements devoid of vegetation for a prolonged period, the mulch cover proved effective. The success of the mulch cover is partly attributed to the use of the sheepsfoot roller that was dragged across the site, which proved very effective at anchoring the mulch to the underlying soil.

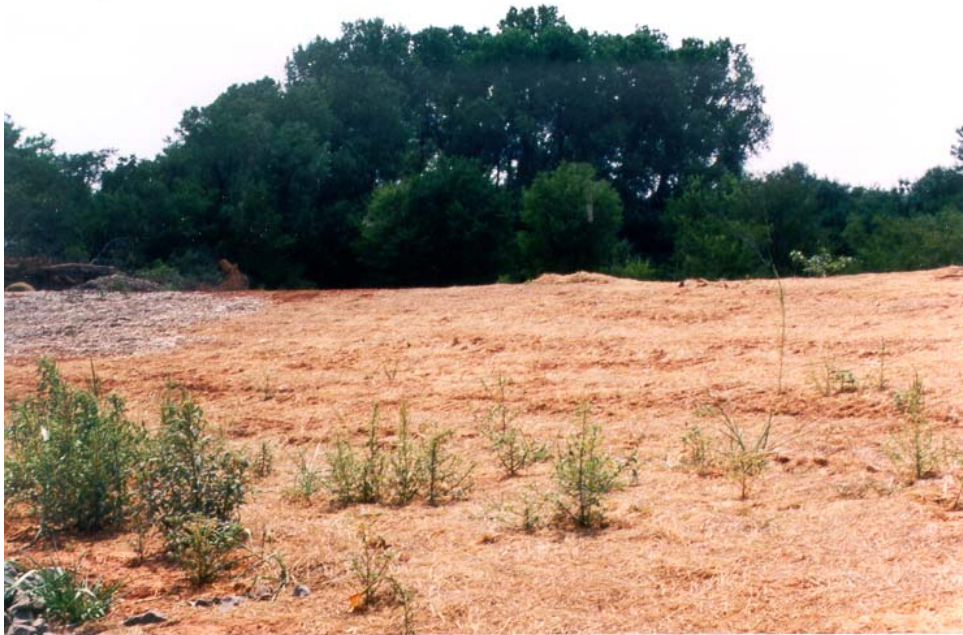
Figure 3.4 Hay Mulch at Site 1 with Limited Vegetation.

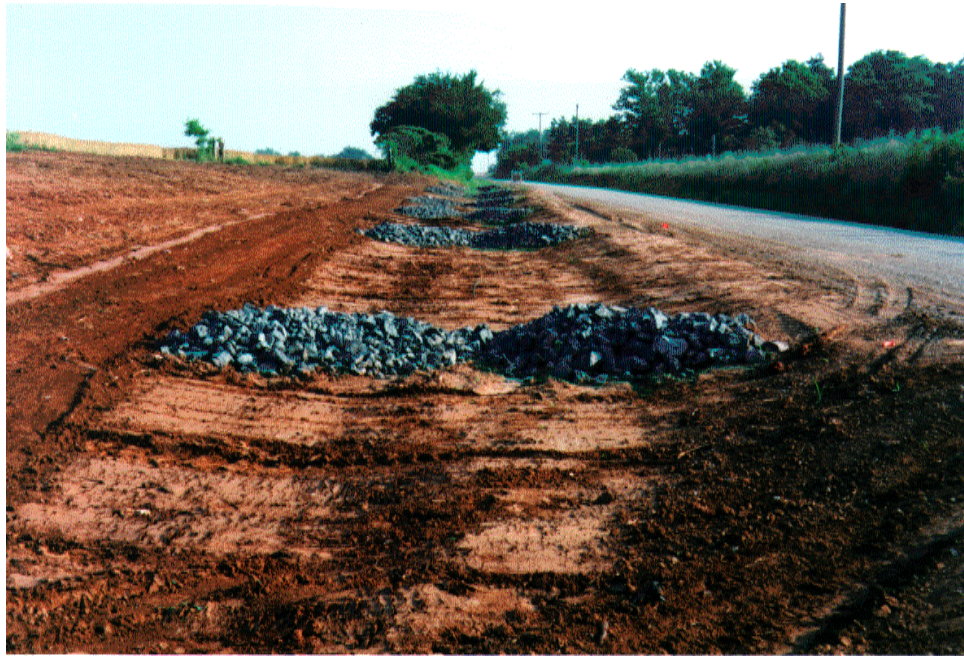
Generally, the rock structures proved effective at reducing erosion in the channel where they were used; however, some problems were encountered that should be considered for future projects. First, the design called for rocks (riprap) with a nominal diameter of 12 inches, but the county commissioner was reluctant to haul rock of this size because of the damage it could cause to the dump truck. Thus, it was decided that 6-inch rock would be sufficient. Some of the rock was actually moved during high flow events and it took some time to maintain these structures; however, they were stabilized due to infilling from soil and vegetation. A second problem was that shortly after construction, during a large rain event, channel flow short-circuited around one the structures because it was too high. Some reshaping of this particular rock berm alleviated the problem. Finally, while these rock structures are durable, the commissioner has complained that they make mowing operations more difficult. In place of rock berms, a series of swells, terraces, or berms formed of soil can be used, generally spaced every 100 feet or so depending on the channel slope. It is likely, however, that soil berms will be subject to erosion until vegetation is established and some maintenance will be required. One way to protect soil berms would be to encapsulate them in erosion control blanket to provide protection while vegetation is established.

Figure 3.6 Rock Berms Placed at Site 1.

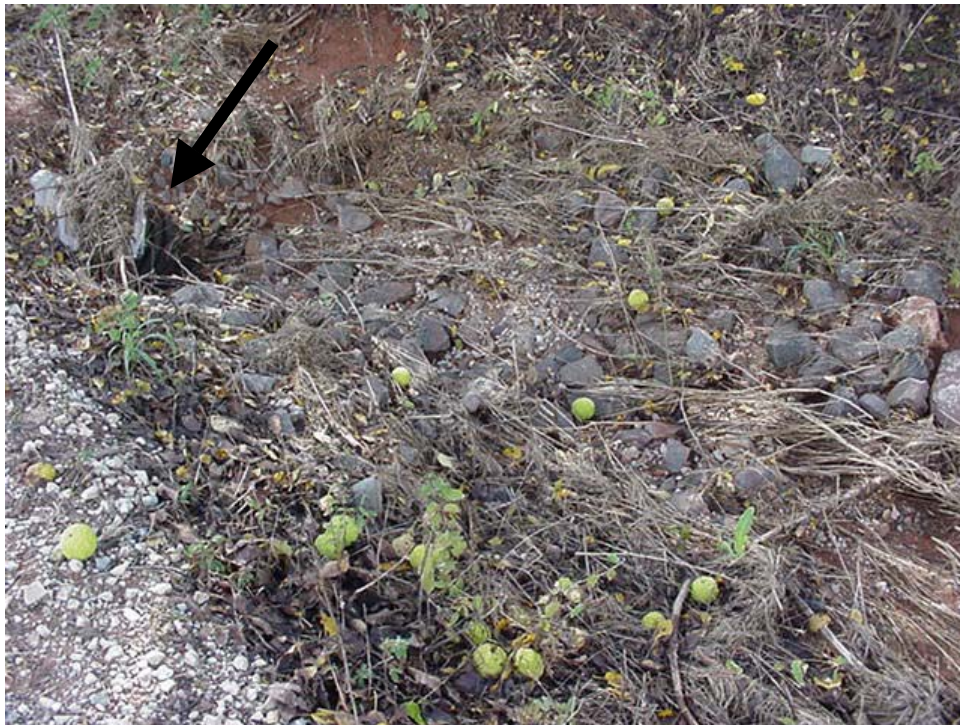
Figure 3.7 Rock Placed to Protect Soil Near Culvert Entrance. [Arrow points to culvert]

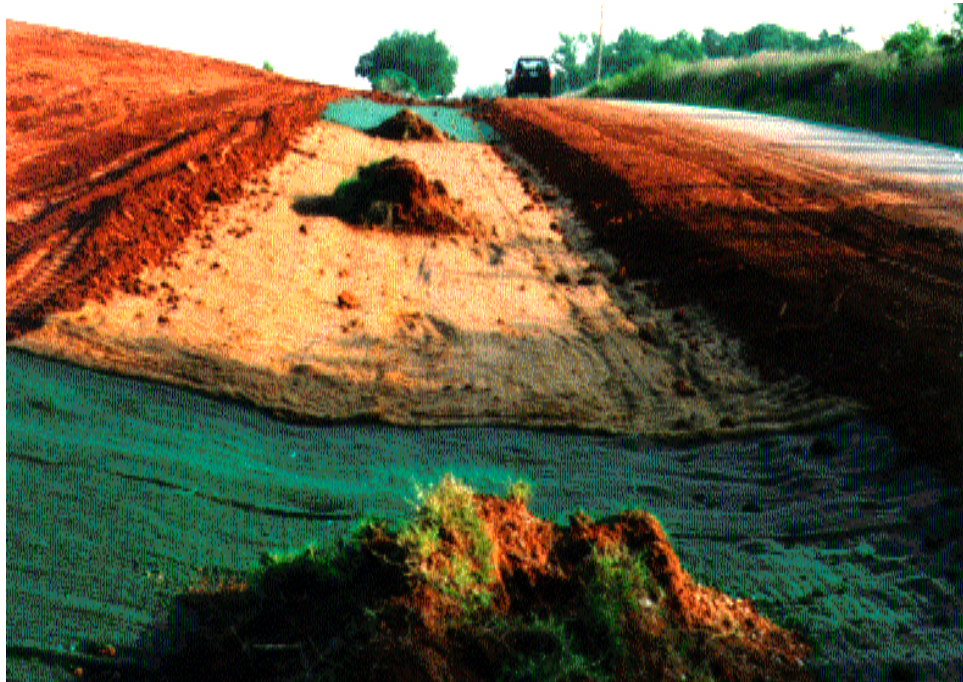
Erosion control blankets were effective at protecting the soil; however, the polypropylene blanket proved far more durable over the two years during which vegetation was established. Both natural fiber blankets tended to degrade and break down under exposure to the environment, and some repairs were required.

Figure 3.8 Erosion Control Blankets at Site 1.

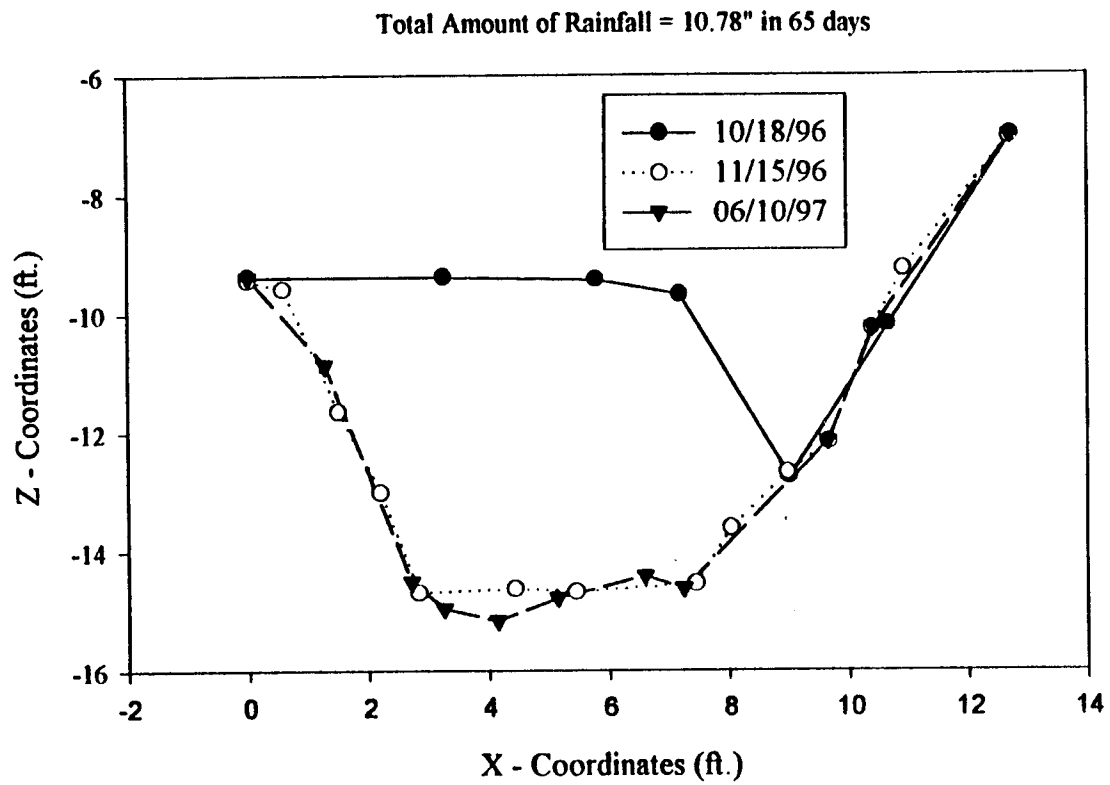
Bank pin measurements were made between the beginning of March and early October 1997. Sections 3, 4 and 5 show substantial down cutting, on the order of 0.5-1 ft., in the bottom of the channel, while the remaining sections show little change. At section 3 some deposition was also noted. Results from pin-section measurements are consistent with mass wasting observed along portions of the gully, where undercutting at the base of the channel caused the sides of the bank to collapse. When this happens, the loose soil in the bottom of the channel is rapidly carried downstream. A dramatic example of mass wasting was captured using optical surveying.

Figure 4.7 Mass Wasting Measured via Surveying at Cross-Section No. 4 at Site 1.

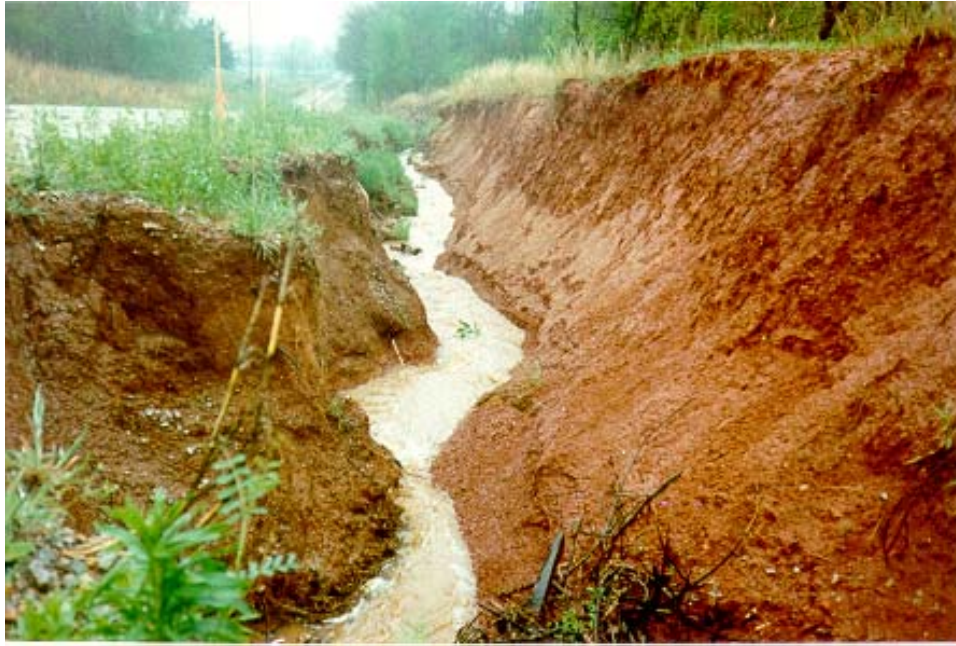
The sequence of photographs in Figs. 4.9-4.12 shows the conditions of the channel during each project phase. Note in comparing Figs. 4.10 and 4.11, that the soil covering the erosion control blanket (Fig. 4.10) has been eroded away (Fig. 4.11), which may partly explain the increase in total solids during post-construction before vegetation was

Figure 4.9 Flow in Channel Prior to Erosion Control, Looking South at Site 1 (Spring 1997).

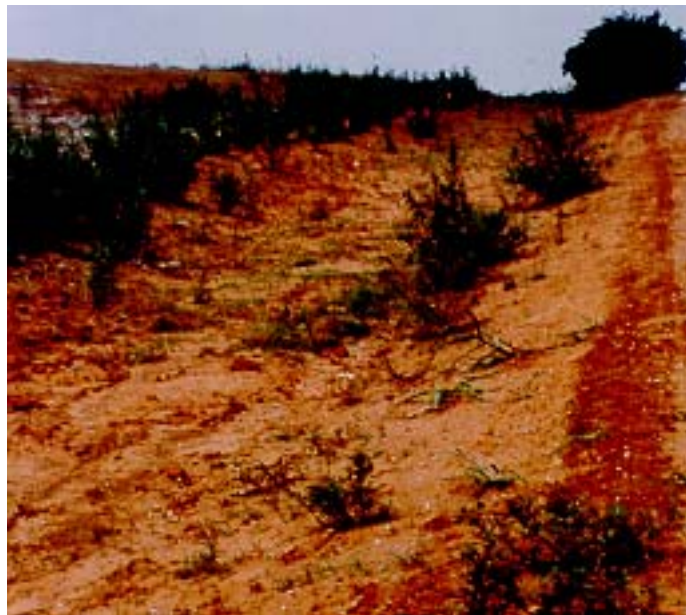
Figure 4.10 Condition of Channel 2 Months after Construction, Looking North at Site 1 (Summer 1998).

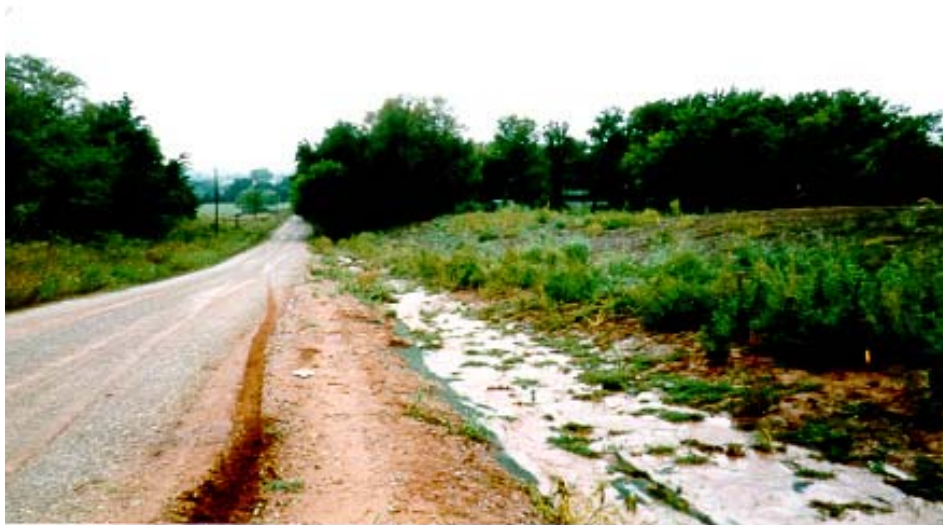
Figure 4.11 Condition of Channel 5 Months after Construction, Looking South at Site 1 (Fall 1998).

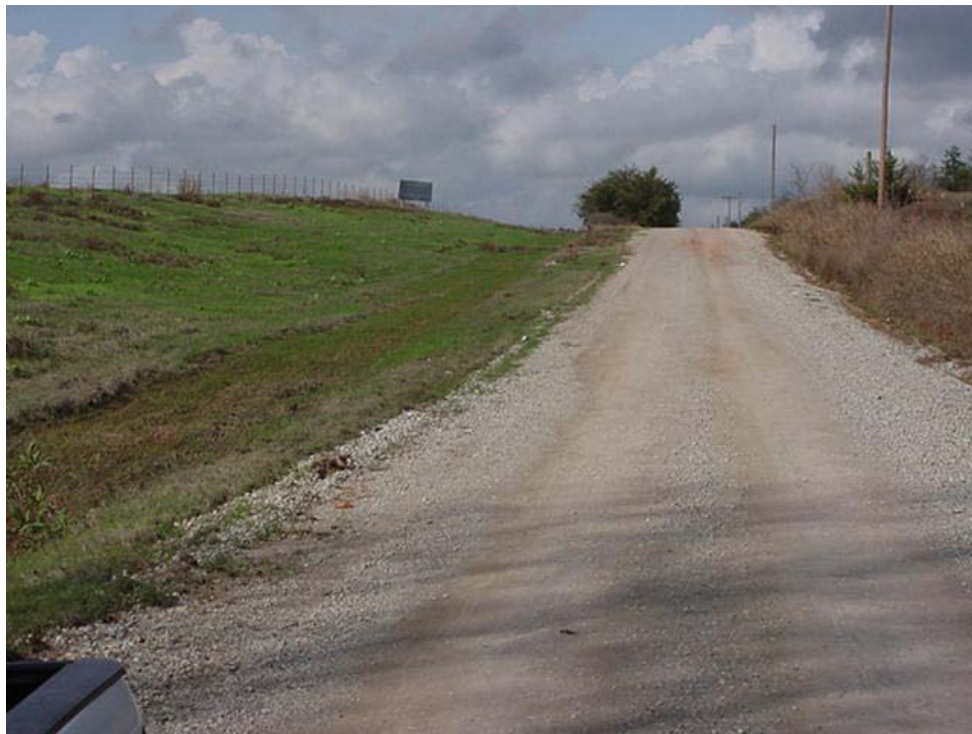
Figure 4.12 Condition of Channel Approximately 2.5 Years after Construction, Looking North at Site 1 (Fall 2000).

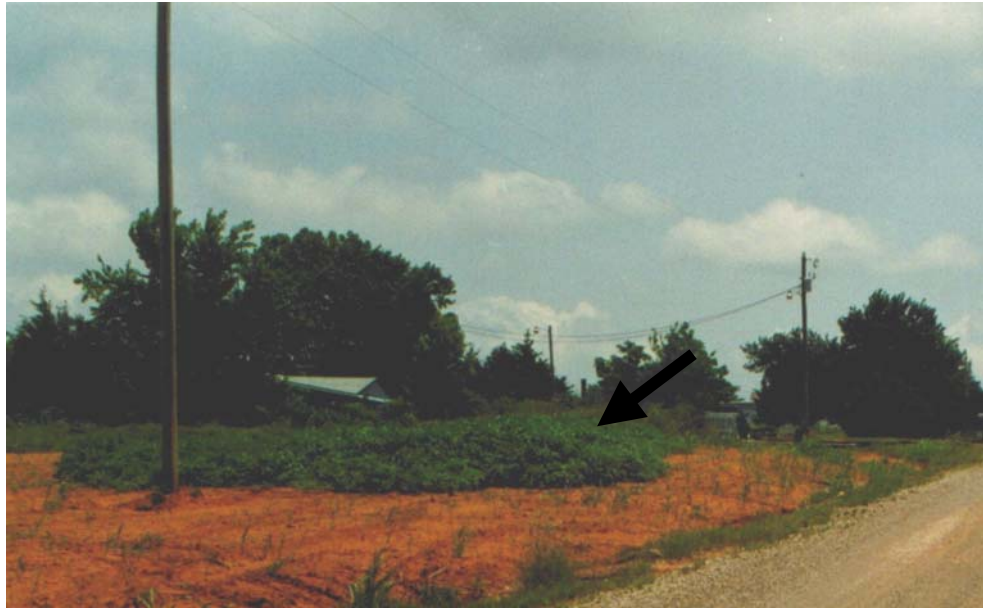
Figure 4.20 Site 2 Looking East 1.5 Months After Erosion Control (Spring 1999). [Note area of thick vegetation (arrow) where cotton burrs were placed.]

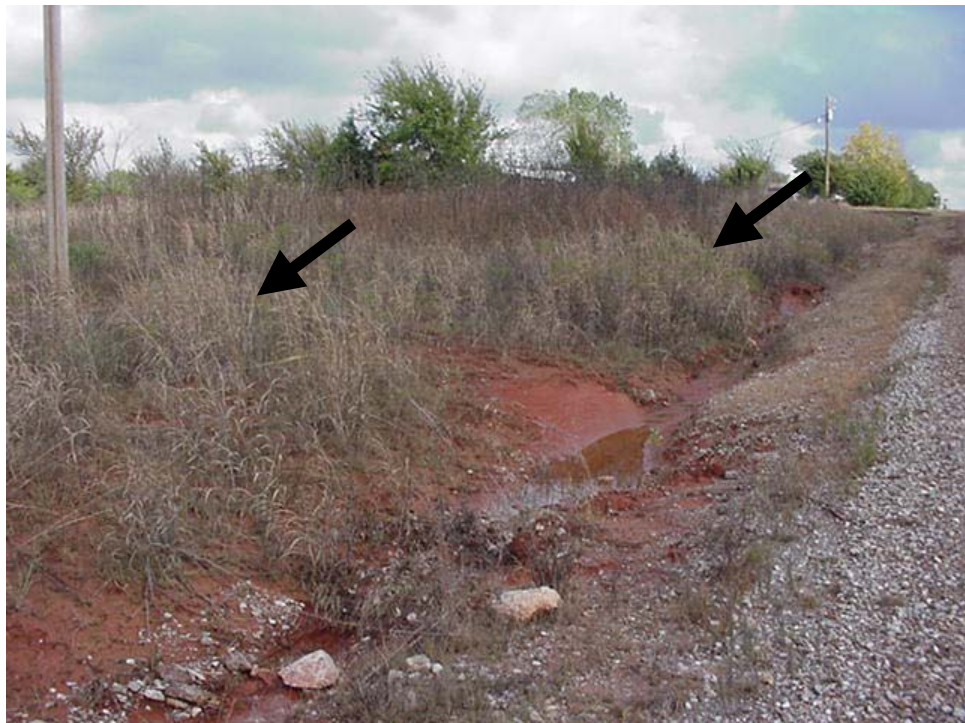
Figure 4.21 Site 2 Looking East About 1.5 Years After Erosion Control (Fall 2000). [Note vegetation (arrows) in vicinity of telephone pole and along road not observed in Fig. 4.20]

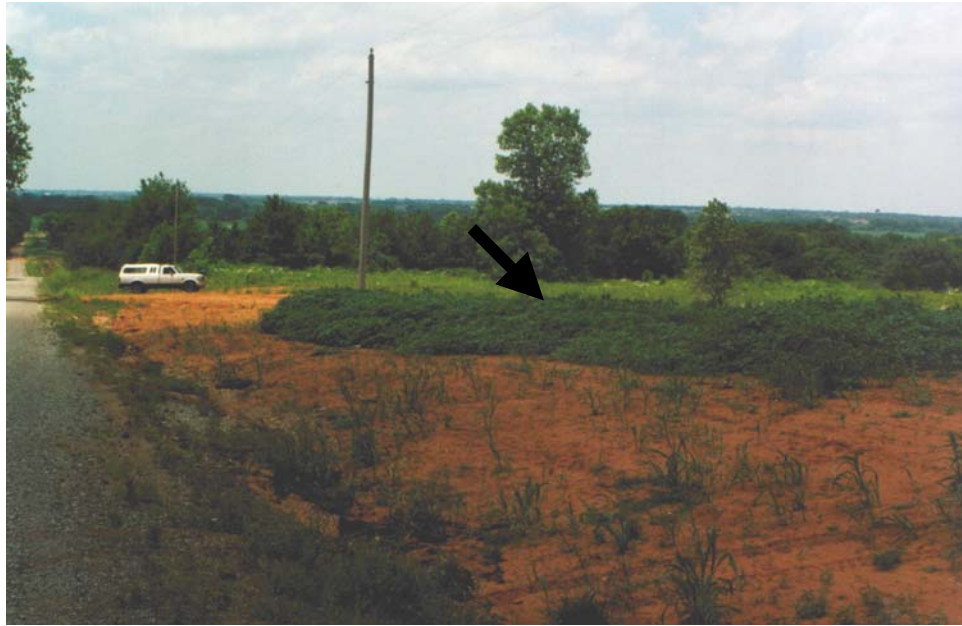
Figure 4.22 Site 2 Looking West 1.5 Months After Erosion Control (Spring 1999). [Note area of thick vegetation (arrow) where cotton burrs were placed.]

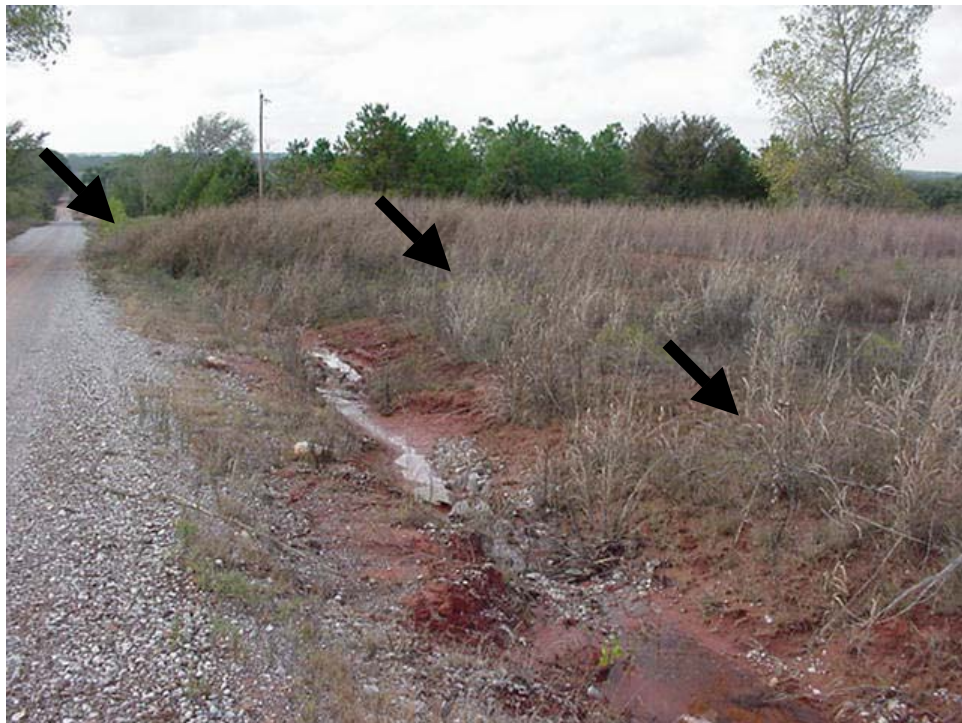
Figure 4.23 Site 2 Looking West About 1.5 Years After Erosion Control (Fall 2000). [Note vegetation (arrows) in vicinity of telephone pole and along road not observed in Fig. 4.22]
