# Honey Creek Restoration Project

*...restoration of wetland, stream  
& riparian habitat*

**EPA Grant C9-996100-10, Project 9**

**FINAL REPORT**

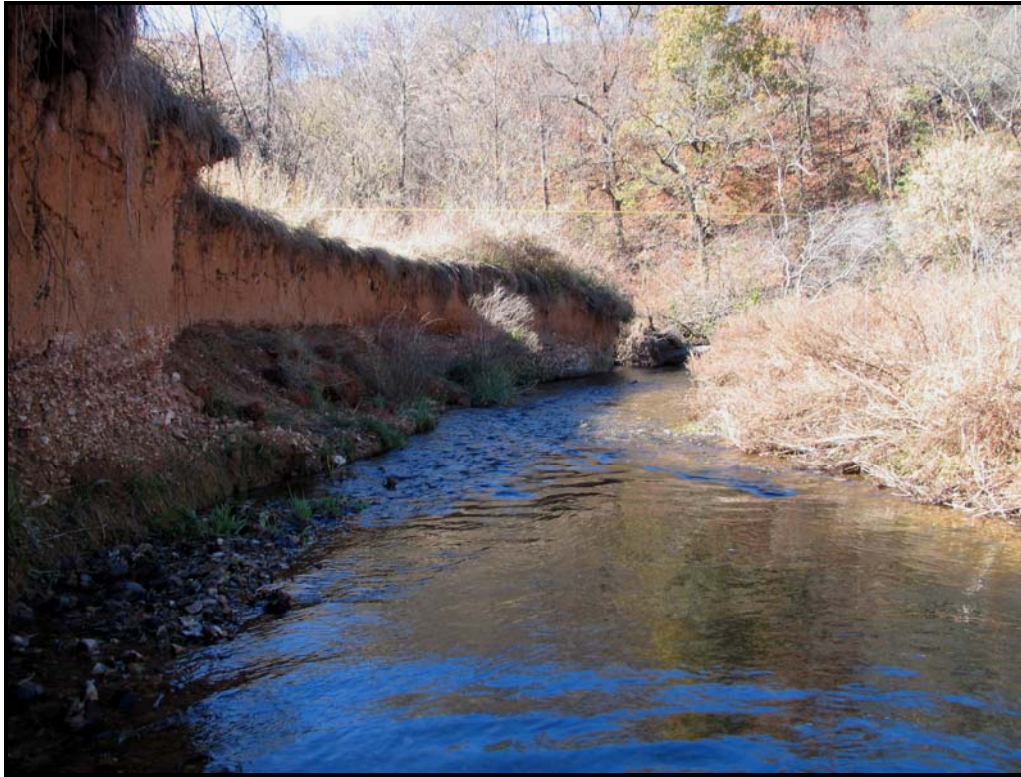
**Figure 2: Vertically eroding bank with gravel lens**

Prior to restoration, the study site was experiencing accelerated lateral migration (mean ~ 2'/year; Fisch 2003) inferring significant channel instability. A vertical bank of 7 to 8-feet in height was contributing excessive erosional materials to the stream. Incorporated in this bank was a lens of gravel approximately 2 feet above the bank top that further complicated site stability (**Figure 2**). An estimated 1500 cubic yards of material were added to the stream from this single bank during the last 10 years (Fisch 2003). Much of this material consisted of fine-grained particles which filled interstitial substrate space causing emburcation of otherwise mobile bed materials and associated channel aggradation. The negative consequences of these processes are well documented and include reduced biodiversity, disruption of food web mechanics, poor fish and insect reproduction, reduced year-class success and diminished water quality.

Left alone, sediment contributions from this reach to the Honey Creek system would likely exponentially increase as the radius of curvature continued to decrease. This trend in curvature tightening, which further increases near-bank shear and subsequent erosion, would probably continue until the meander evulsed. Impacts from this scenario would have included loss of adjacent lands and significantly higher sediment contributions to the stream. Ultimately, the physical complications of the reach would limit its overall biological productivity, hydrology and sediment transport regimes. Completion of the restoration endeavors presented below should circumvent these consequences and improve the stability of the study and adjacent downstream reaches.

A bankfull bench with an average width of 10 to 15-feet was constructed along the entire vertically eroding bank (**Figure 5**). A natural bench occurring upstream of the vertical bank was surveyed and used as a general template for bench construction. The dorsal surface of the constructed bench was relatively flat while the slope from channel toe to bench top mimicked adjacent stable conditions. The bankfull bench was vegetated subsequent to construction. The vertical bank, stabilized at lower portions by the vegetated bankfull bench, was returned to a < 1:3 ratio slope.

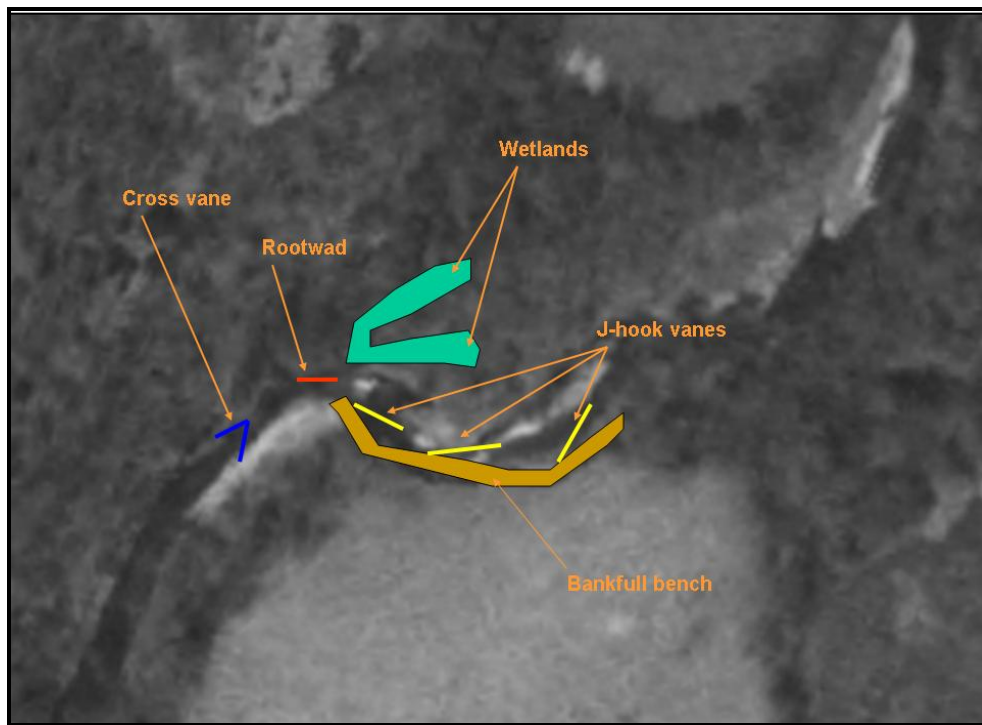
**Figure 3: Restoration plan overview**

Enhanced in-stream habitat, sediment transport, biological productivity and stability of the restoration site were achieved using applied fluvial geomorphology techniques. **Figure 3** depicts the general location of the constructed bankfull bench and stabilization structures and enhanced wetlands. The following portion of the plan includes a discussion of each restoration component.

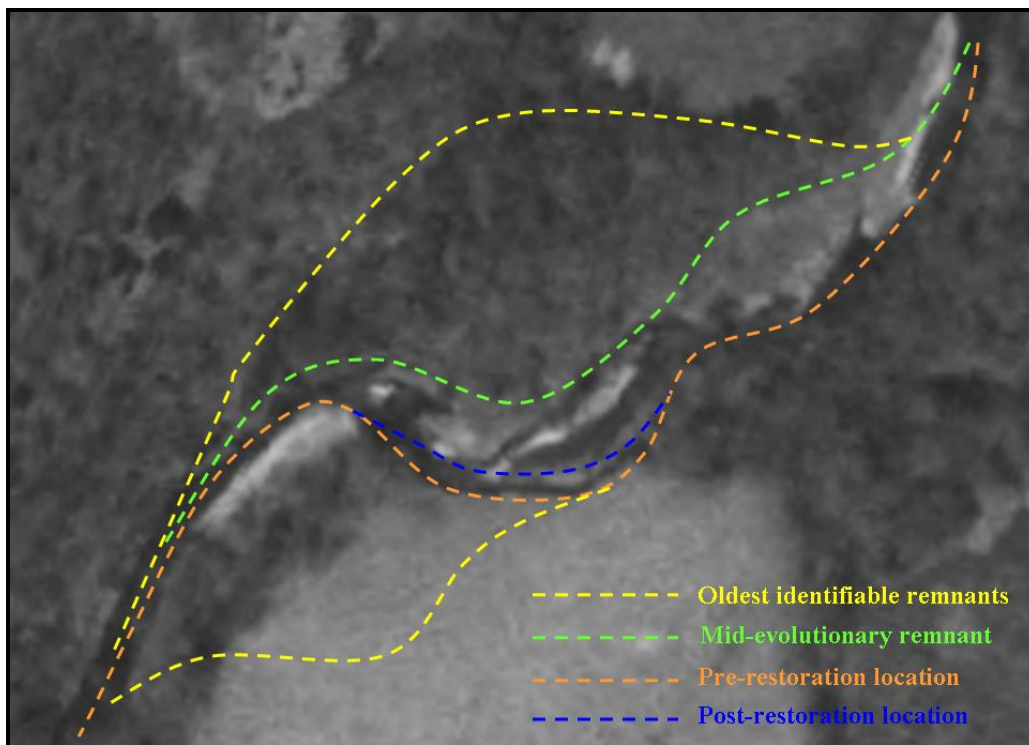
**Figure 4: Historic channel locations**

The degraded channel had migrated a significant distance across the valley floor (**Figure 4**) illustrating deviation from stable conditions. Much of the noted historic channel movement is likely associated with larger scale adjustments made by Honey Creek. A new left bank line was established about 10-feet from the existing bank to gain proper channel alignment. Adjacent reaches indicated stability could be achieved with the target radius of curvature once appropriate vegetation buffers and bank slopes were instituted.

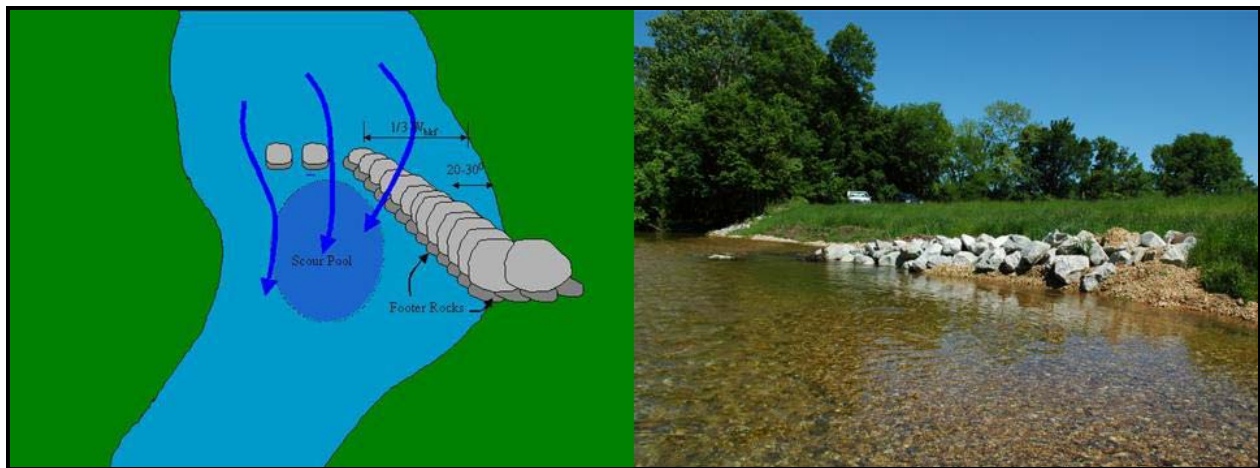
**Figure 6: J-Hook Vane**

Hard structures constructed from natural materials, including three J-hook vanes (**Figure 6**) and a cross-vane (**Figure 7**), were used to maintain appropriate energy gradients. Additional benefits of these structures include grade control, bank stabilization and in-stream fish habitat improvement. All vanes were constructed of large boulders (> 30" diameter) with root wads or logs integrated when possible. The vanes were built with an interior departure angle of 20 to 30-degrees. The proximal end of the vanes have an elevation at or near the bankfull stage then decrease toward the distal end to an elevation slightly above bed grade. A single cross-vane was used below the primary site to insure upstream grade control and reduce the chance for headcut disturbance of the site. Similarly, a rock sill was constructed across the entire bankfull channel width at a grade commensurate with the uppermost J-hook vane.

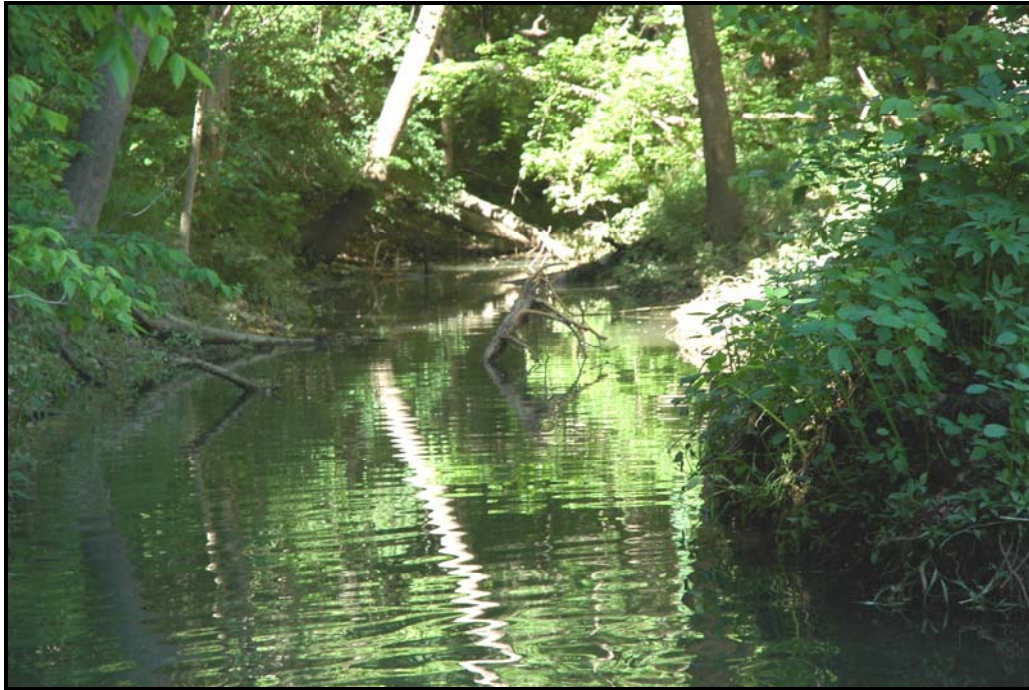
**Figure 8: Image of newly constructed wetland**

An existing wetland feature occurring adjacent to the active channel was enlarged and deepened. Additionally, a remnant channel was reconnected for wetland and backwater habitat near the limestone bluff, located on the right descending floodplain perimeter (**Figure 8**). Highly permeable gravel lenses accommodate filling of disconnected wetlands during low flow periods. Reinforced floodplain plugs increase stability of these features. Lastly the uppermost J-hook vane was positioned to preserve a small wetland feature occurring upstream of the study reach.

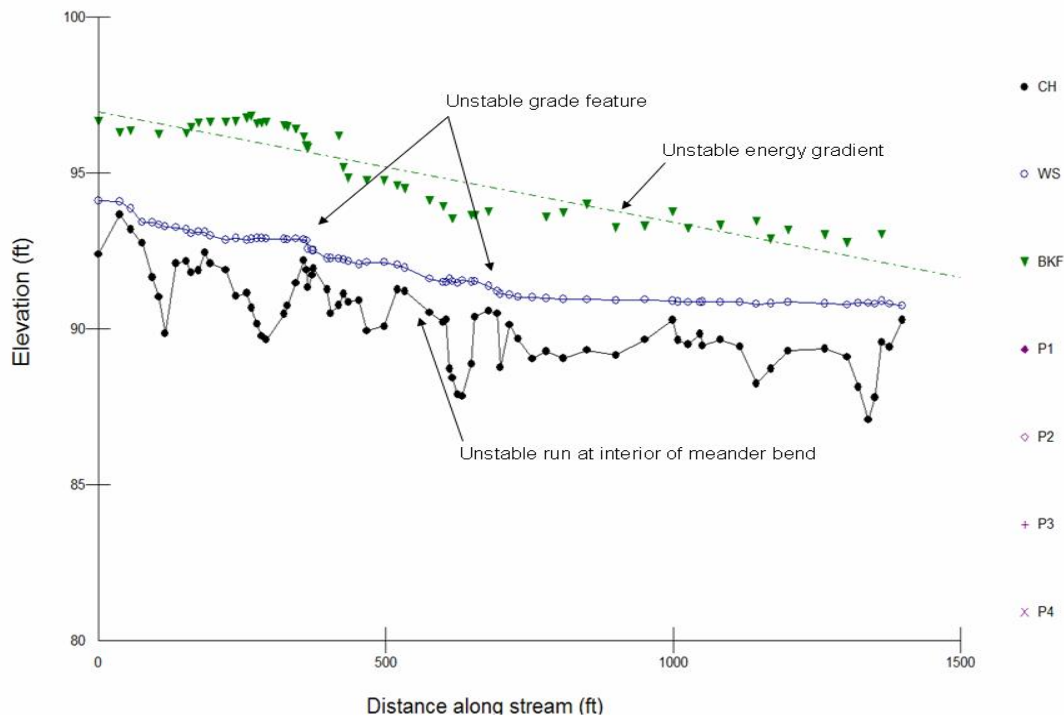
**Figure 9: Pre-restoration longitudinal profile**

Channel slope was assessed with longitudinal profiles (**Figures 9 and 10**). Hydraulic slope was reduced from approximately .0055 to .0040, more typical of stable reference conditions (.0020 to .0038), by installing a cross-vane at the terminal end of the project reach. Further, a bankfull bench was constructed along the vertically eroding bank at a longitudinal slope of .0030. The energy gradient (.040) of the stream will likely evolve towards the bankfull slope (.030) as sediment transport is performed and the reach finds equilibrium in its restored condition. The stable energy gradient should be maintained because of: 1) downstream structural control via the cross vane; 2) upstream structural control via a rock sill installed at grade in association with the upper-most J-hook vane; and 3) proper energy distribution and sediment transport attributed to re-establishment of a stable pattern, dimension and profile.

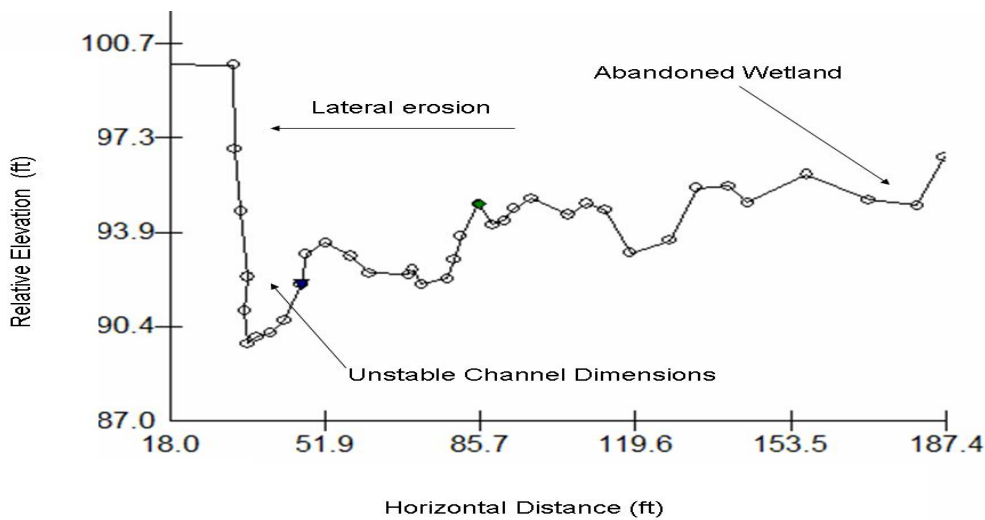
**=Figure 11: Pre-restoration cross-section (typical)**

Six cross-sections were measured to quantify changes following restoration. Two representative cross-sections depicting pre- and post-restoration conditions (**Figures 11 and 12**) are presented below. It is important to note the constructed bankfull bench (post-restoration cross section; **Figure 12**) which improves dissipation of near bank shear stress.

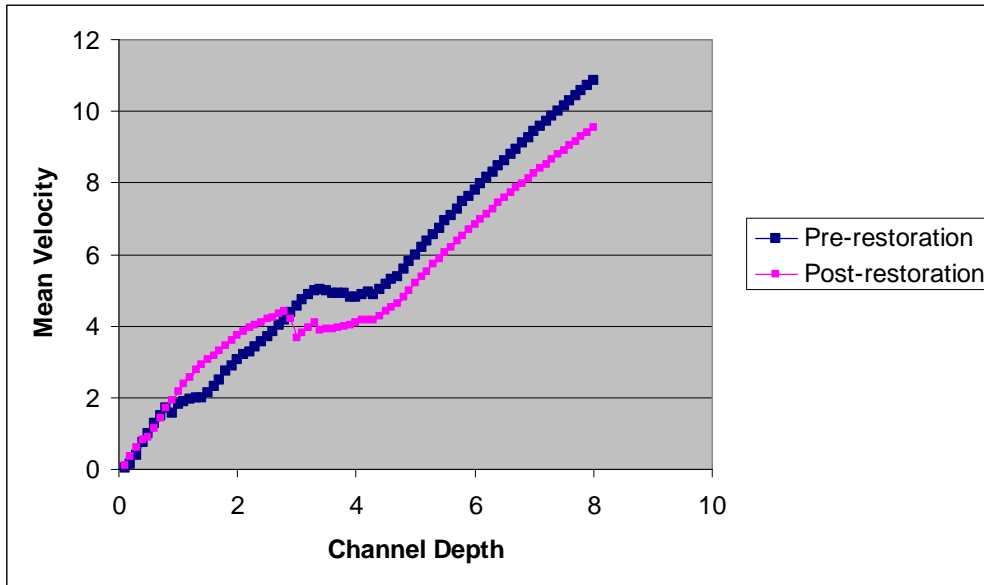
**Figure 13: Mean channel velocity (pre- vs. post-construction)**

Using RiverMorph, near bank shear stress values were predicted for the pre- and post-restoration channel. Unstable channel pattern, dimension and profile (manifested in a vertically eroding bank) produced excessive shear stress and average channel velocity values in the pre-restoration condition (blue line, **Figures 13 and 14**). Re-establishment of reference conditions decreased shear stress and velocity predictions (pink line; **Figures 13 and 14**) thus increasing channel stability.

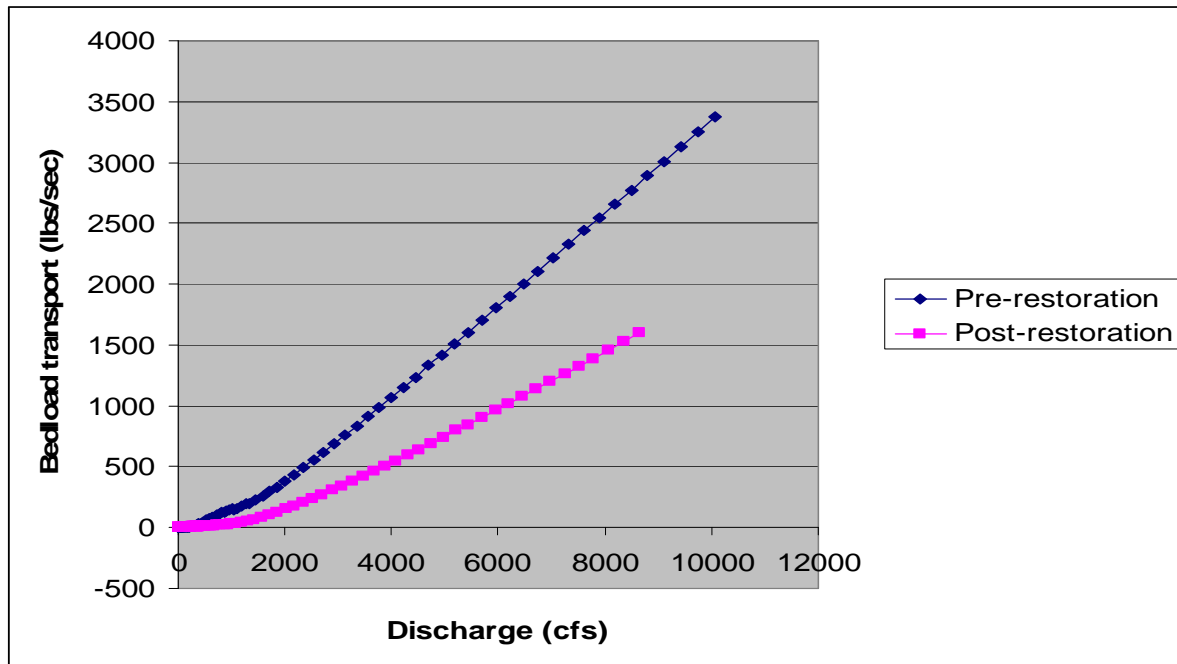
**Figure 15: Predicted bedload transport (pre- vs. post-construction)**

Estimations of local bedload transport in the pre-restoration channel demonstrate the unstable characteristics which exist between high energy and bedload transport. Excessive bedload transport rates are a product of the unstable energy conditions at the restoration site. Bedload transport rates (**Figure 15**) should be reduced in the new channel as the energy gradient has been stabilized both longitudinally and cross-sectionally.

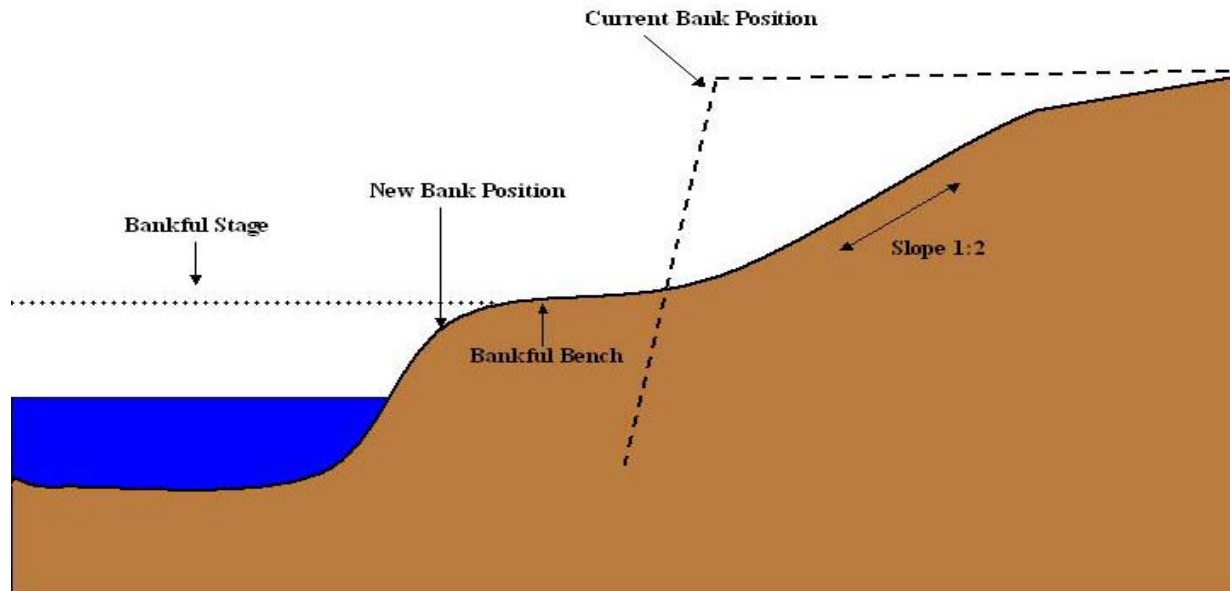
**Figure 25: Bank slope and bankfull bench**

A bankfull bench, or floodplain, will be constructed where presently absent. While the distance between the bench and present left bank will vary, depending on target meander geometry, the average distance will be 10 to 40-feet. The vertical bank, stabilized at lower portions by the bankfull bench, will be returned to a target 1:2 ratio slope. **Figure 25** depicts post-restoration condition of the bankfull bench and upper bank slope.
