Demonstration Project: *Mitigation of NPS Impact to Littoral Zone of Lake Thunderbird Cleveland County, Oklahoma*

Lake Thunderbird FY- 00 319

October 24, 2005

Agency: Oklahoma Water Resources Board (OWRB)

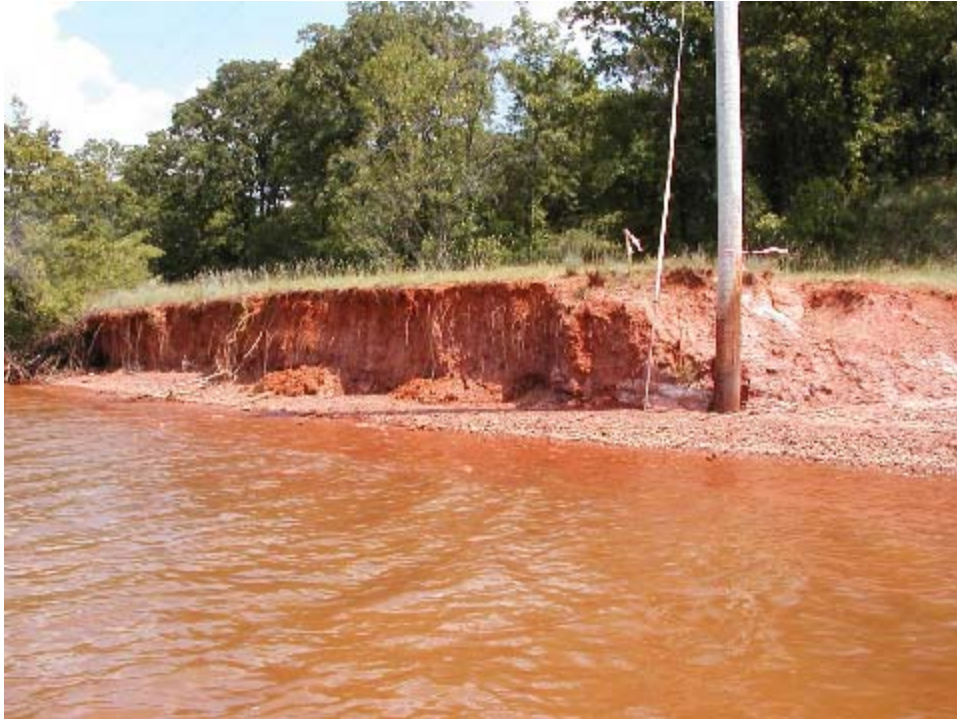
Above the site is an old roadbed that, while not in use, is threatened by scour. The taller more vertical escarpment on the western end approaches 9 ft. in height. The escarpment diminishes as it runs east to a much shallower slope 3 ft. tall with a gentle bench slope to the water (Figure 4). There is a rock outcrop at the easternmost point. The rest of the bench along the site is made up of stones, very small gravel, and clay.

Figure 2: West end. Escarpment near Calypso Cove Marina. Note the once-buried telephone pole.

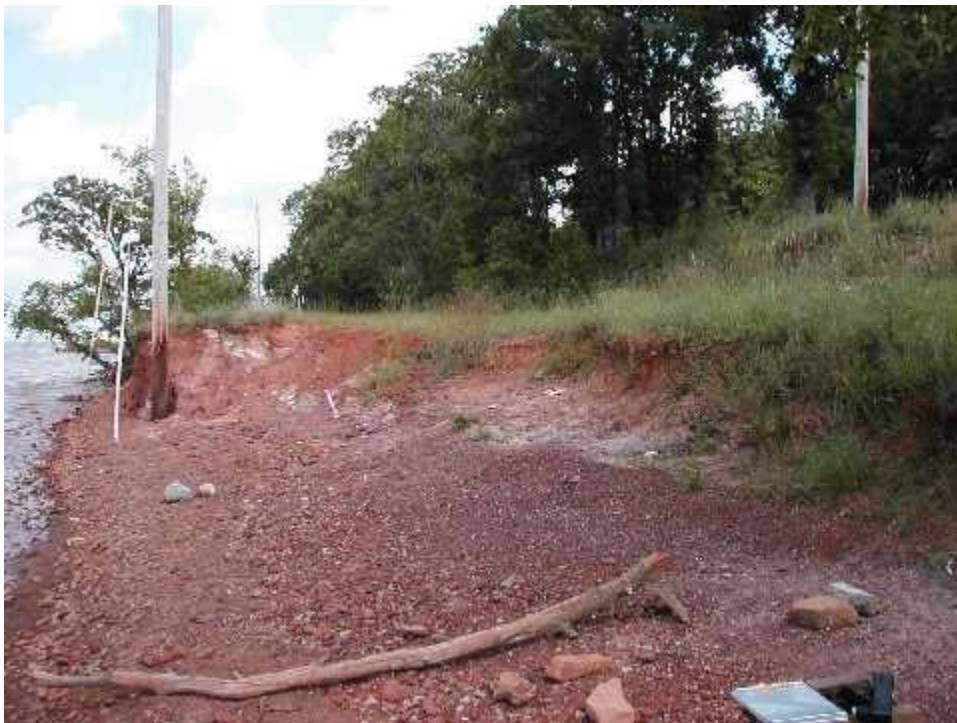
Figure 3: West end looking east. Eroded beach and drop-off at site. Note the once-buried telephone pole.

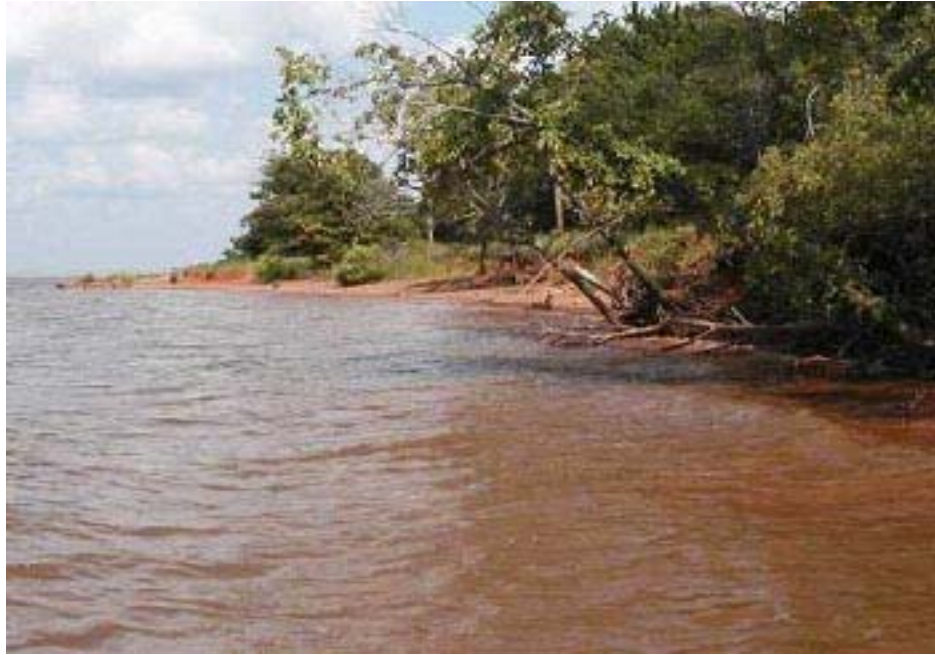
Figure 4: East end (Looking east). Gently sloping banks up to 3 ft. escarpment to the old roadbed.

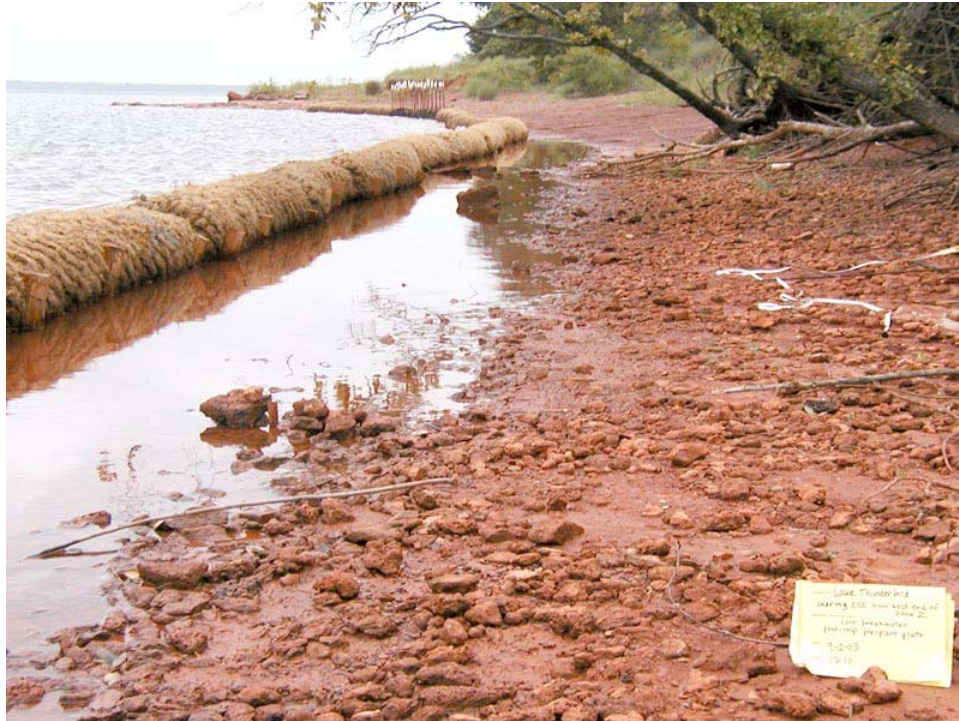
September 2, 2003: The preliminary sampling of extant plants before planting showed a prevalence of terrestrial species with a few scattered water willows (*Justicia americana*) and pondweed (*Potamogeton spp.*), at or above the 1040' pool elevation. No other aquatic species were found (Figure 17).

Figure 17: Sparse vegetation on original shore

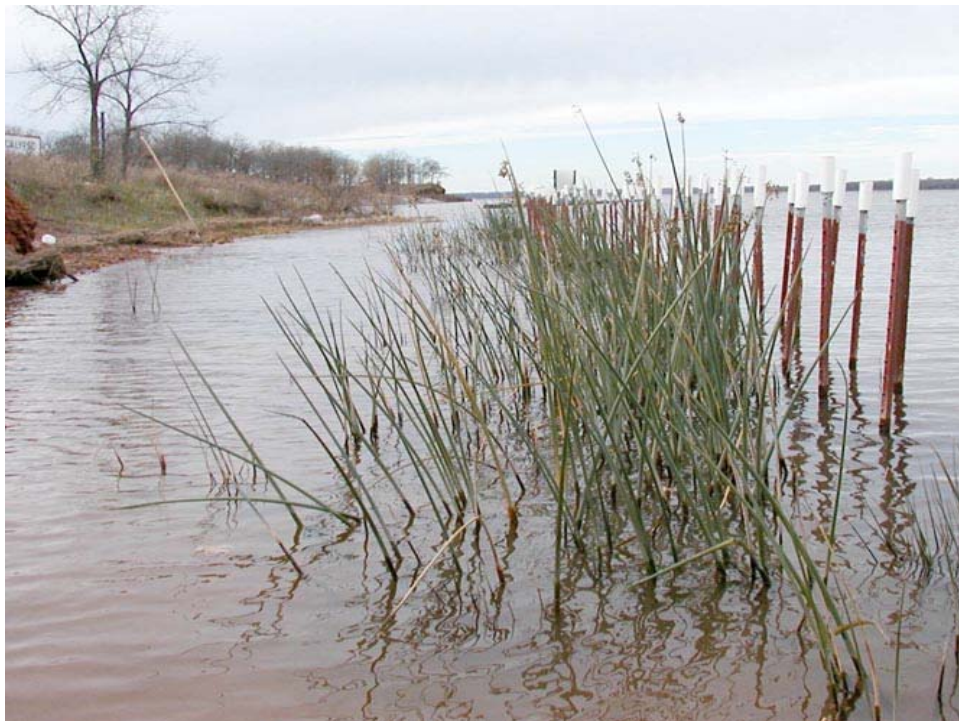
December 8, 2004: The water was still warm and the lake had not yet experienced its first freeze. It is not presumed that the December assessment date had a great effect on the survival counts for bulrush or water willow. The limited species that were seen in the previous session were still vibrant and not yet dormant (Figure 18).

Figure 18: Tall healthy stand of softstem bulrush. View of western branchbox, December 8, 2004.

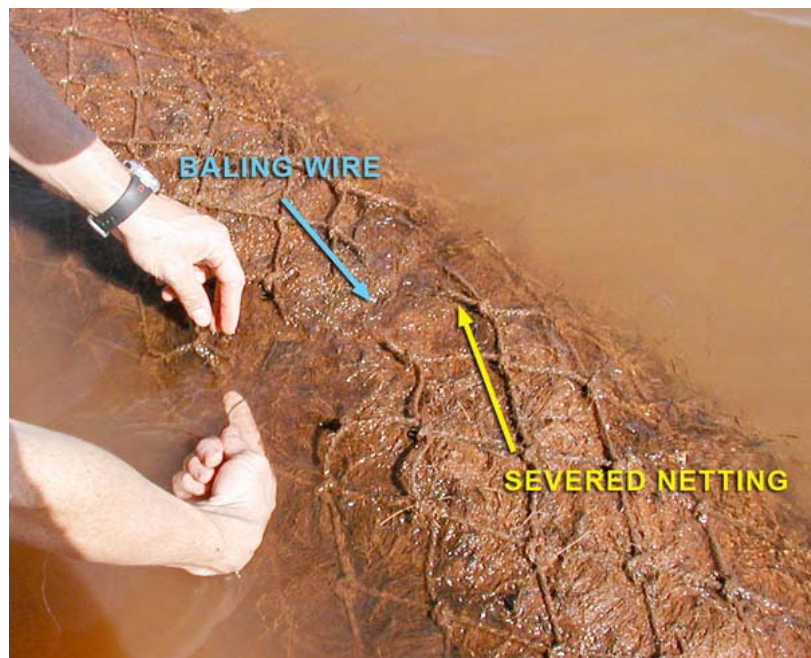
Problem 1. The Coir breakwater (CGR) washed out after a storm in July of 2004 after waters had finally risen to the top of the CGRs. Heavy waves apparently rocked the CGRs enough to rub the outer netting against the baling wire that held them in place. This rubbing action worked to eventually sever the netting on the CGRs and loose the fibers within. Only three rolls remained when the problem was discovered on July 8th, 2004. From these rolls it was possible to see the cut nets and determine what happened to the collapsed rolls (Figure 19). Many of the wooden stakes had pulled up or come loose as well. The coconut husk fibers collected along the shore (Figure 20).

Figure 19: Wave action and baling wire severs netting on a remaining CGR that will eventually allow fibers to wash out.

Heavier vinyl coated 3/16" cable should be substituted for the thin baling wire to protect the netting from abrasion. More durable nylon netting is available for CGRs and should probably be used in future projects. The netting for these CGRs was a natural fiber rope chosen because it would biodegrade over time. Another anchoring system should be used for the CGRs instead of the 24" wooden stakes to insure they stay in place.

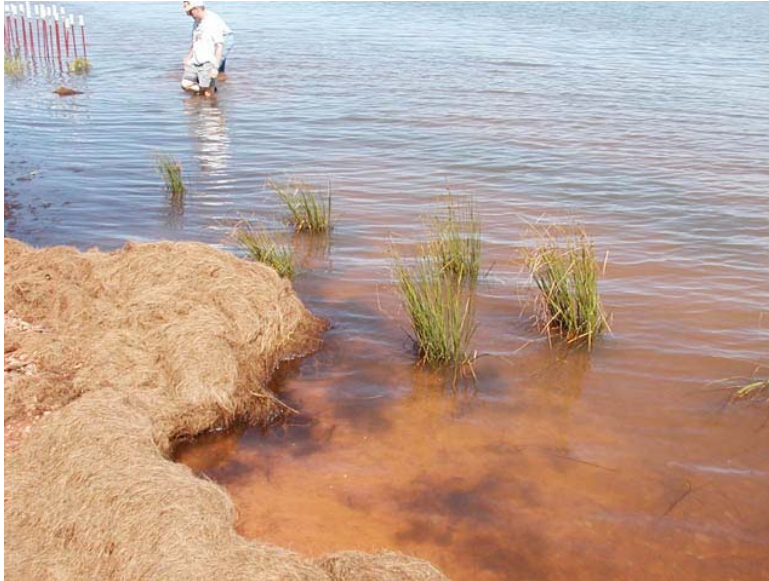
Figure 20: July 14, 2004 - Assessment of CGR breakwater collapse after storm event. Coconut fiber rests on the shore with remaining plants once protected by the CGR.

Solution: While nothing could be done to repair the disintegrated CGRs, remedies can be formulated for use of such rolls as breakwaters in future projects.

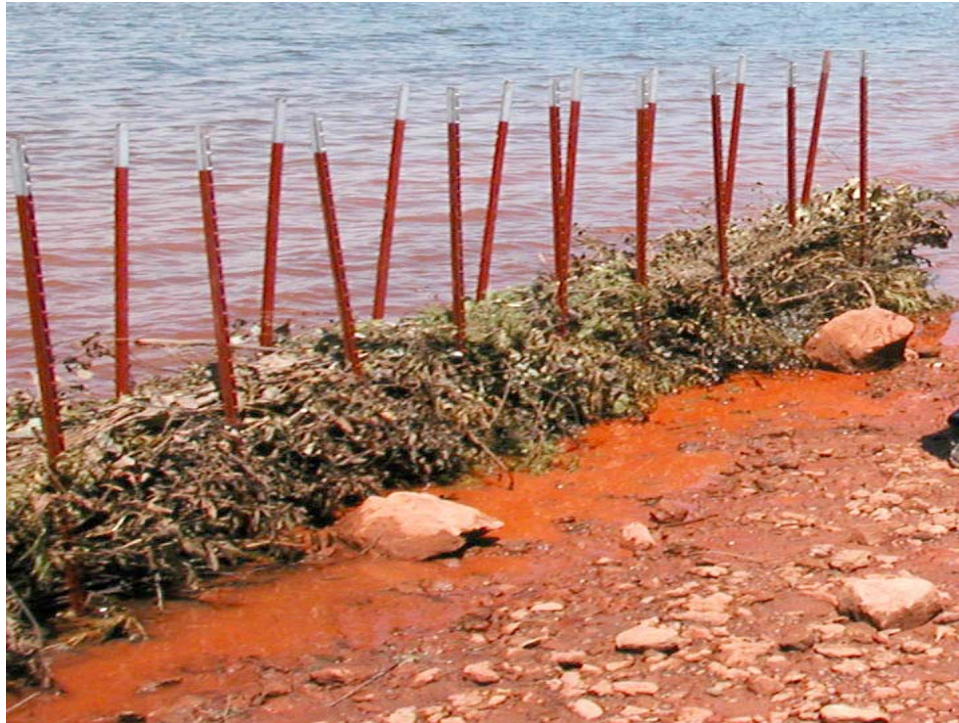
Figure 21: Rocky shoreline at time of breakwater installation, August 2003.

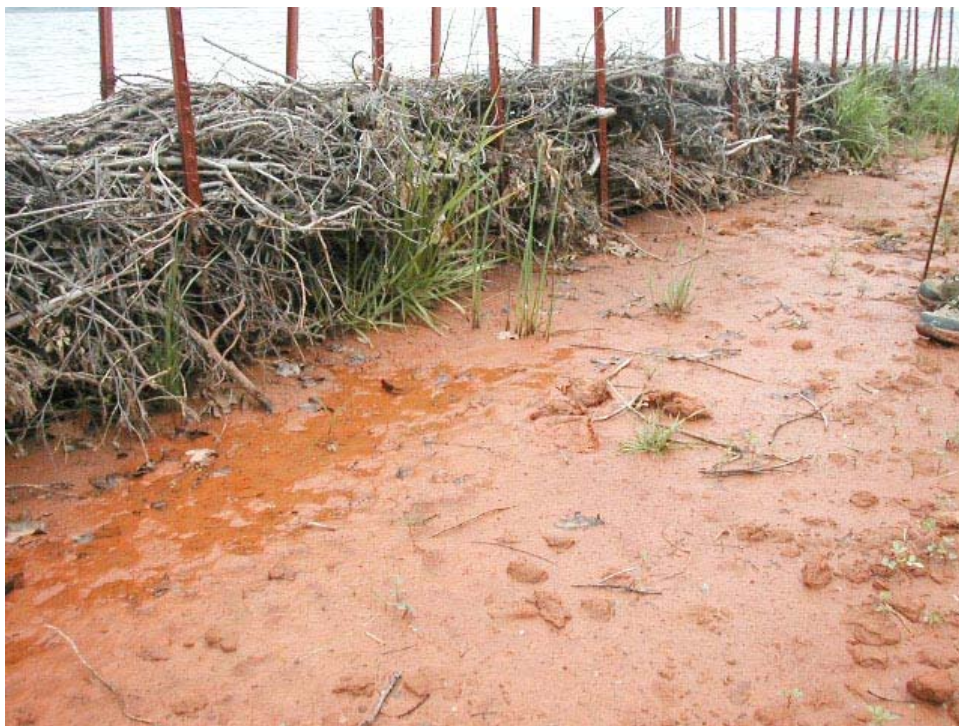
While below the detection of our chosen methods, positive accretion was visible and did occur just shoreward of the breakwaters (near 1,037' MSL) where very shallow water (several inches) pooled behind (Figure 21 & Figure 22). Fine sediment settled and filled in between the small rocks that originally made up the shore.

Figure 22: Fine Sediment filled in the originally rocky shore, April 2004.

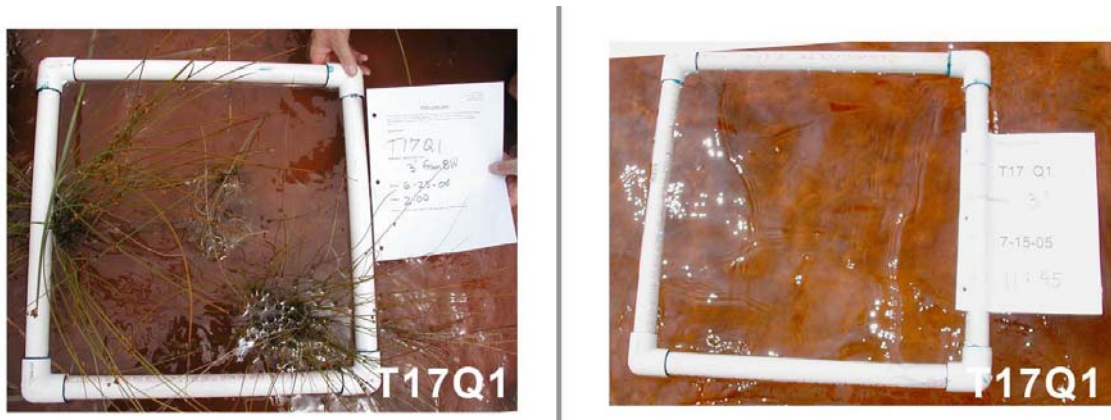
Plant survival and growth can be deemed successful in part given that there is a “*visual confirmation of plant cover and explosive plant reproductive rate*” behind the breakwaters. Plant assessments calculate an overall increased density (after planting) of 480% with the vast majority of those plants growing behind the remaining of breakwater, approximately one-third of the site. This can be further illustrated negatively by comparing planted sites where the CGR breakwater collapsed. Figure 23 shows quadrat T17Q1 with one year of significant plant growth behind the CGR and the complete absence of any plants in the subsequent year following the CGR collapse.

Figure 23: T17Q1 Before (6/23/04) and After (7/15/05) CGR collapse
