Final Report

Critical Area Channel Restoration in the Illinois River Watershed
CA # C9-00F91801, FY 2014, §319(h), Project 1

Oklahoma Conservation Commission

May 2018

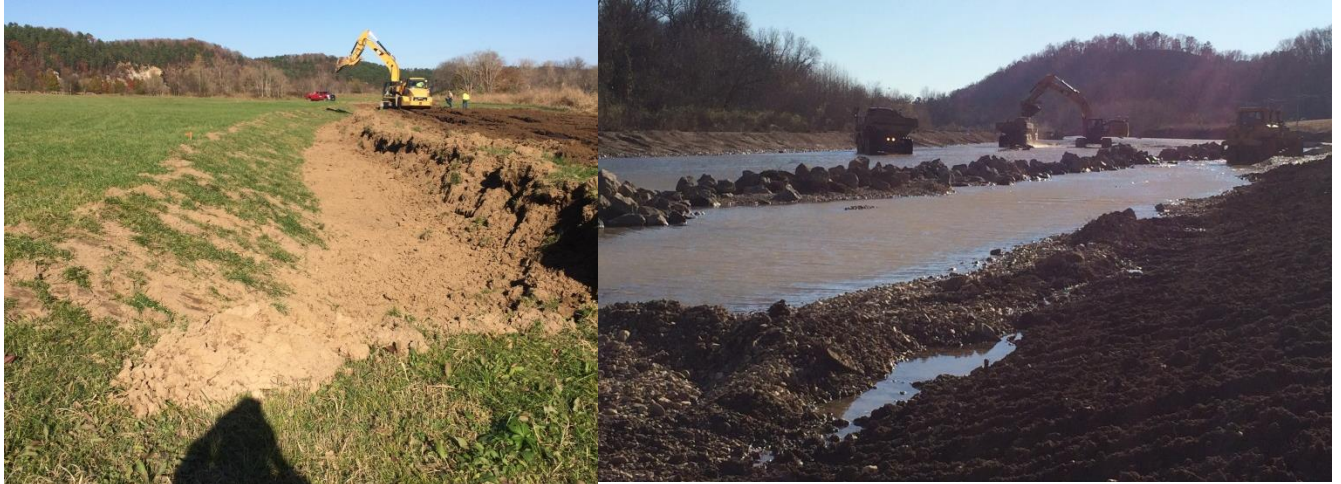
Figure 4. Construction of Bankfull Bench and Channel Reconfiguration begun in Fall 2015.

Unfortunately, as this new bank and channel were being constructed, fall rains began and continued. The river remained too high and ground too saturated. After more than two weeks of limited site access, the decision was made to postpone the work until after the winter holidays. The team planned to return after the first of the year.

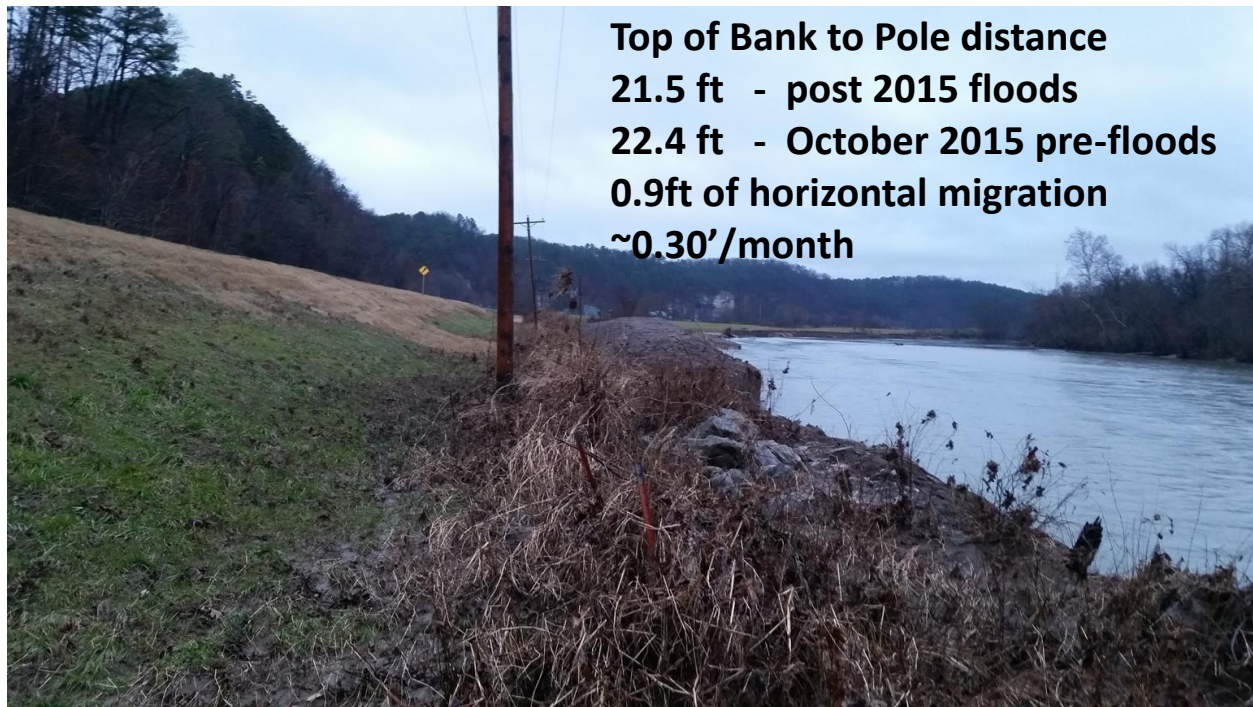
Figure 6. Photo describing post-flood bank migration.

However, the flood of December 2015 did cause some damage to the site which led the team to reconsider the design (Figure 6). On a positive note, although there was some damage to the site, many of the features that had been constructed held up well to a period of record event.

Examples of positive response to the flood include a relative small migration of the bank of concern after the flooding. In the area where the bank was closest to the road and therefore of greatest concern, in most places, the bank only migrated 0.9 feet. Overall, the average bank erosion rate at the site was about 1.8 feet, which was not as bad as expected for a period of record flood event at a site with a disturbed bank and bed (Figures 6 and 7).

At that point, the team determined to mulch and seed the disturbed riparian areas, and to revisit the site and design the following year, allowing for scheduling of other projects, and rainfall patterns and river levels.

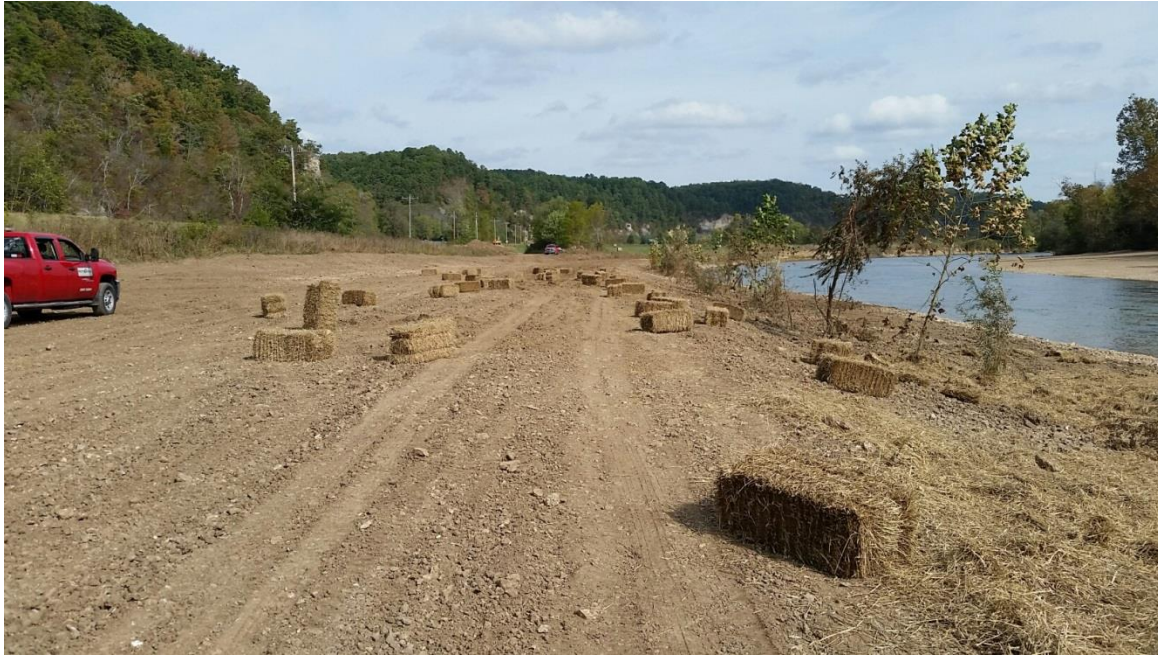
Figure 8. Preliminary mulching and seeding occurred in late October, although full planting was planned for December. Trees were transplanted from the opposite bank and rootballs placed near the water level to promote optimal survivability.

Although the project experienced some relatively high flows during the winter of 2016/17, by April, vegetation had come in nicely along the planted banks while transplanted and newly planted trees were beginning to leaf out (Figure 9). The final restoration included 2,830 feet of restored bank.

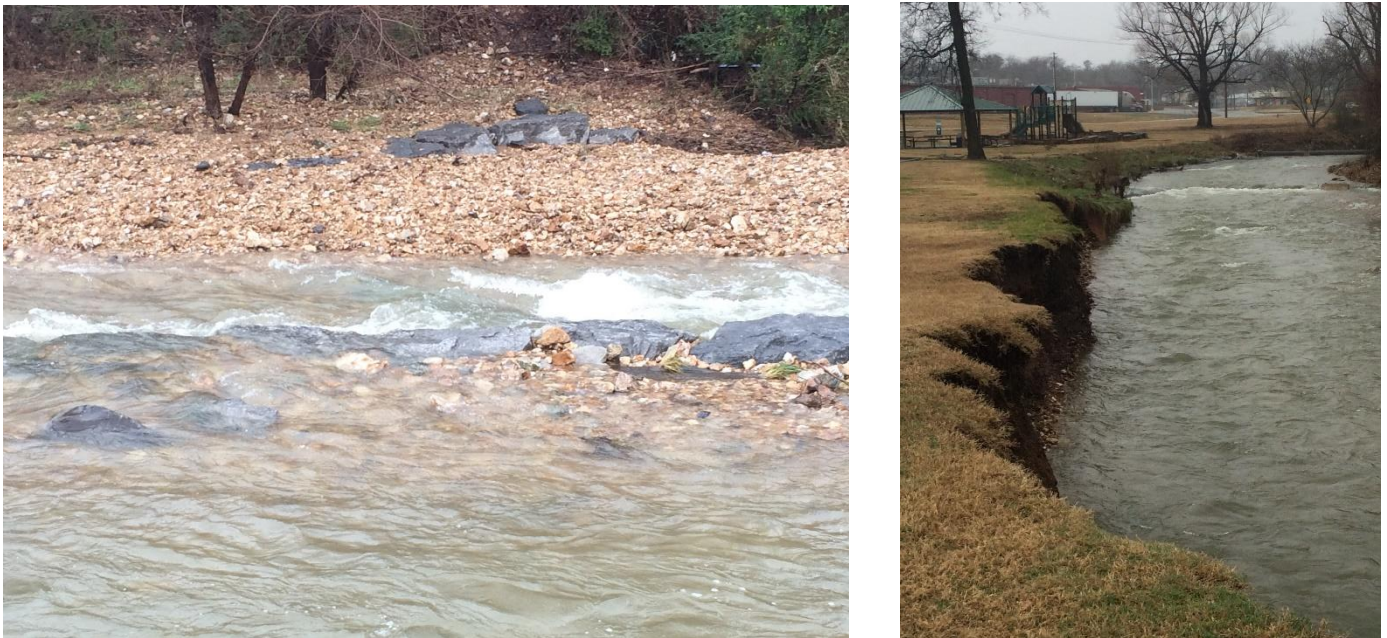
Figure 11. Damage to Felts Park Restoration in December 2015.

Design plans were finalized and construction began at the four sites in late October 2016. The site at Felts Park had degraded in the historic December 2015 flood (Figures 10 and 11). The stabilizing toe-wood had washed out allowing the bank to slough and the channel to migrate west. This allowed gravel from upstream to bury structures and further push the channel toward the less stable bank.

The result was a project that was back in line with the original structures and had a better anchored and sloped west bank which should allow better growth of stabilizing vegetation (Figure 12 and 13). Additional live-stake trees were planted along the upper banks and at the water line along with stabilizing annual and perennial grasses. The final project restored 250 linear feet of eroding bank.

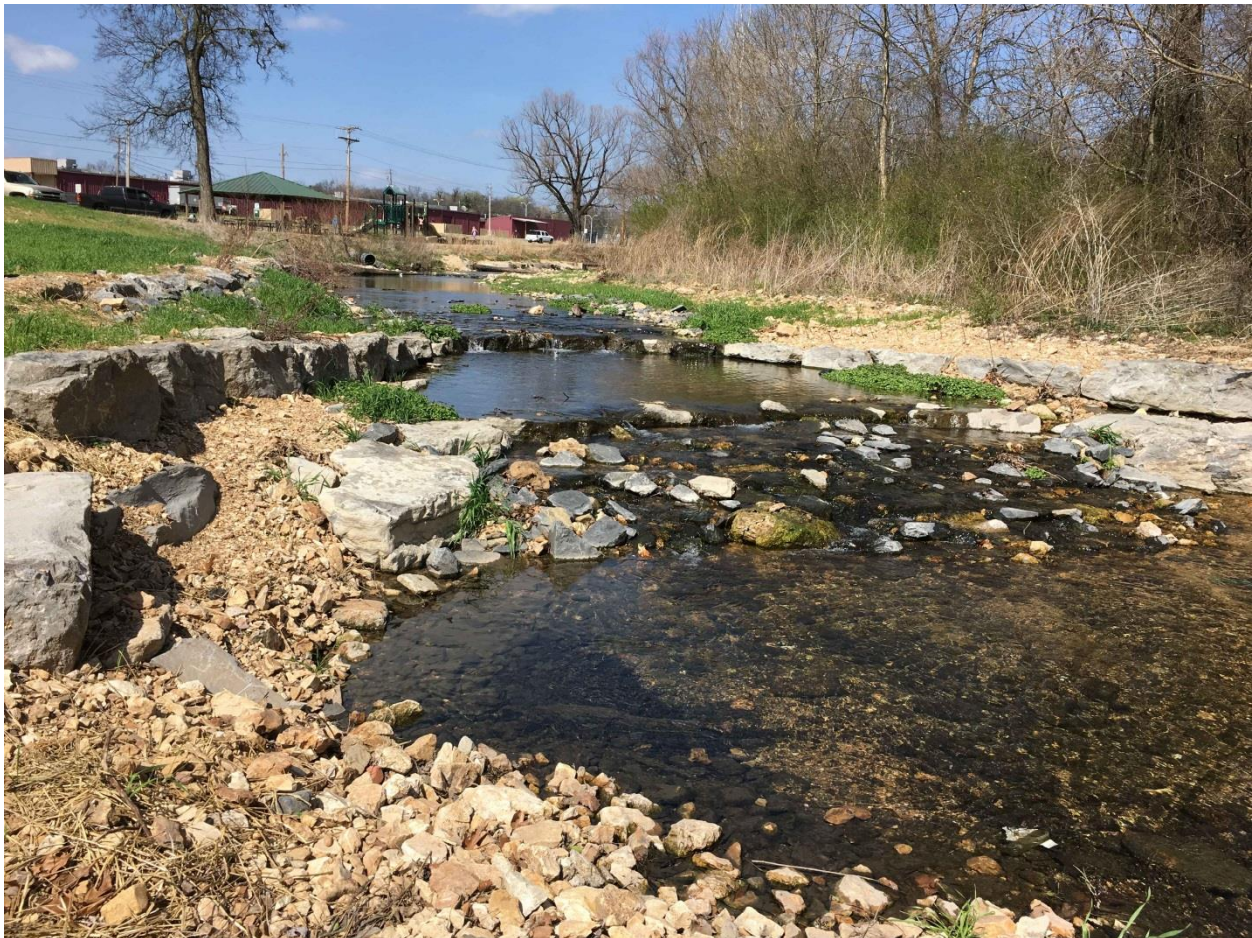
Figure 12. Felts Park right (west) bank looking upstream (spring 2016).

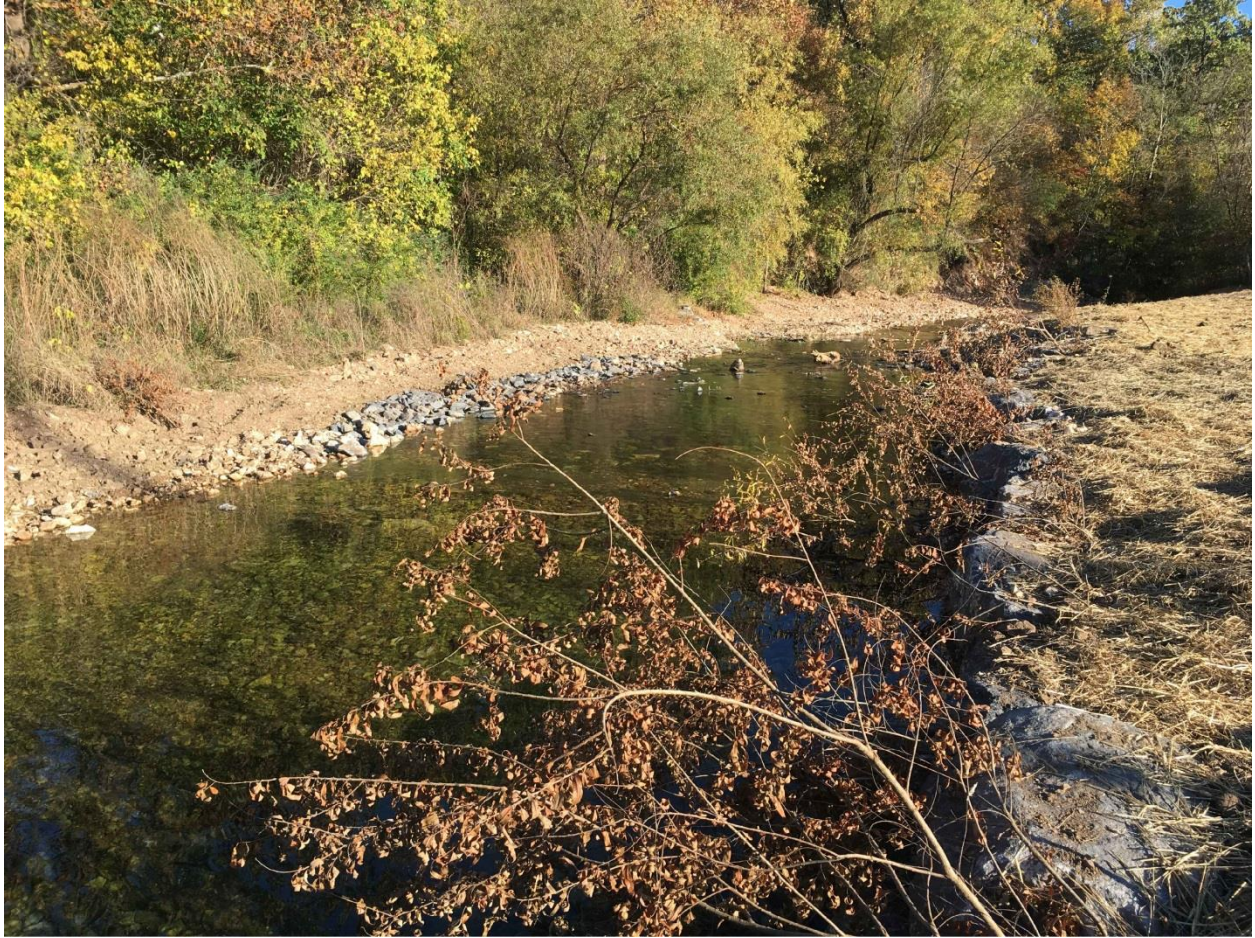
Figure 13. Right (west) bank looking downstream immediately following construction (Fall 2016).

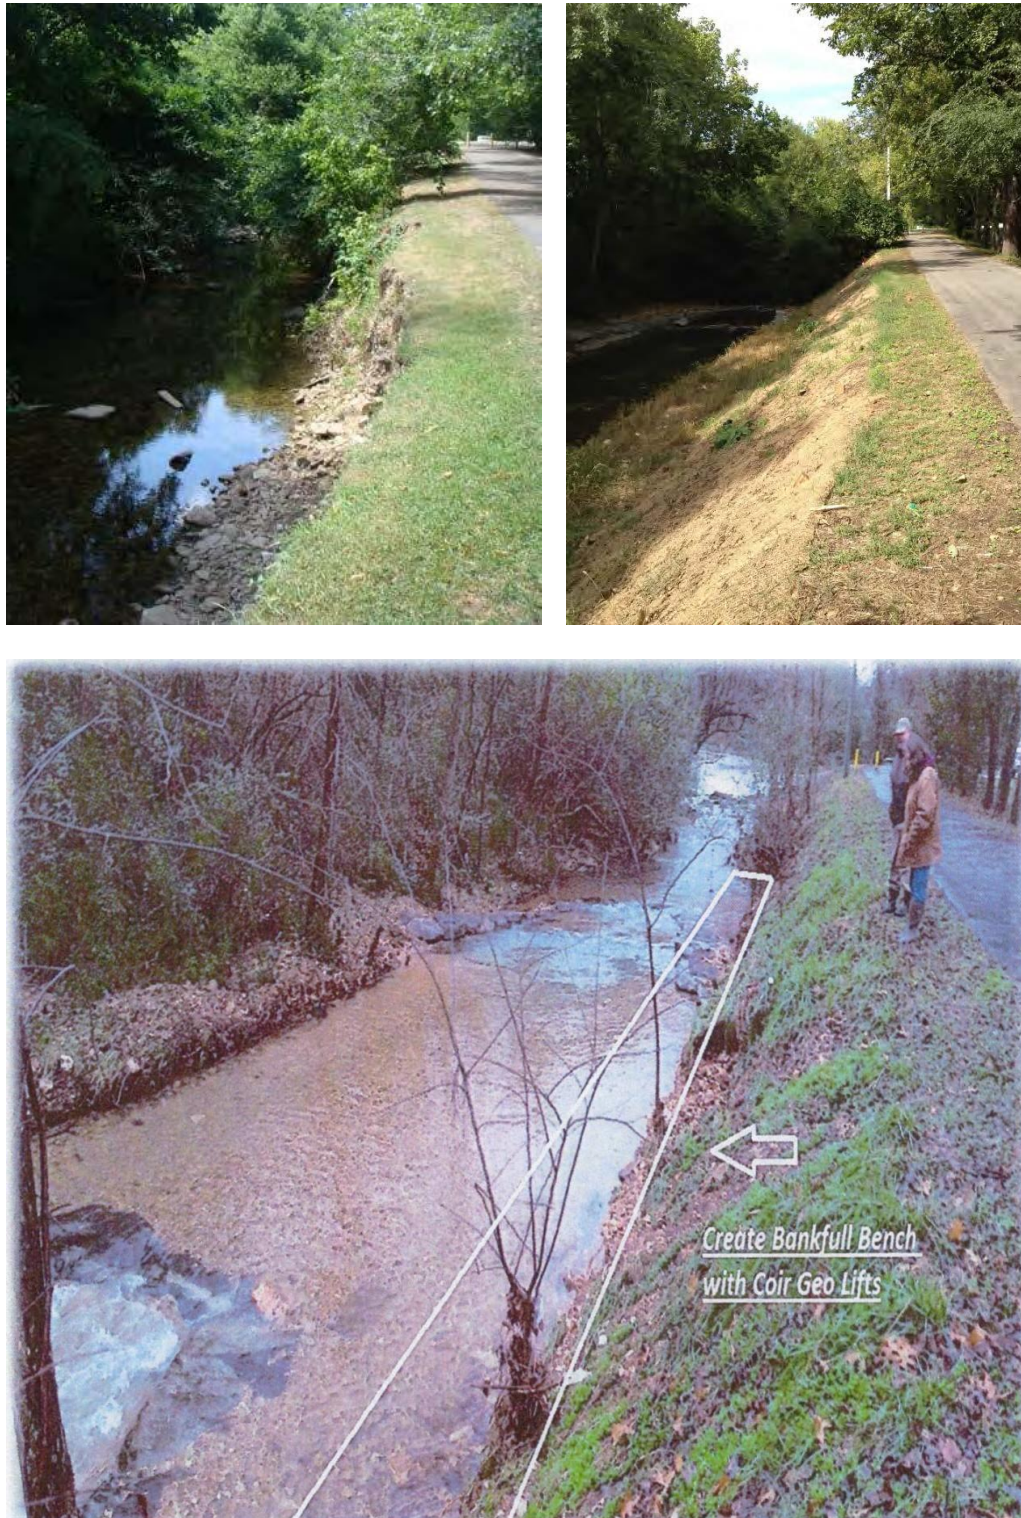
The History Trail site had also degraded in the December 2015 floods, moving almost back to the original position before the 2012 restoration (Figure 15). The damage removed the toe and slope and supporting vegetation that had been added to protect the walking path and sewer pipe beneath it. The restoration plan included reforming and armoring more of the left bank bench with rock as well limiting the channel back to the width of the original structures. The sloped bank would then be replanted with native trees and grasses (Figure 16).

Figure 15. History Trail before (top left) and after (top right) 2012 restoration as well as after 2015 historic flood (bottom).

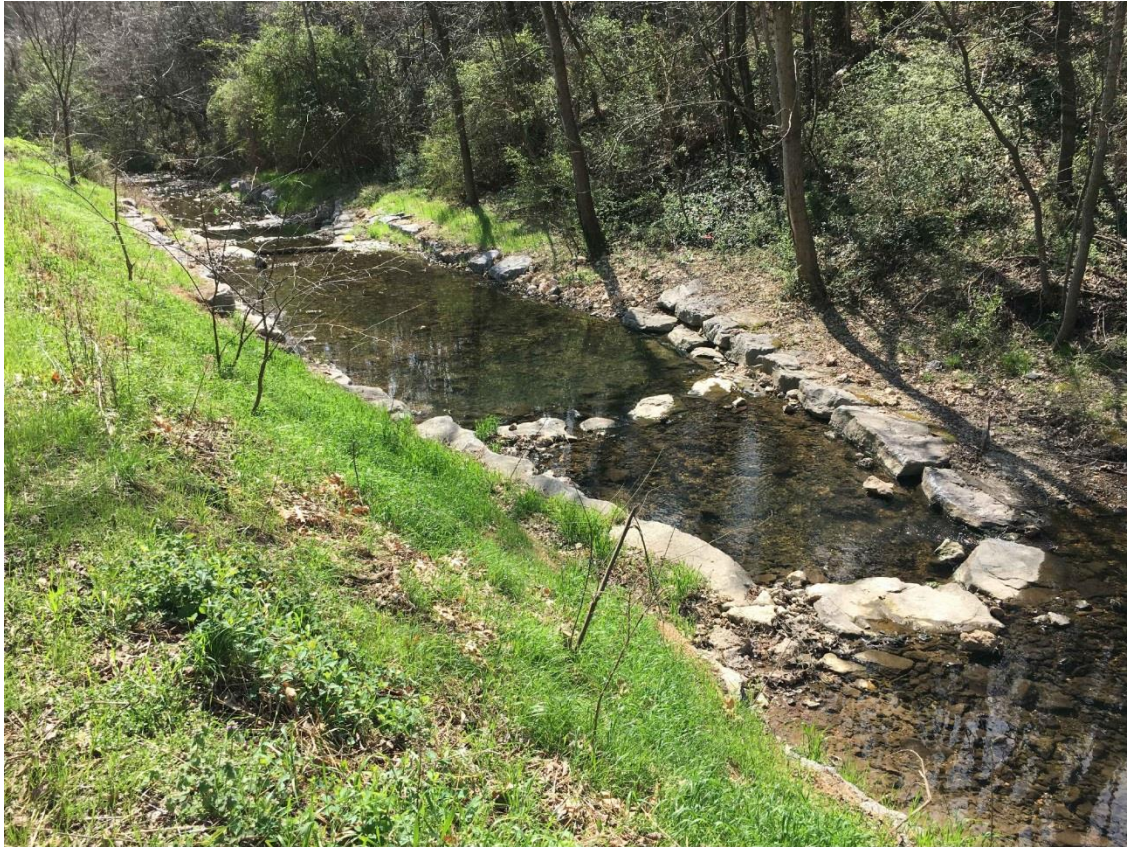
Figure 17. History Trail in Spring 2017 left bank looking downstream. The bench has been reconstructed, anchored with boulders, and replanted with trees and grasses.

Construction was completed on the 200 linear foot project in November 2016 and vegetation began to grow in quickly. By the following spring, grass coverage was very good on the slope and many of the trees were showing signs of life (Figures 17 and 18).

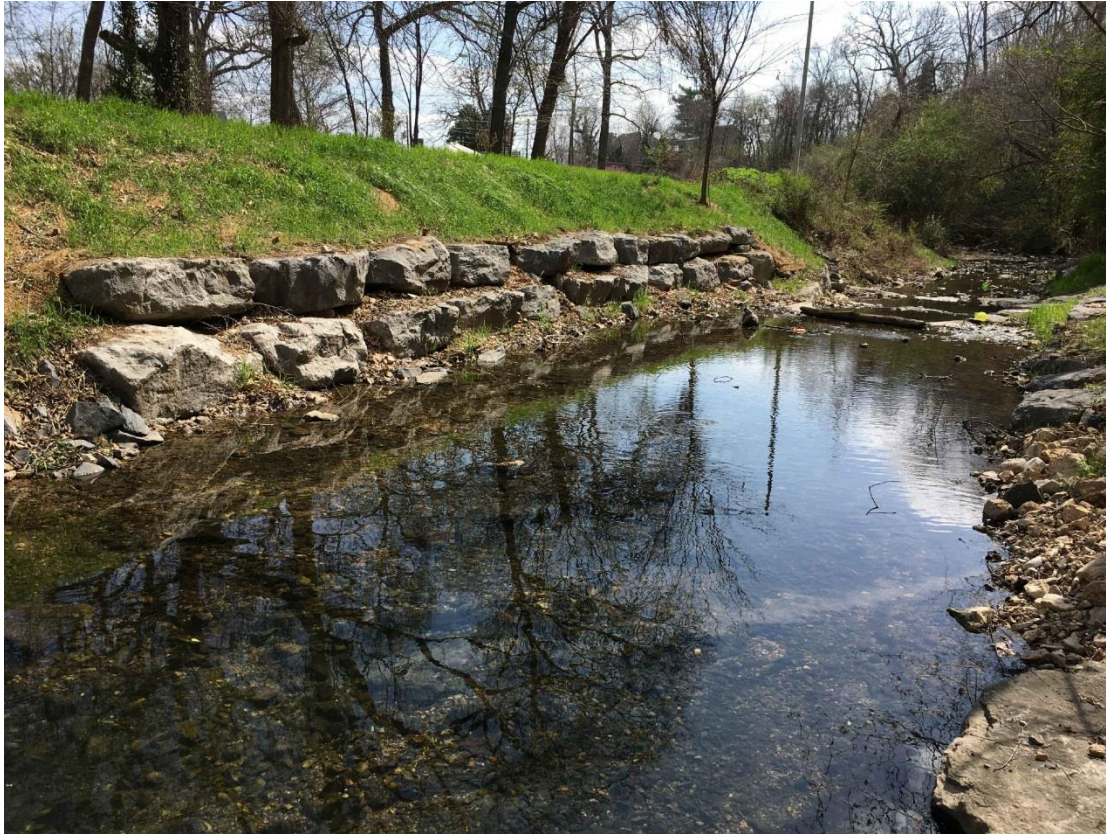
Figure 18. History Trail from right bank looking downstream depicts the left bank boulder placement utilized to stabilize the bank toe.

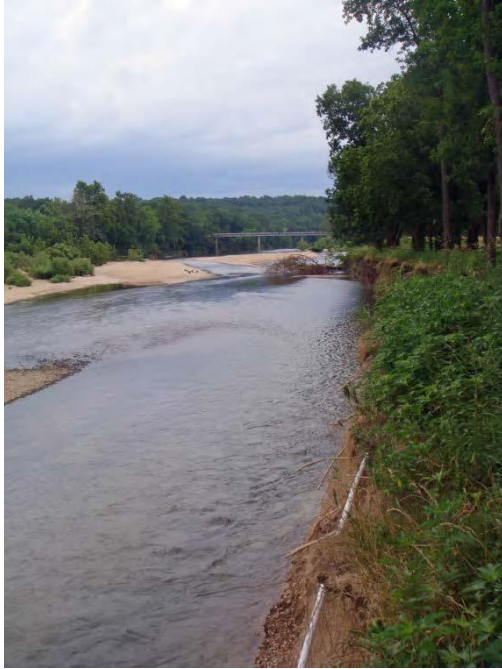
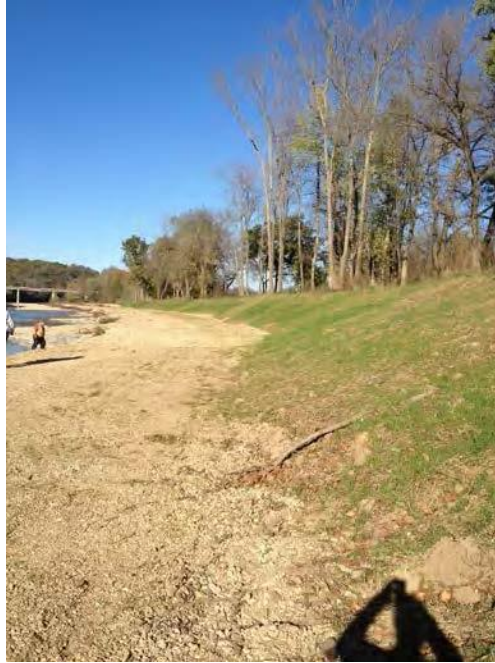
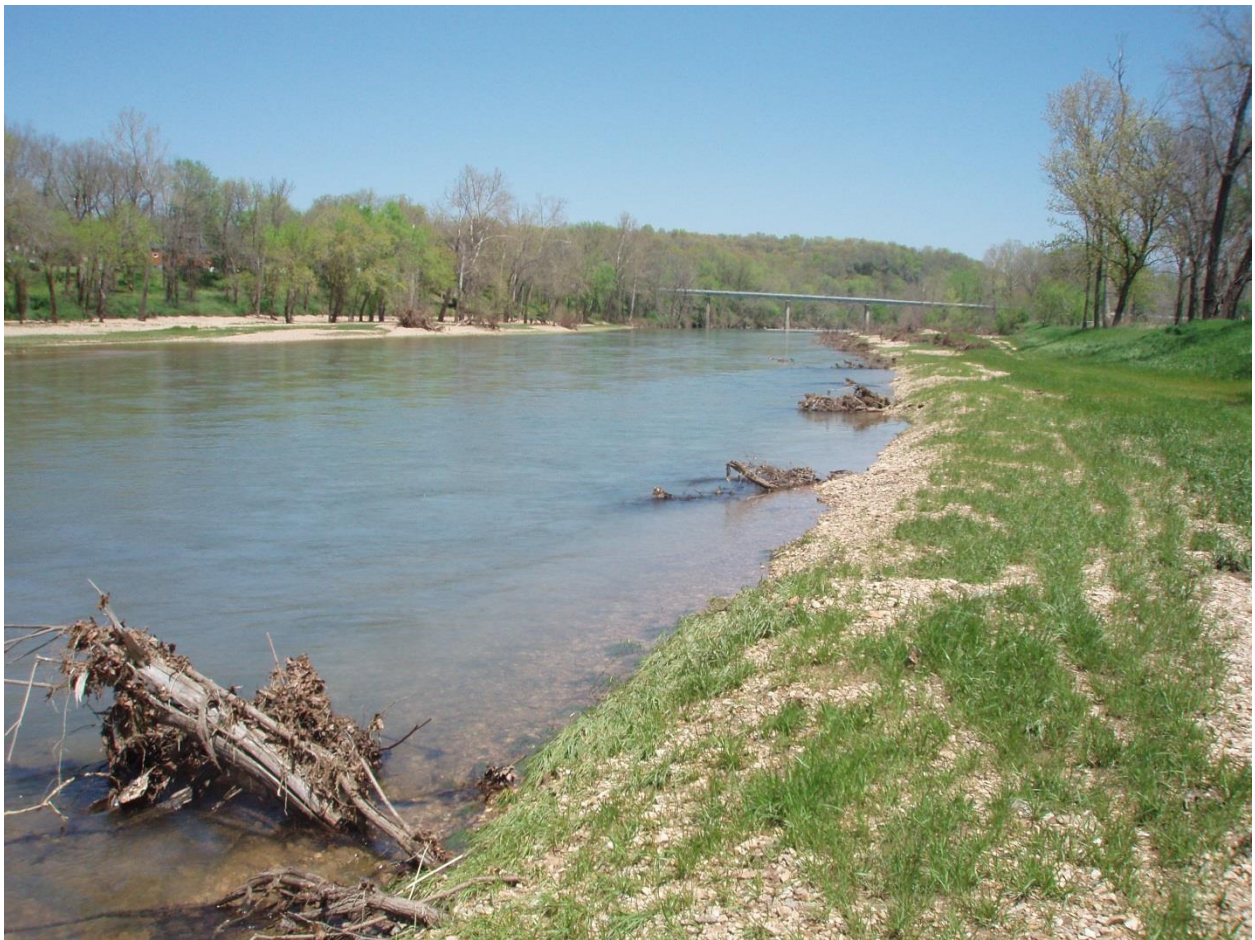
Repair work at the Illinois River Ranch site was a priority for the project partners but also for the NorthState Environmental Team. The site, restored in 2012, had undergone several big floods in the intervening years with very little change to the design. Deposition was occurring on the constructed benches, vegetation was improving and the landowners on both sides of the river were very happy with the improvements that had been made. The upstream bridge underwent a substantial overhaul in 2014 that necessitated building a low-water crossing downstream, but few impacts of that effort were seen on the downstream project (Figure 19).

Figure 19. Illinois River Ranch site before (top left) and after (top right) 2012 restoration work. The lower photo depicts the site after a bankfull flood in April of 2013 left no evident damage.

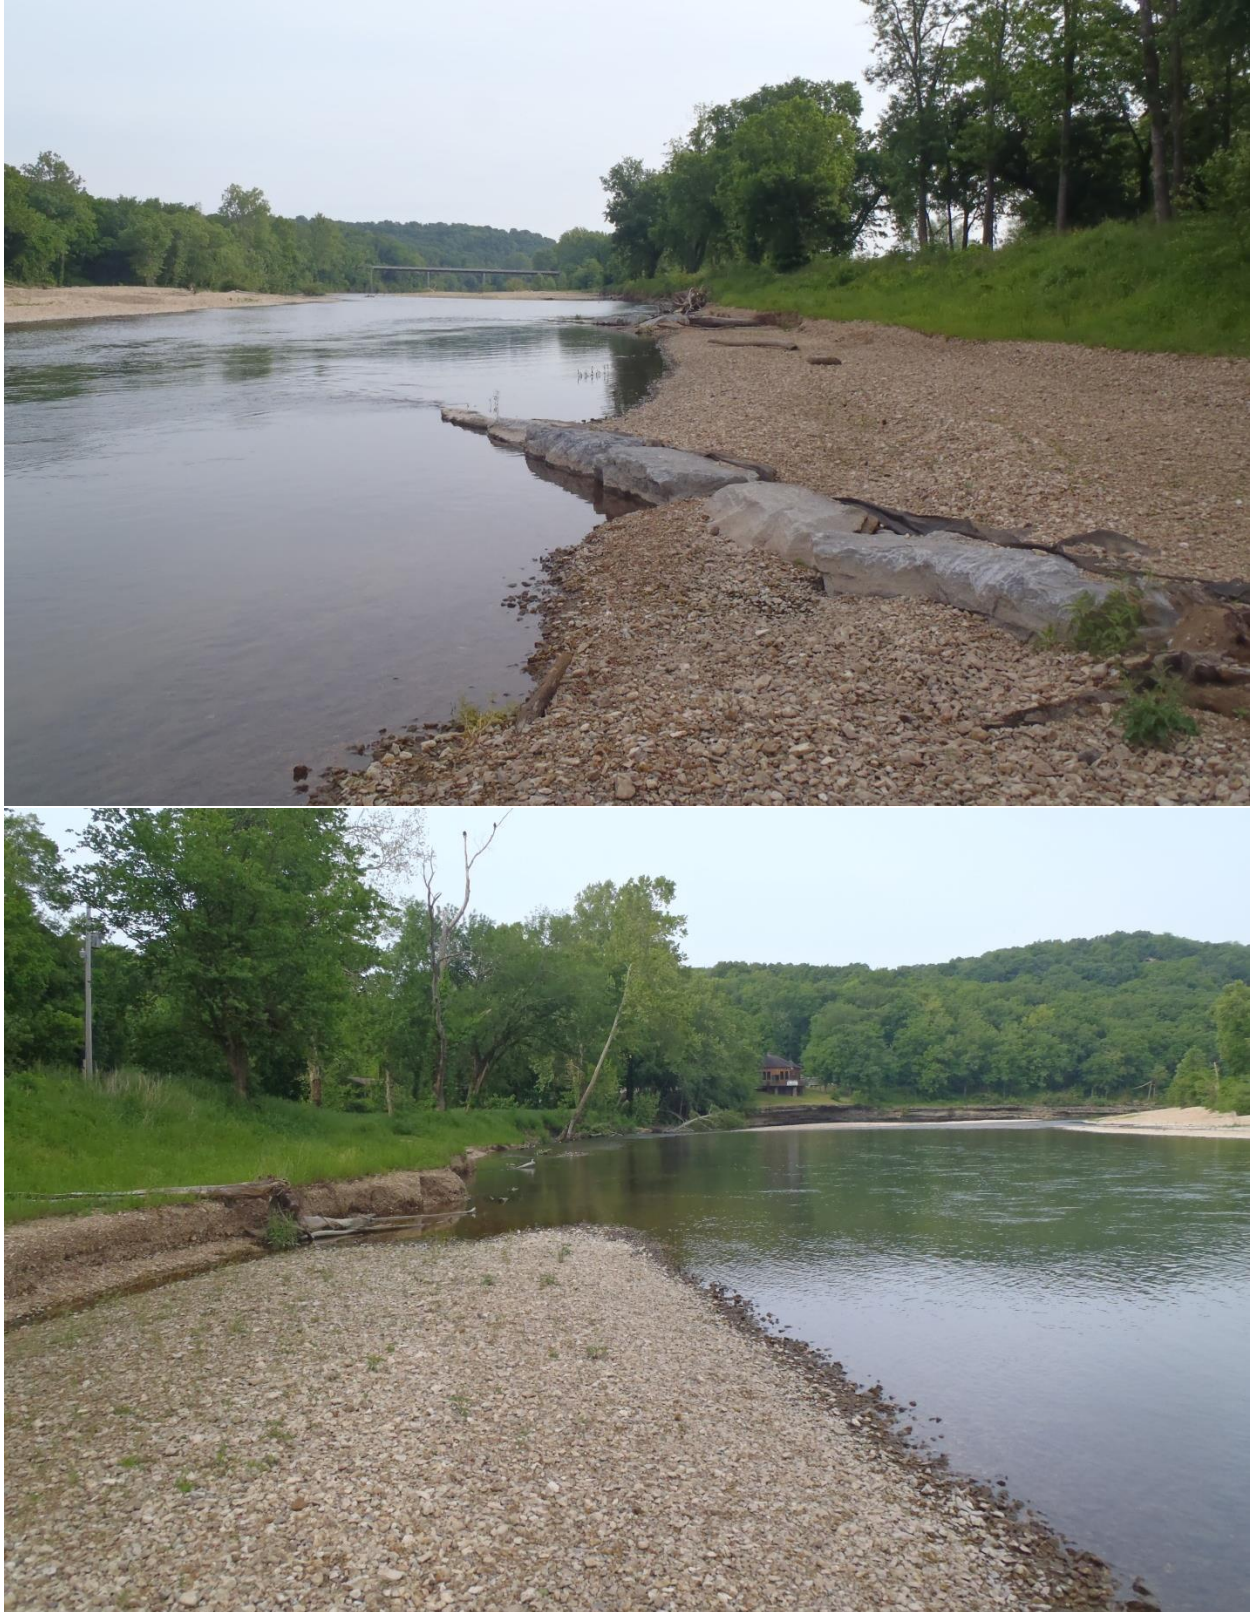
Figure 20. Upstream (top) and downstream (bottom) photos of damage to Illinois River Ranch site which occurred during December 2015 flooding.

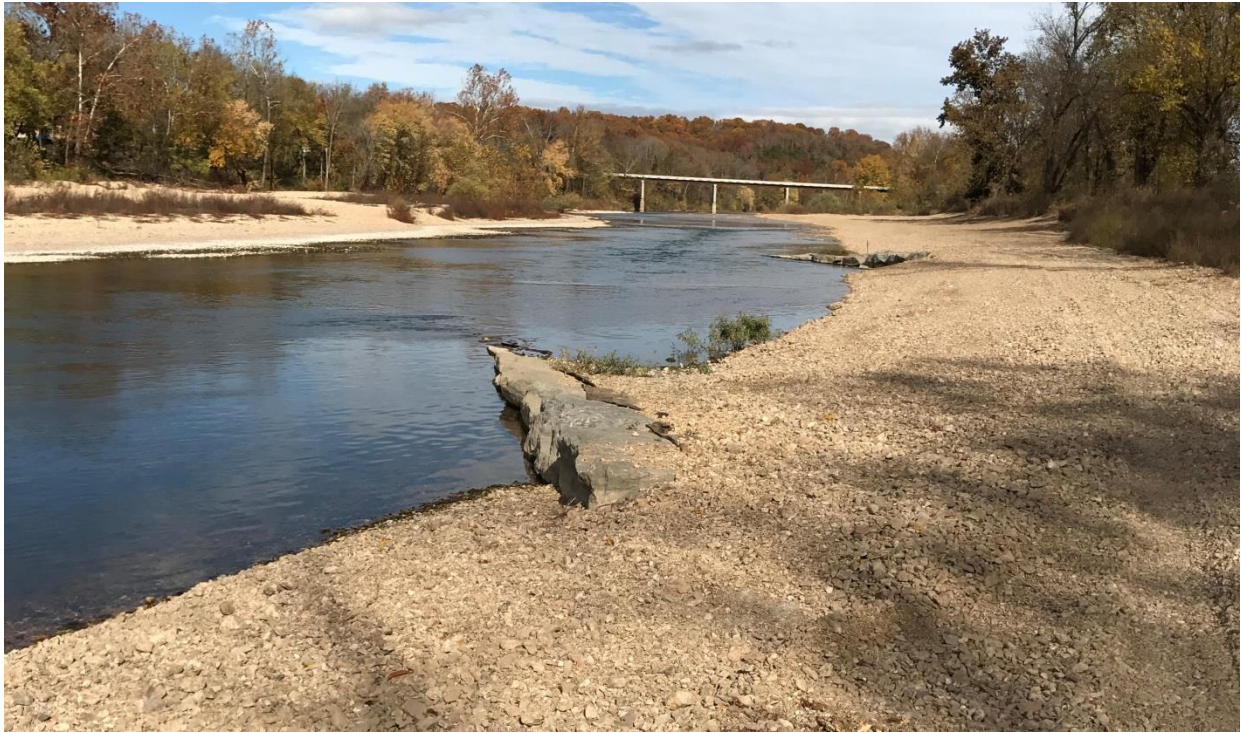
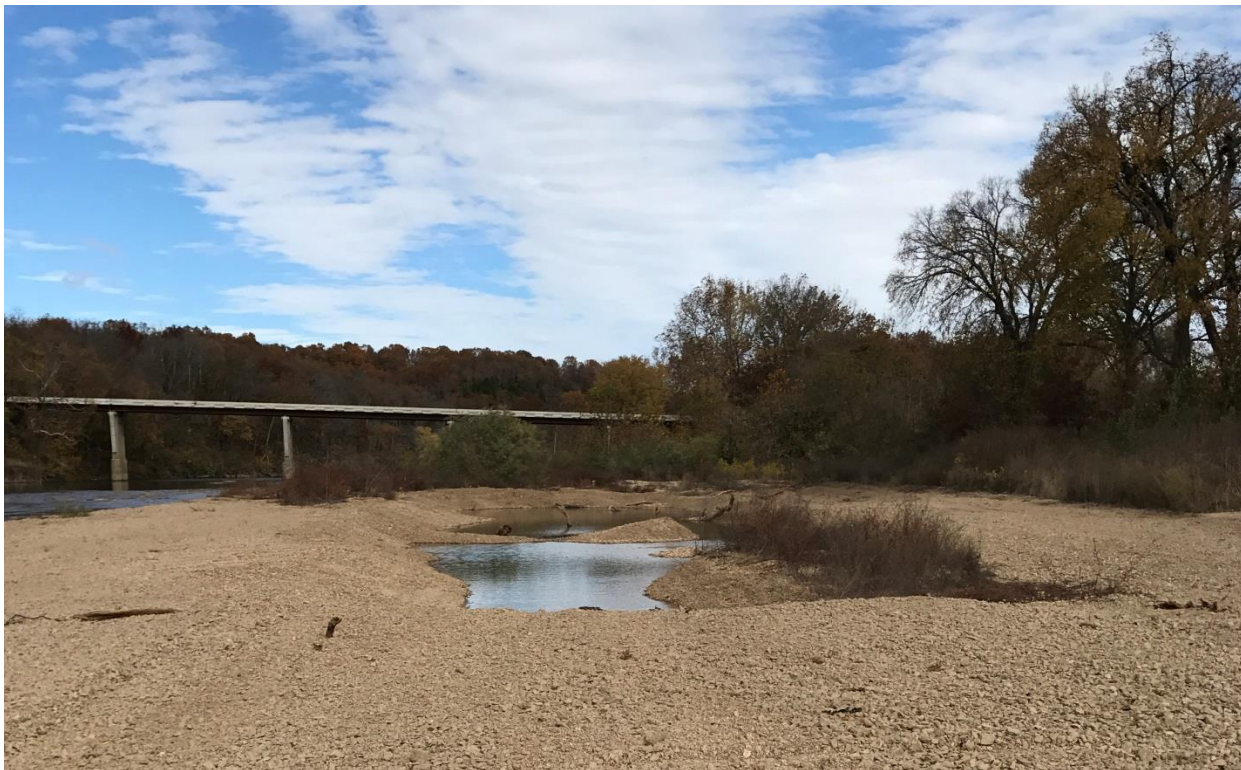
Figure 23. Restored Illinois River Ranch Site from left bank upstream (top) and showing the borrow pit/wetland area anticipated to sediment in at a later date (bottom).

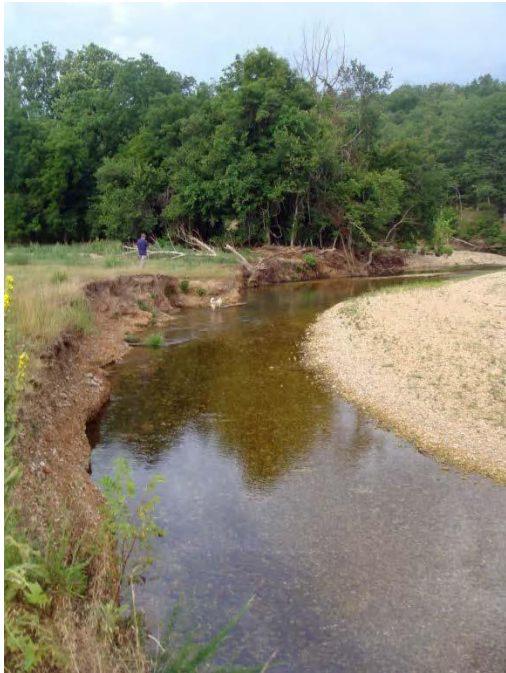
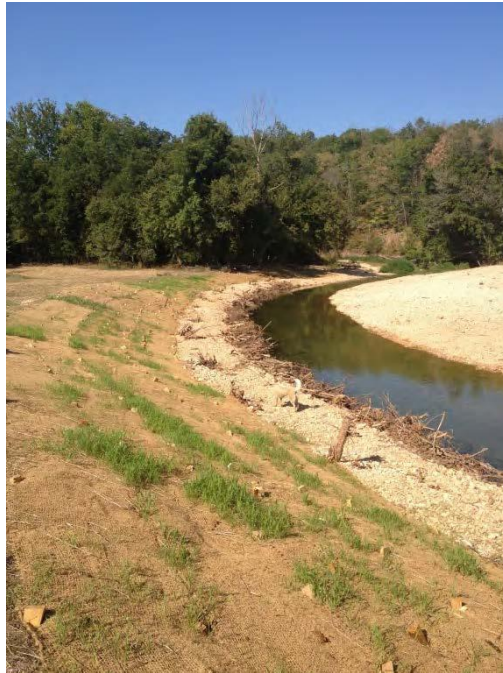
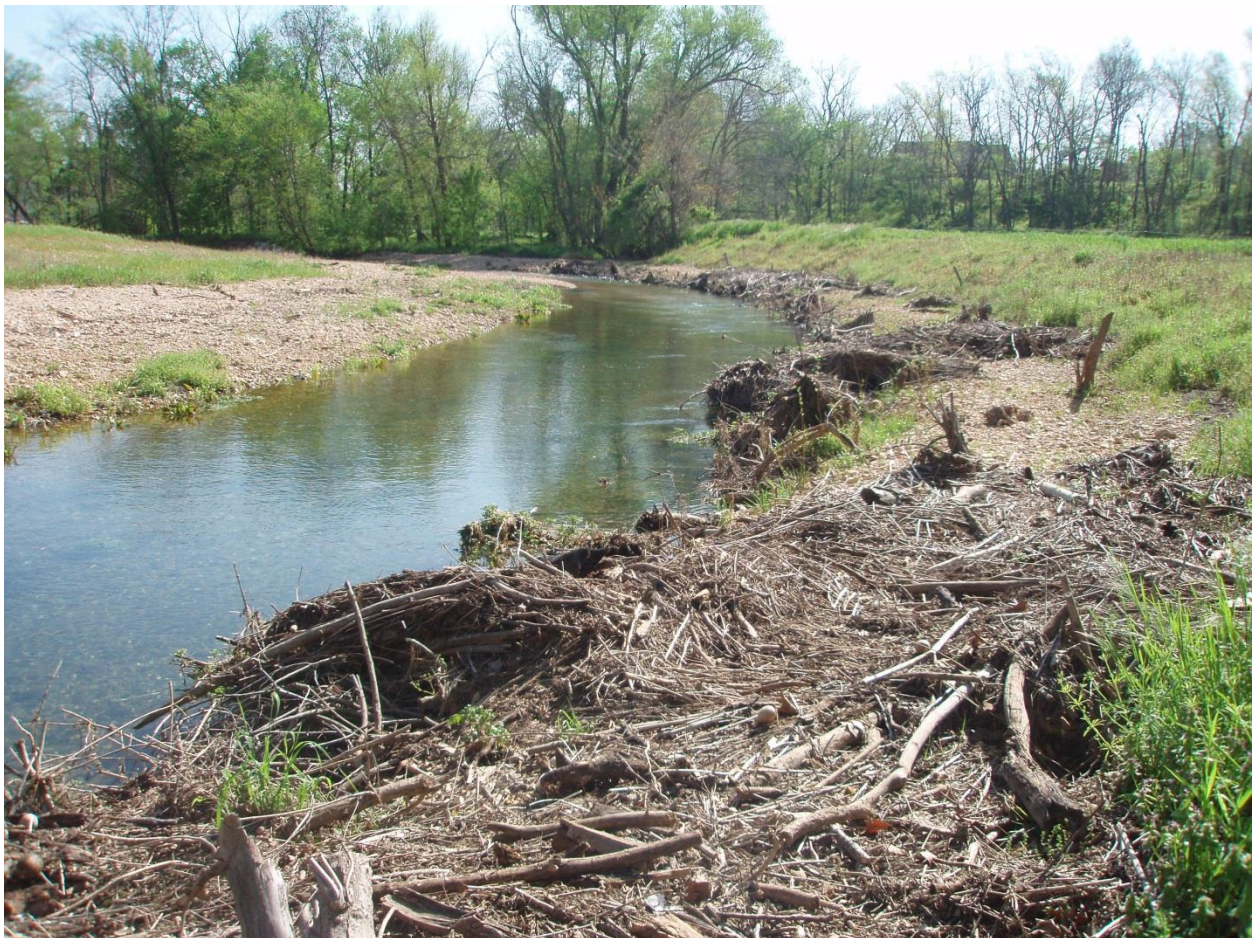
Figure 24. Tyner Creek site before (upper left) and after (upper right) 2012 restoration project. Lower image depicts the site the following spring in 2013 after green-up was beginning.

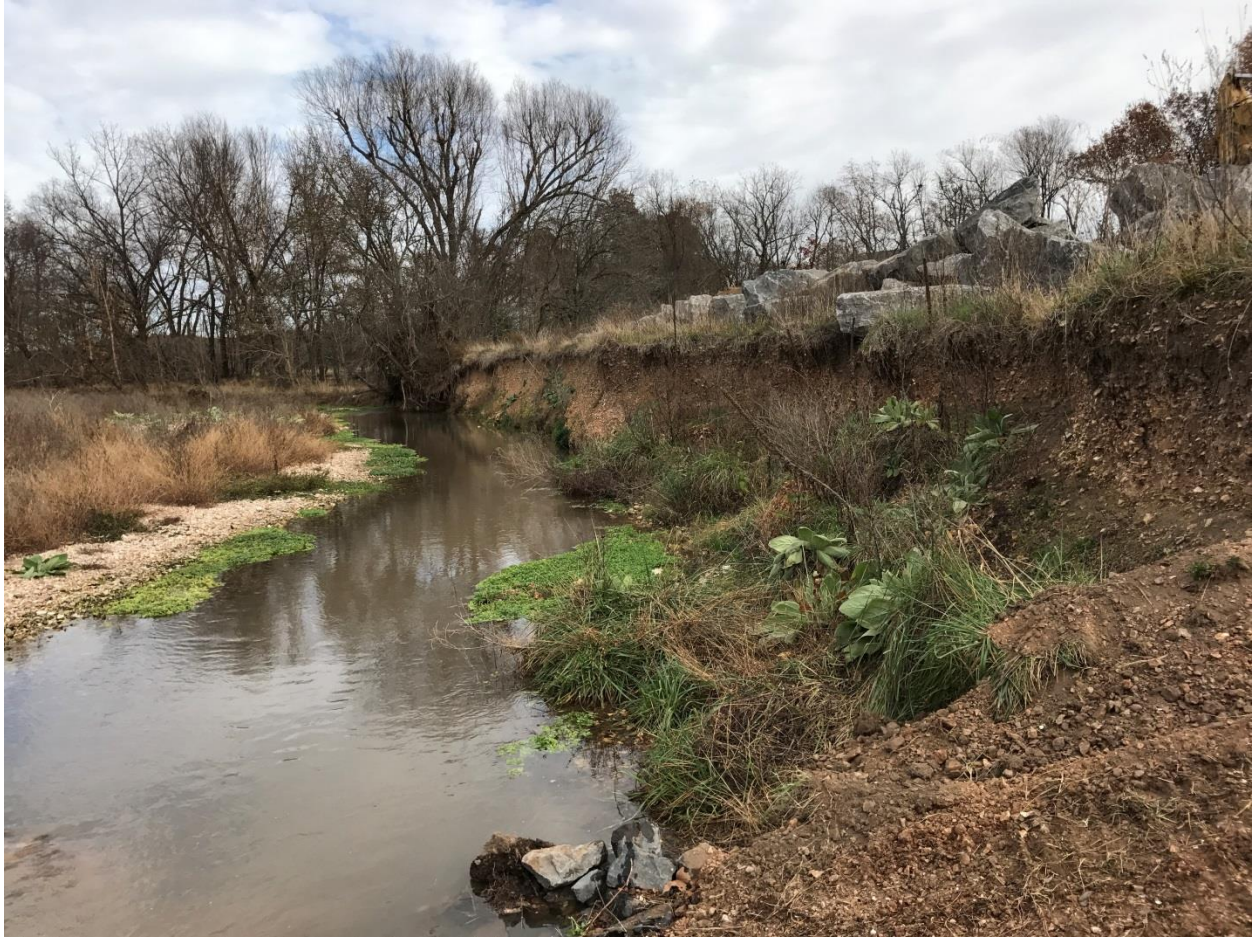
Figure 25. Tyner Creek site at the onset of restoration work in late fall 2016.

Although some minimal damage occurred to portions of the site during highflow events prior to the 2015 flood event, the 2015 event heavily damaged the site. Damage included complete washout of the bench and toewood, resulting in reforming of the cutbank. Although the site did not erode fully back to the original cutbank, it would eventually move there without repairs. Figure 25 depicts the site as restoration work began in December 2016.

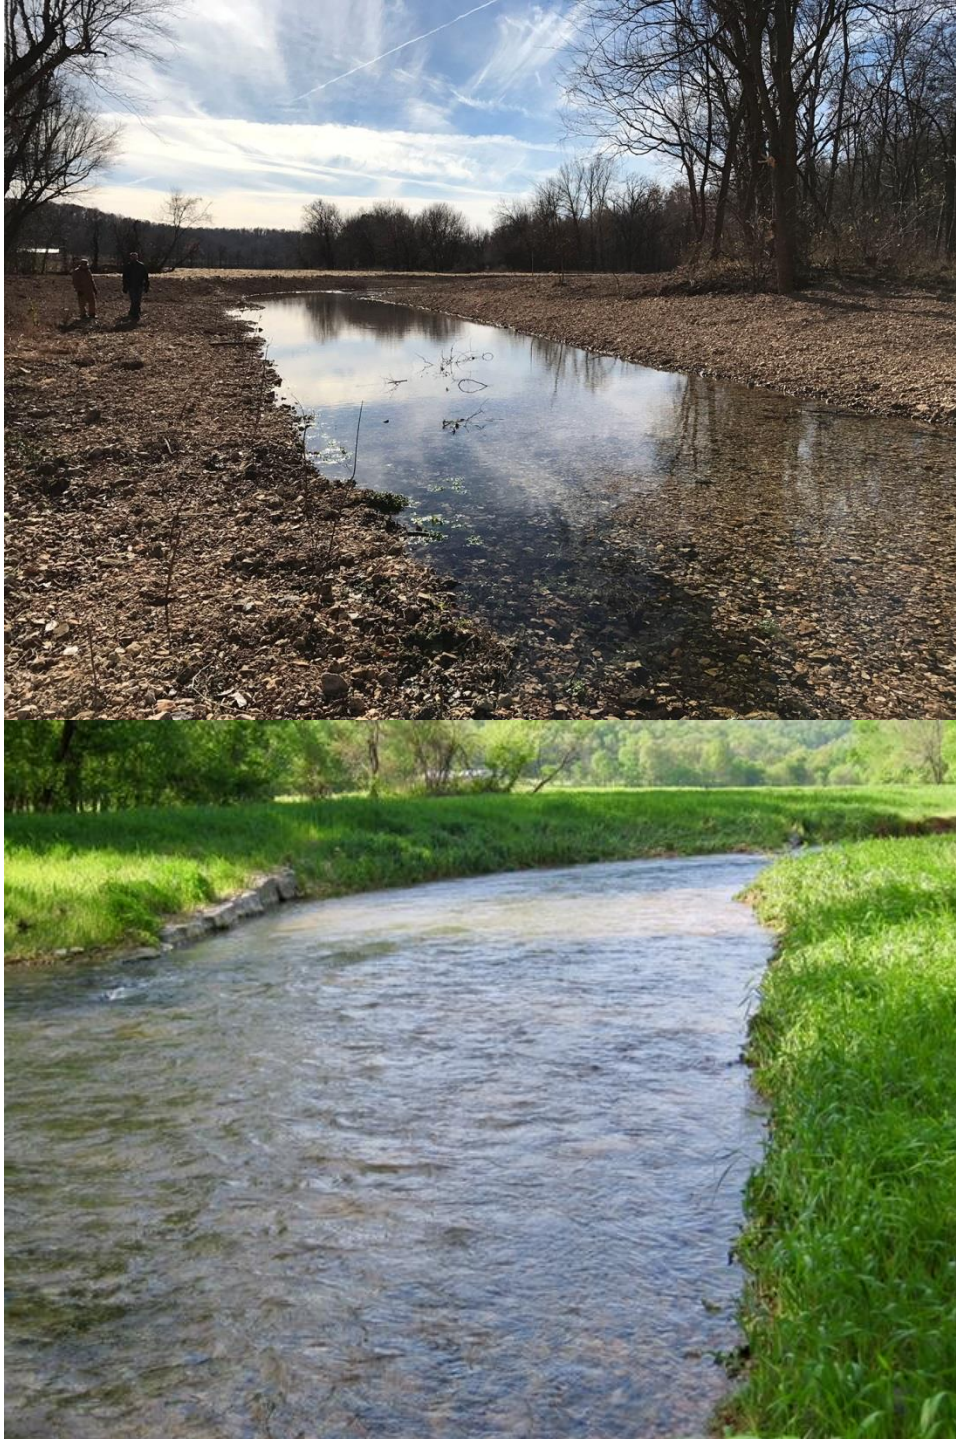
Figure 27. Restored Tyner Creek site near the upper end looking downstream immediately following construction (upper) and later in Spring 2017 (lower).

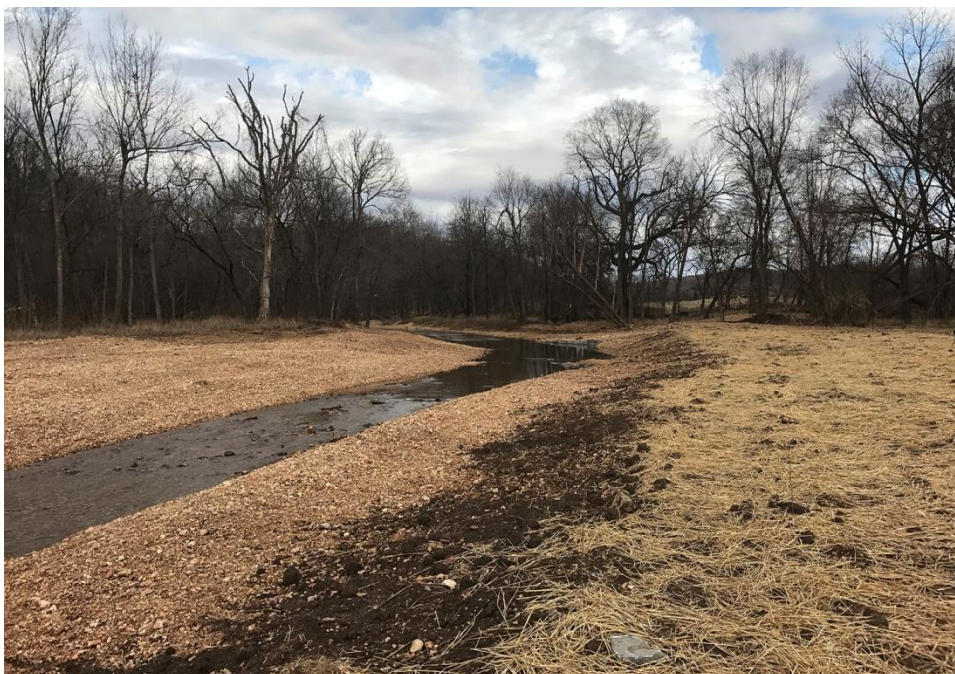
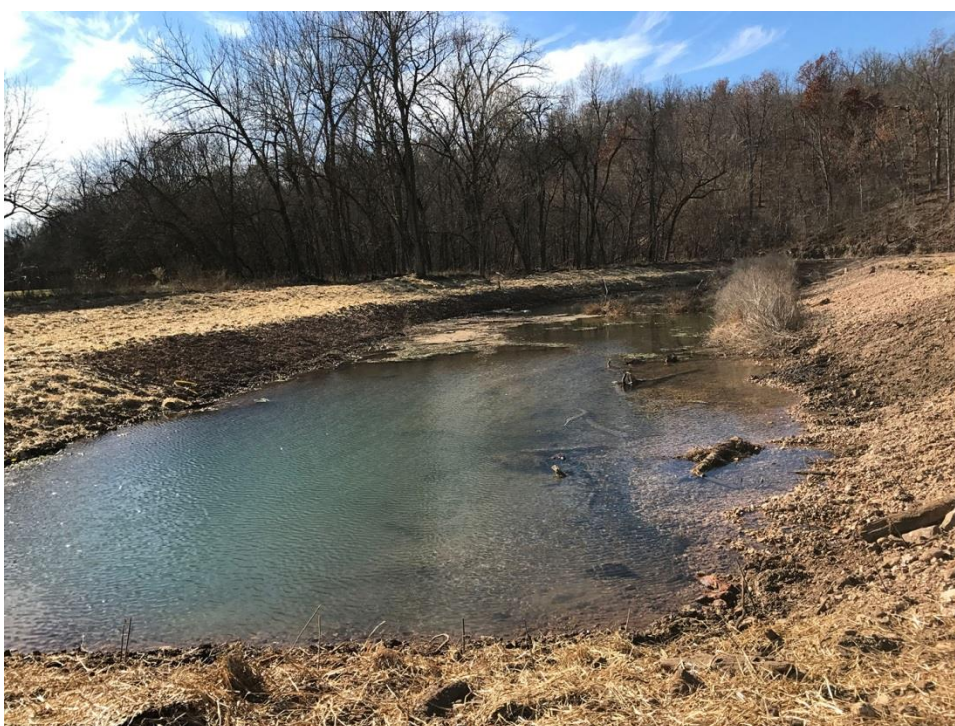
Figure 28. Restoration from left bank looking upstream (upper) and aquatic habitat and refugia pond (lower).

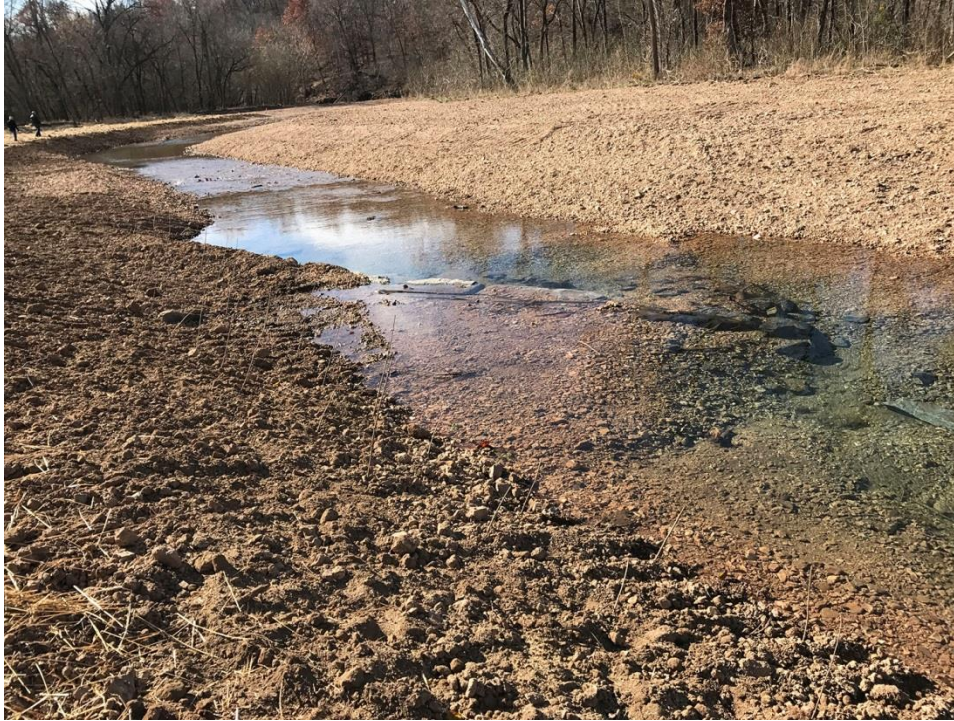
Figure 29. Restoration was completed to stabilize the reach but also to construct a variety of habitats.
