Final Report

Critical Area Channel Restoration in the Illinois River Watershed
CA # C9-00F91801, FY 2014, §319(h), Project 1

Oklahoma Conservation Commission

May 2018

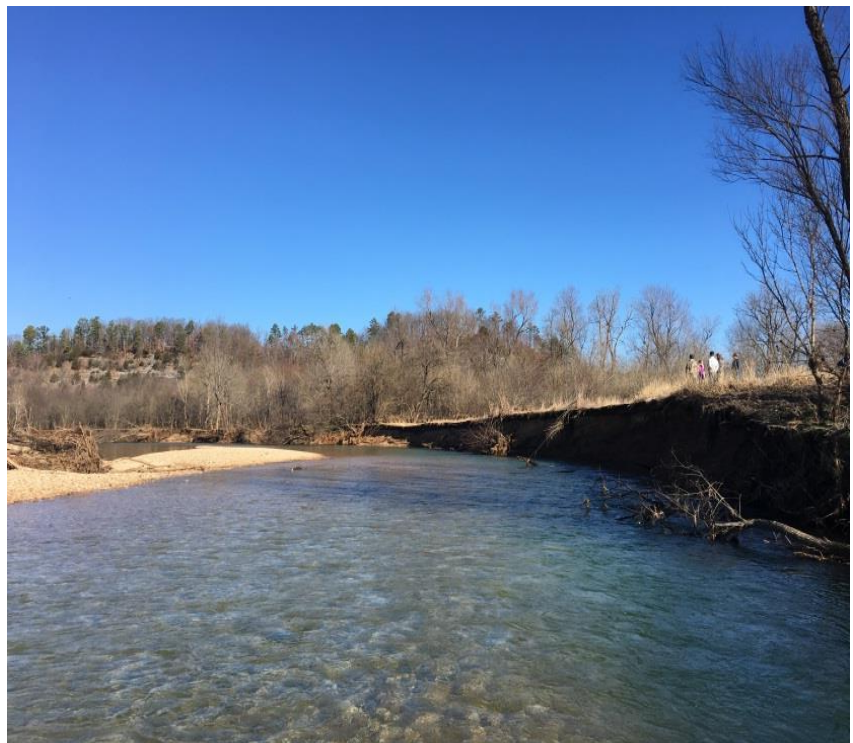
Figure 2 Eroding Streambank on Barren Fork

Figure 2 also shows the movement of the streambank over time based on historic aerial photographs that were available. Since 1995, the streambank has eroded approximately 300 feet, generating 140,000 cubic yards of sediment over approximately 21 years. Using data collected from streambank samples collected in NW Arkansas, the erosion has generated an estimated 182,000 tons of sediment and 54,000 pounds of phosphorus during this time period.

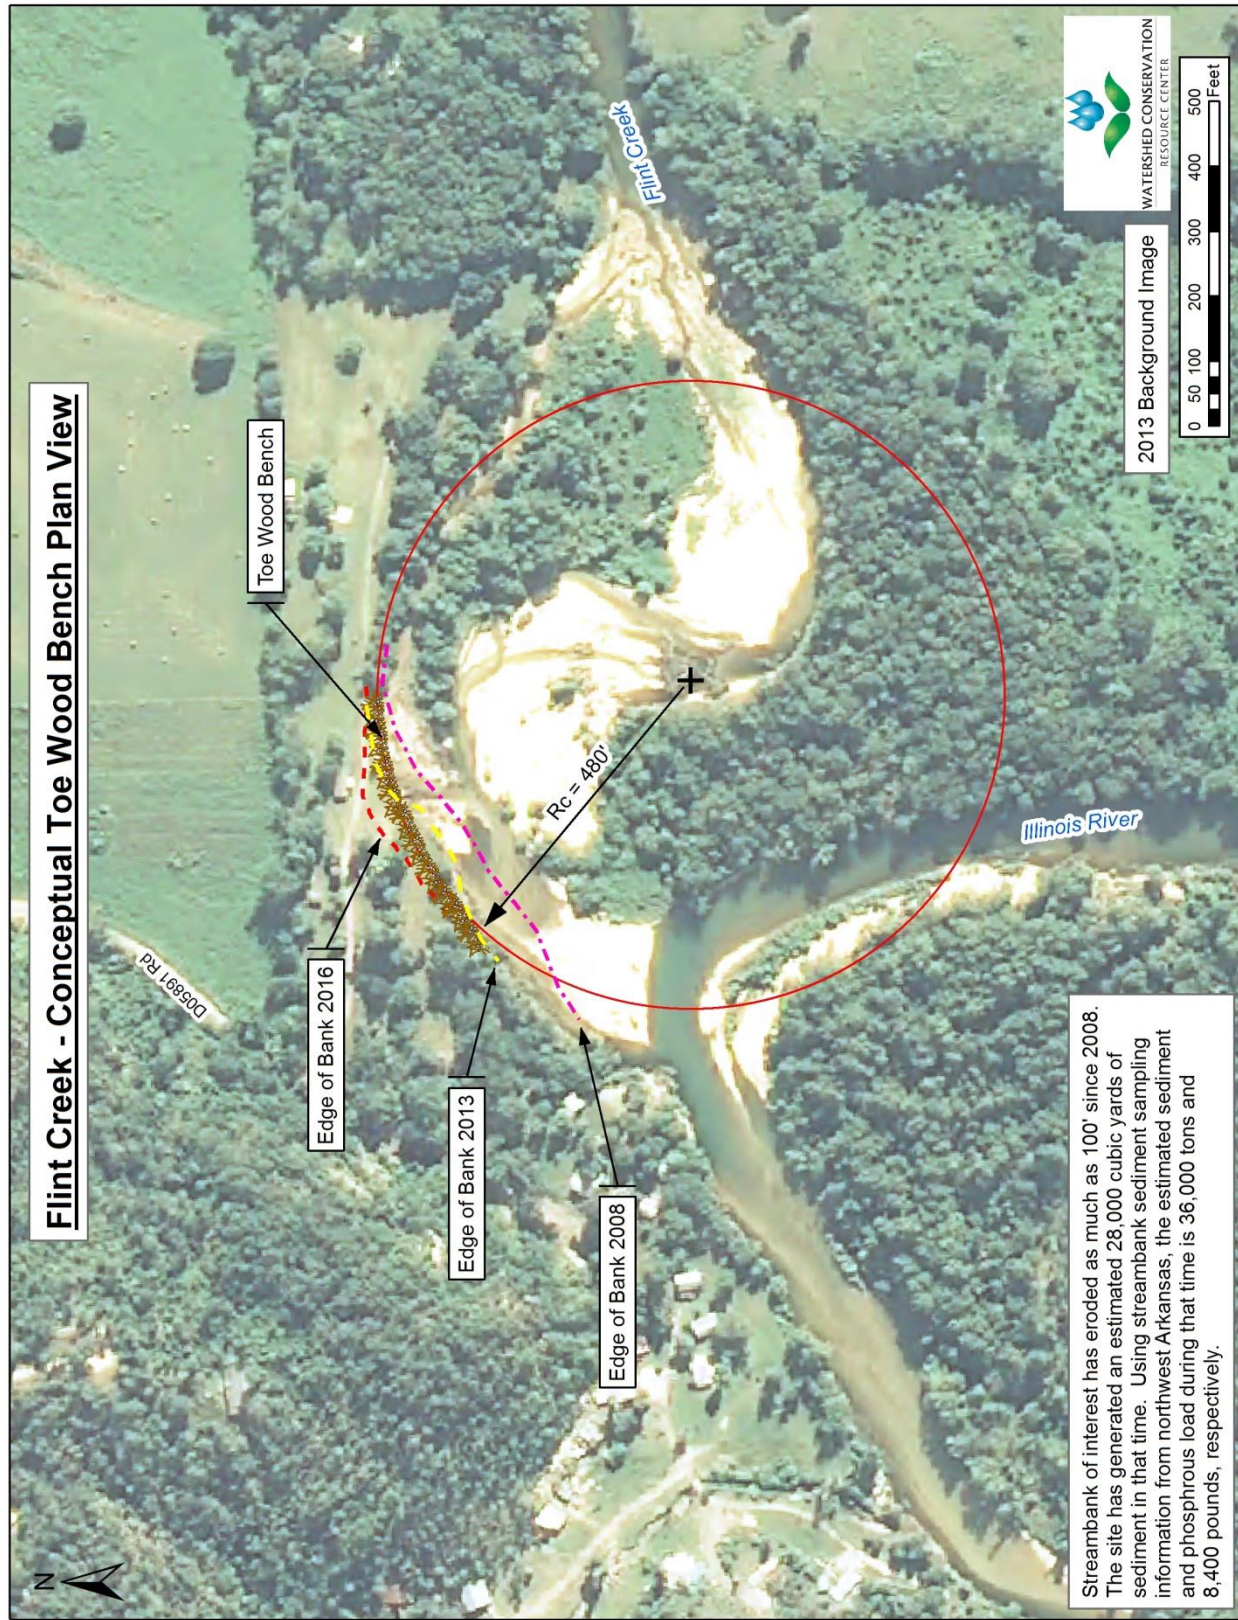
Figure 7 Conceptual toe wood bench layout for bank stabilization on Flint Creek near Dripping Springs, OK

Figure 7 also shows the movement of the streambank over time based on historic aerial photographs that were available. Since 2008, the streambank has eroded approximately 100 feet, generating 28,000 cubic yards of sediment over approximately 8 years. Using data collected from streambank samples collected in NW Arkansas, the erosion has generated an estimated 36,000 tons of sediment and 8,400 pounds of phosphorus during this time period.

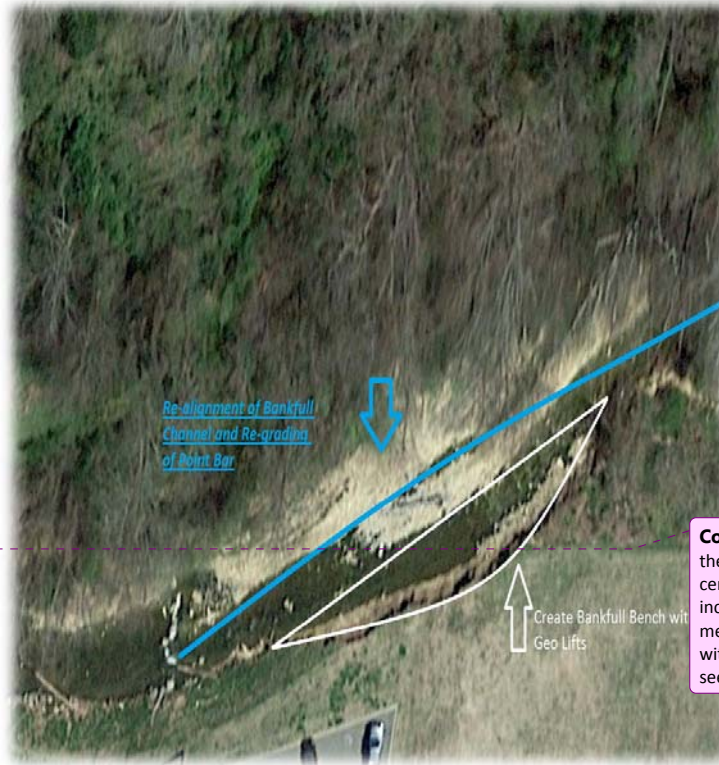
4.1 Felts Park

The project approach to the Felts Park site will be to re-grade the point bar by re-aligning the river's velocity vectors to generate a softer approach to the existing boulder cross vane. The NSE/5SSR team will also build a bankfull flood prone bench by constructing geo-lifts with coir matting and suitable/fertile soils to ensure adequate vegetation establishment. The terrace slope will be graded and permanently seeded to a 3:1 slope. The pre-existing log vane will be backfilled with onsite suitable sub-straight material to help eliminate future scouring in this area. All areas within the project reach that identifies signs of slight erosion caused by near bank stress will be addressed by the NSE/5SSR team during construction. All pre-existing pools that were filled with deposition during the 2015 storm event will be excavated to design depth to assist with energy dissipation.

Comment [BS1]: For this site we discussed the method of re-aligning the thalweg to center flows. Also discussed alternatives to include woody plantings. Left this part of the meeting agreeing that we could make changes within the budgeted items under "permanent seeding".

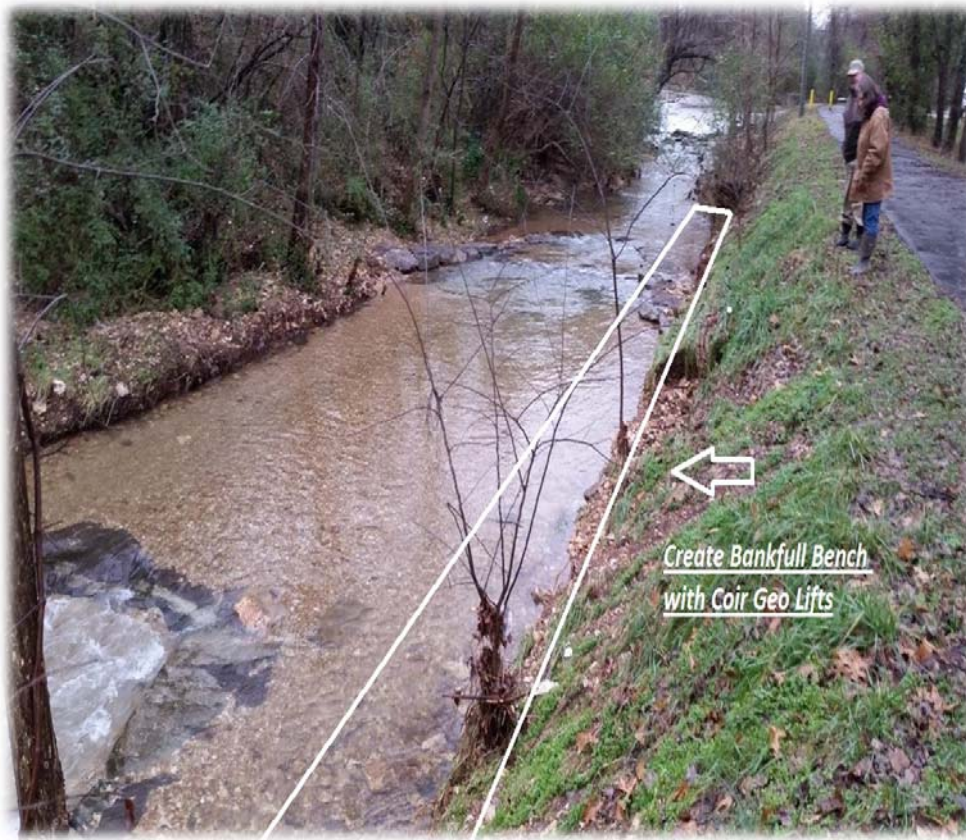
The approach for the History Trail site will be to construct a flood prone bankfull bench with Coir Geo-Lift on river left to serve as toe stabilization. This approach will help maintain the pattern, profile, and dimensions that are necessary to ensure adequate sediment transport. All areas within the project reach that identifies sign of slight erosion caused by near bank stress will be addressed by the NSE/SSSR team during construction. All pre-existing pools that were filled with deposition during the 2015 storm event will be excavated to design depth to assist with energy dissipation.

Comment [BS2]: The interview team appreciated the concept of the geolifts at this location to help with bank stabilization and erosion issues. Jeri stated that there may need to be an adjustment to the “permanent seeding” items to substitute woody plantings into the budget for this site. She also stated that there had been some of the riparian plants removed from just upstream that may need to be replanted for some of this project budget.

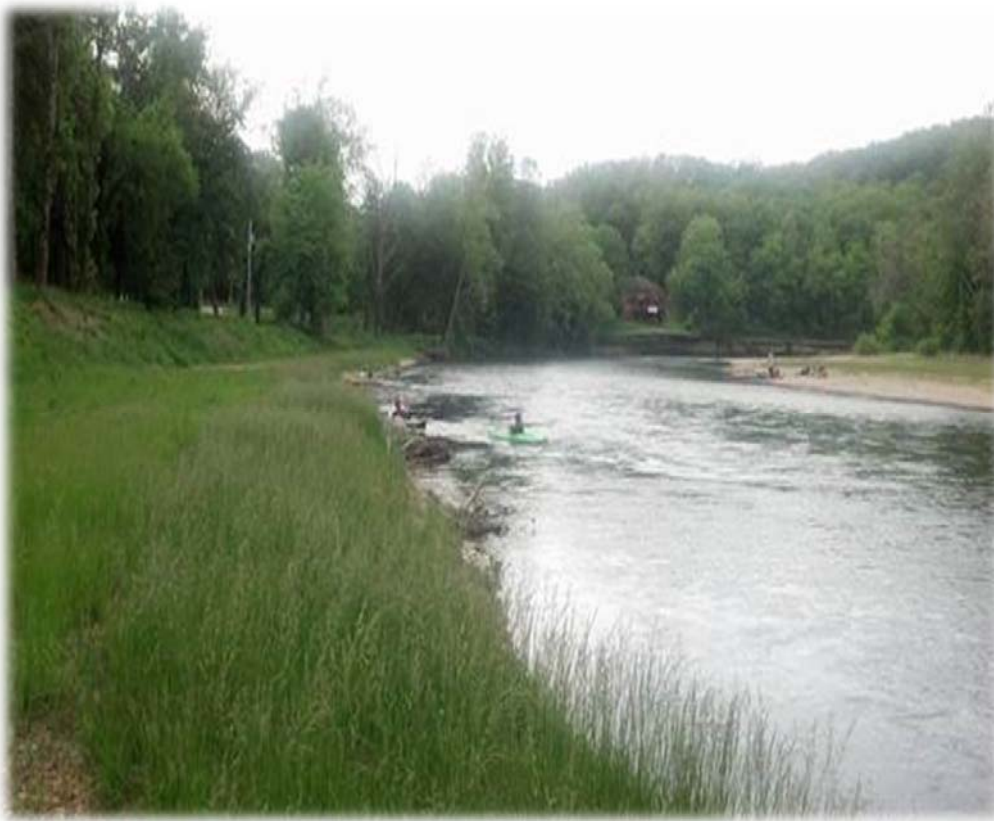
If there are additional funds remaining in the budget, the NSE/5SSR team would like to offer several alternatives that will address the issues at the River Ranch Project Site. Alt 1: The NSE/5SSR design team can meet with the stakeholders of the project to determine the goals and objectives of the site so that a preliminary design can be generated relative to the budget constraints. Alt 2: The NSE/5SSR team can assist with obtaining permits for future construction once the preliminary design has been approved by the stakeholders. Alt 3: The NSE/5SSR team can assist with any onsite maintenance to ensure stability for a short term program until adequate funding is obtained.

Comment [BS4]: Several alternatives were discussed of what to do with the additional money that OCC has available for these projects. The most likely alternative was that NSE would give a "time/material" pricing for several projects that need slight repair attention. The most talked about site was a boat ramp access location. IF all of the other 3 sites do not require additional funding for any additions, the remaining funding will be \$69,000.
