Grand Lake (Oklahoma) Watershed Implementation Project Phase I Task 5.3 Bioretention Cell Design, Evaluation, and Technology Demonstration

FY 2004 319(h) Project 5 **EPA Grant # C9-996100-12** Oklahoma Conservation Commission

Prepared by Oklahoma State University Department of Biosystems and Agricultural Engineering 111 Agricultural Hall Stillwater, Oklahoma 74078

> Final Report December 2008

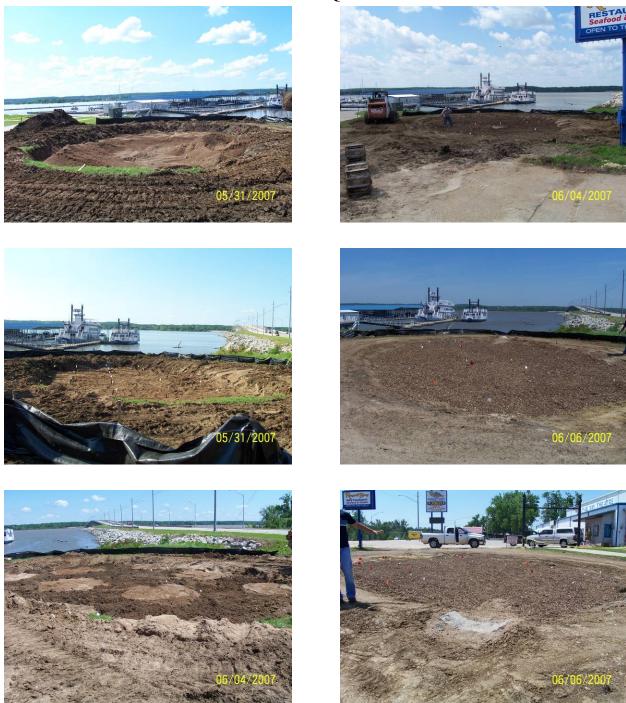
## **Cherokee Queen**

**Top Left:** Partially backfilled cell. **Middle Left:** Flags marking sand plug locations. **Bottom left:** Completed top soil / sand plug layer. **Top Right:** Application of hardwood mulch. **Middle Right:** Completed, unplanted cell. **Bottom Right:** Overflow weir.

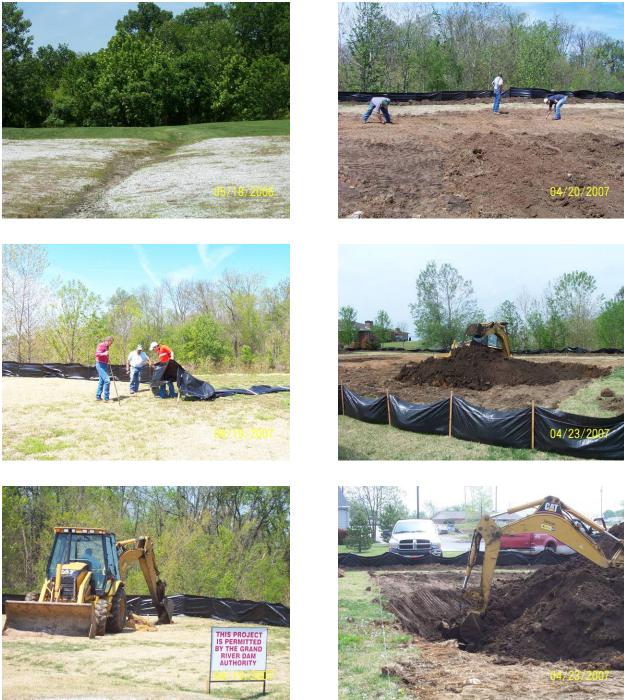
**Top Left:** Site prior to cell construction. **Middle Left:** Installation of silt fence. **Bottom left:** Removal of grass from designated excavation area. **Top Right:** Marking cell location. **Middle Right:** Cell excavation. **Bottom Right:** View of 1:1 side slope during excavation.

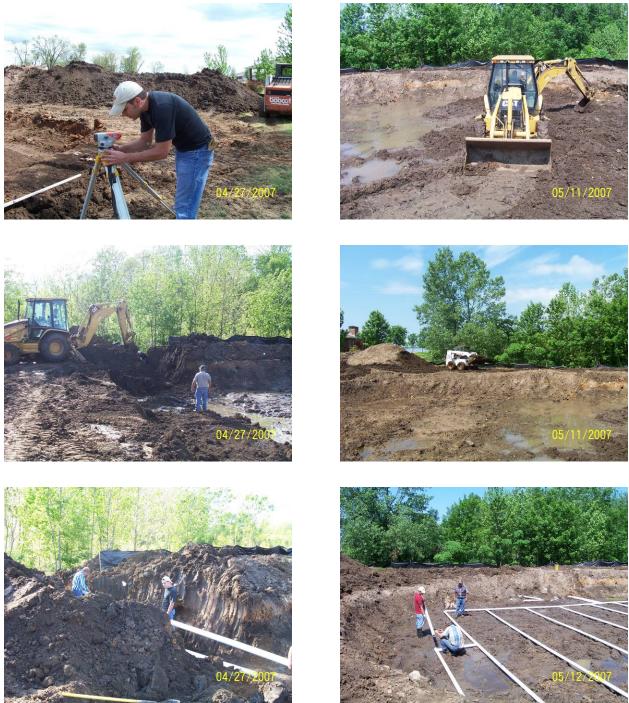
**Top Left:** Reading elevations to establish excavation depth. **Middle Left:** Excavation of trench for drainage outlet. **Bottom left:** Installation of drainage outlet. **Top Right:** Front loader leveling cell floor. **Middle Right:** Completed excavation. **Bottom Right:** Installing drainage system.

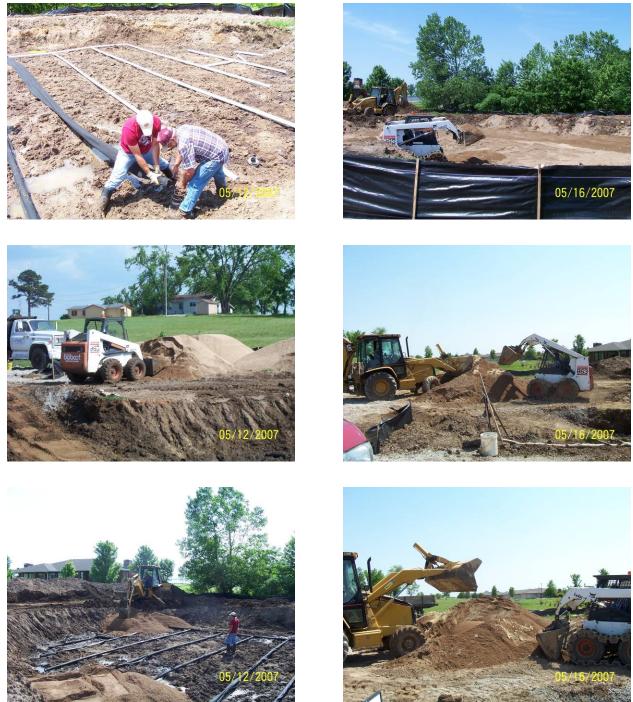
**Top Left:** Securing filter fabric to drainage pipes to prevent clogging. **Middle Left:** Bobcat loading sand to cover drainage pipes. **Bottom left:** Front end loader covering drainage pipes with sand. **Top Right:** Bobcat applying sand to cell. **Middle Right:** Blending sand/fly ash filter medium. **Bottom Right:** Heavy equipment blending sand and fly ash.

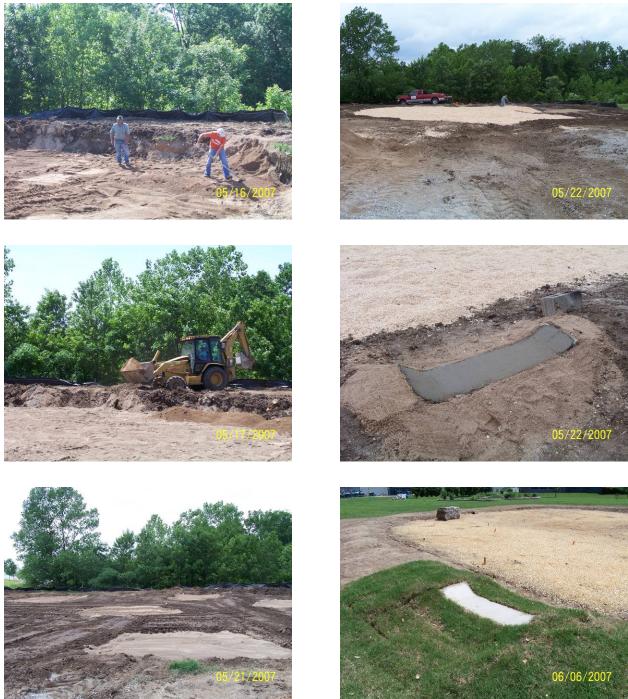
**Top Left:** Leveling one filter layer lift. **Middle Left:** Sand plug placement. **Bottom left:** Completed top soil/sand plug layer. **Top Right:** Application of mulch. **Middle Right:** View of overflow weir. **Bottom Right:** Completed overflow weir.

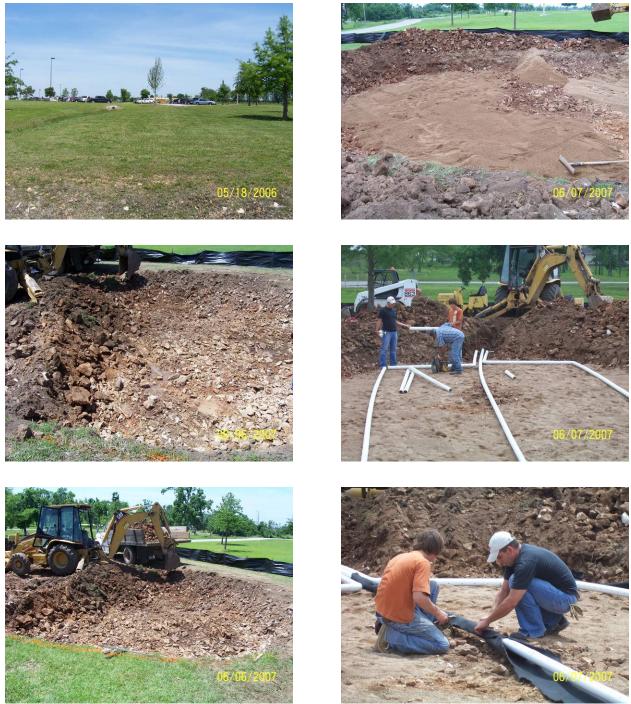
### **Grove High School**

**Top Left:** Site prior to cell construction. **Middle Left:** View of rocky soil conditions encountered during excavation of this site. **Bottom left:** Cell excavation. **Top Right:** Application of sand lift prior to drainage pipe placement due to rocky site conditions. **Middle Right:** Drainage pipe placement. **Bottom Right:** Securing filter fabric to drainage pipe.

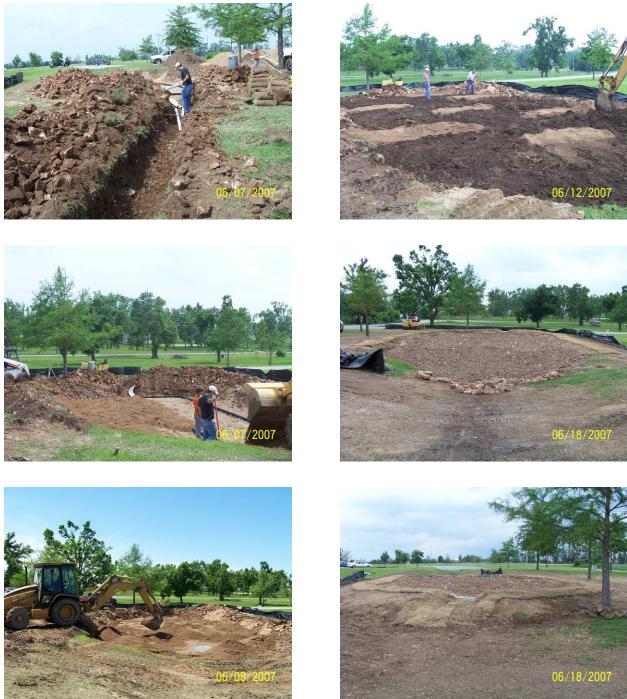
## **Grove High School**

**Top Left:** Installation of outlet drainage. **Middle Left:** Placement of filter layer lift. **Bottom left:** Sand plug placement. **Top Right:** Front end loader placing top soil around sand plugs. **Middle Right:** View of completed, unplanted cell from inlet. **Bottom Right:** View of completed, unplanted cell from overflow weir.

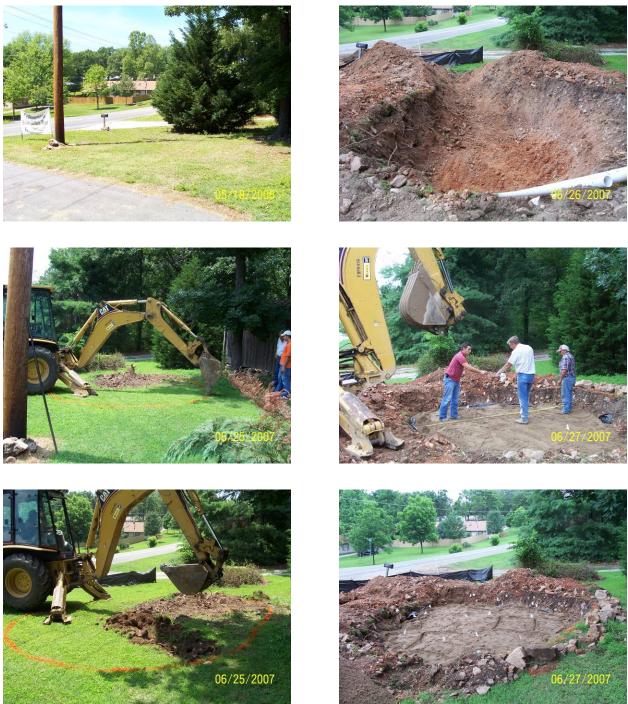
### Lendonwood Gardens

**Top Left:** Site prior to cell construction. **Middle Left:** View of cell outline **Bottom left:** Cell excavation. **Top Right:** View of completed cell and outlet excavation. **Middle Right:** Marking sand plug locations. **Bottom Right:** View of flags marking sand plug outlines.

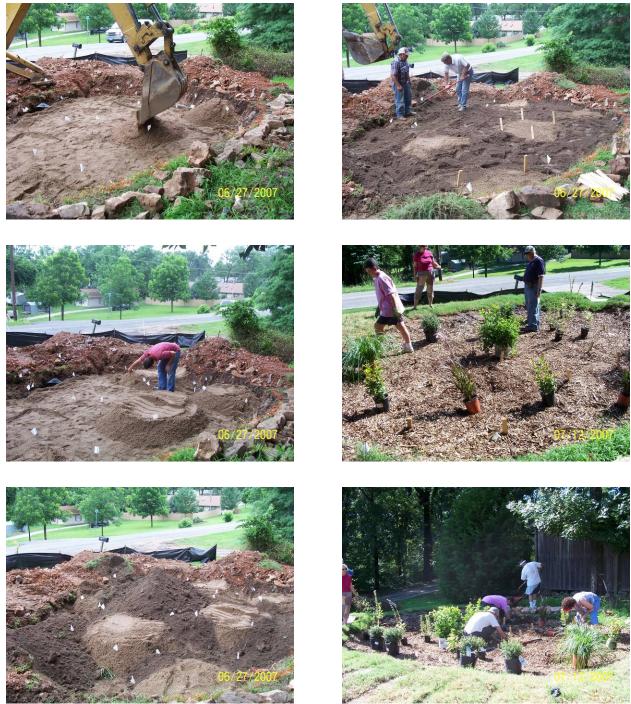
### Lendonwood Gardens

**Top Left:** Front end loader placing sand plugs in designated locations. **Middle Left:** Measuring sand plug height. **Bottom left:** Filling top soil around sand plugs. **Top Right:** Leveling top soil / sand plug layer. **Middle Right:** Vegetation layout for cell. **Bottom Right:** Volunteer group of Master Gardeners planting cell.

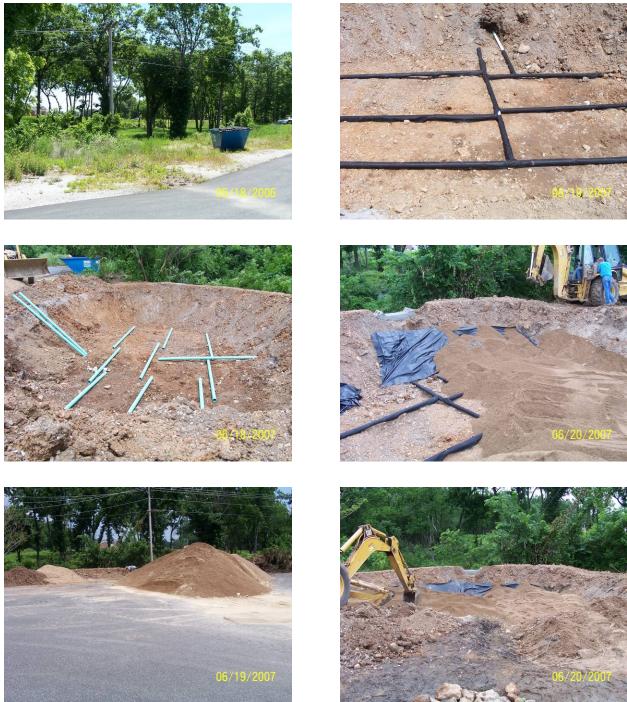
### Elm Creek Plaza

**Top Left:** Site prior to cell construction. **Middle Left:** Drainage pipe layout. **Bottom left:** Load of mixed filter medium ready to be placed in cell. **Top Right:** Completed drainage. **Middle Right:** View of liner used to stabilize cell wall. **Bottom Right:** Installation of one lift of filter layer.

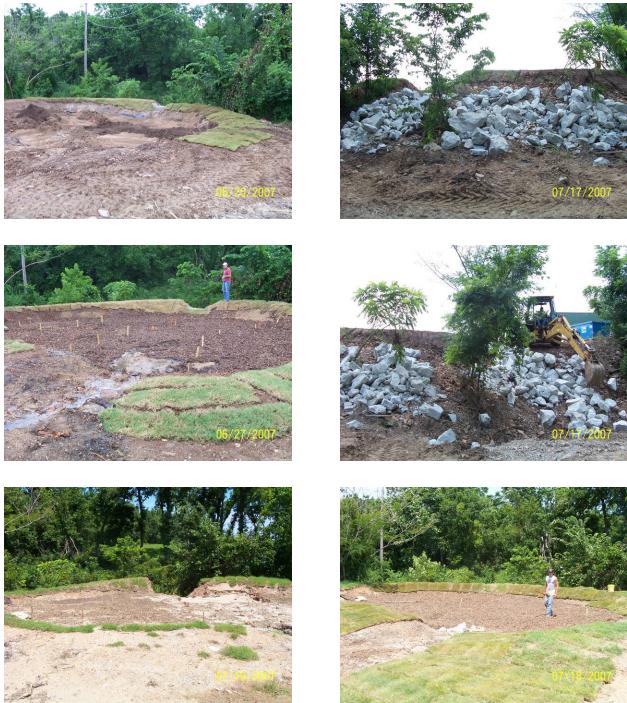
#### Elm Creek Plaza

**Top Left:** Placement of top soil around sand plugs. **Middle Left:** Completed cell after a rain event. **Bottom left:** View of damaged cell. **Top Right:** View of reinforced stream bank behind cell. **Middle Right:** Front end loader placing rock to reinforce stream bank. **Bottom Right:** View of repaired cell.

There were two cell failures. The first was at Elm Creek Plaza, where the cell receives runoff from a parking lot and sits on a stream bank. Berm failure occurred due to fugitive water from a neighboring property during a 50 year storm, providing roughly twice the design flow. The flow destroyed the overflow weir that was poorly placed on the streambank. The cell was repaired and reinforced, and the overflow was moved to a different location to alleviate the possibility of a repeated failure. The property owner also had the channel between the two properties cleaned out and deepened. One positive outcome is that immediate benefits with regard to erosion have been observed at this site. During construction it was necessary to rebuild the bank as it had eroded substantially in the time between the design and construction phases, and the cell would not have fit as designed.

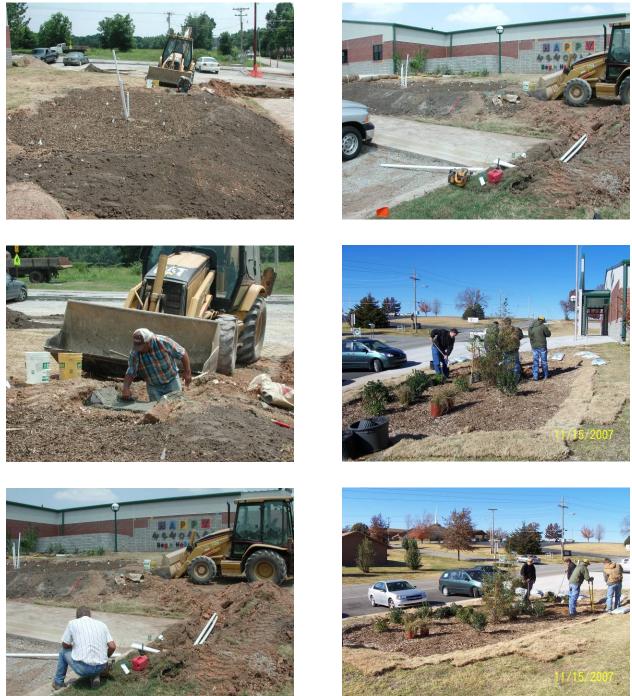
## Early Childhood Development Center

**Top Left:** View of cell with monitoring wells in center. **Middle Left:** Installation of overflow weir. **Bottom left:** Measuring location for drainage outlet. **Top Right:** View of drainage outlet. **Middle Right:** Grove High School FFA students digging holes to plant vegetation. **Bottom Right:** FFA students planting cell.

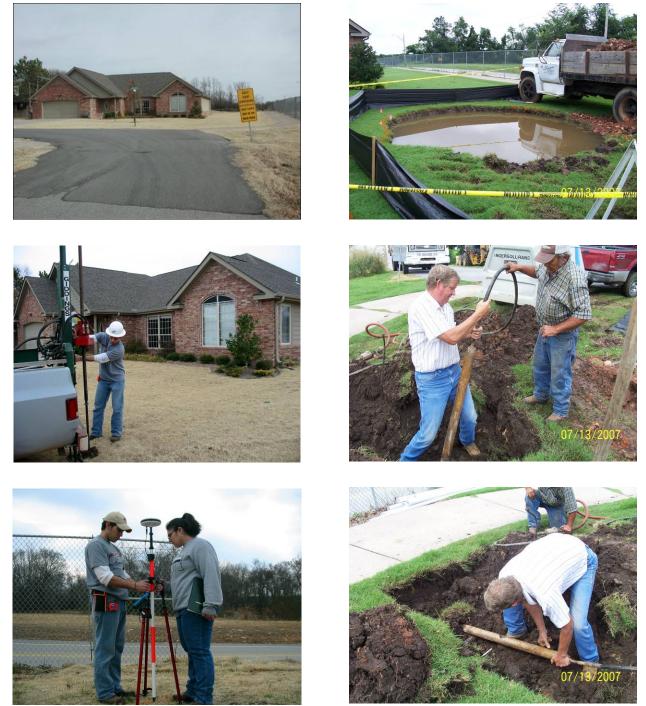
### **Clark Residence**

**Top Left:** Site prior to cell construction. **Middle Left:** Drilling to obtain soil samples for site survey. **Bottom left:** Reading elevation and coordinates from GPS unit during site survey. **Top Right:** Excavated cell filled with water after a storm during construction. **Middle Right:** Assembly of air hammer. **Bottom Right:** Start of tunnel under golf path for drainage outlet.

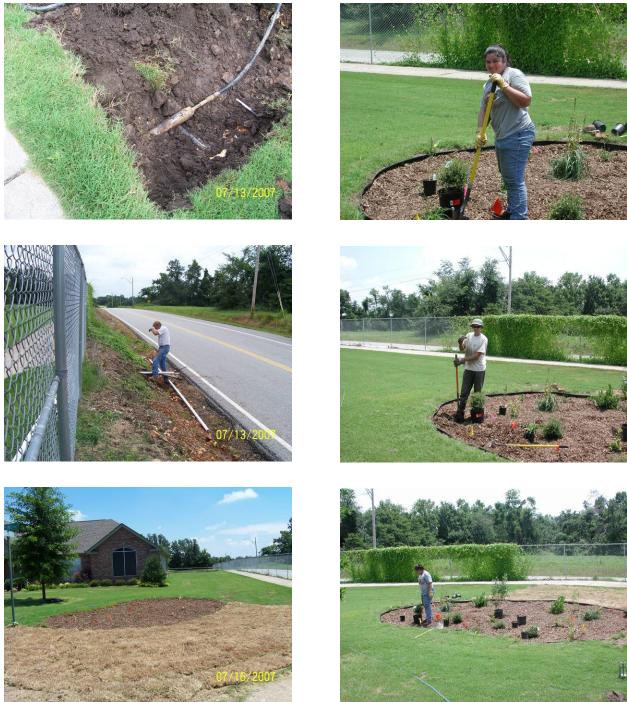
## **Clark Residence**

**Top Left:** Air hammer tunneling under golf path. **Middle Left:** Installation of drainage outlet. **Bottom left:** Completed, unplanted cell. **Top Right:** OSU engineer planting cell. **Middle Right:** OCC project coordinator planting cell. **Bottom Right:** View of plant layout for cell.

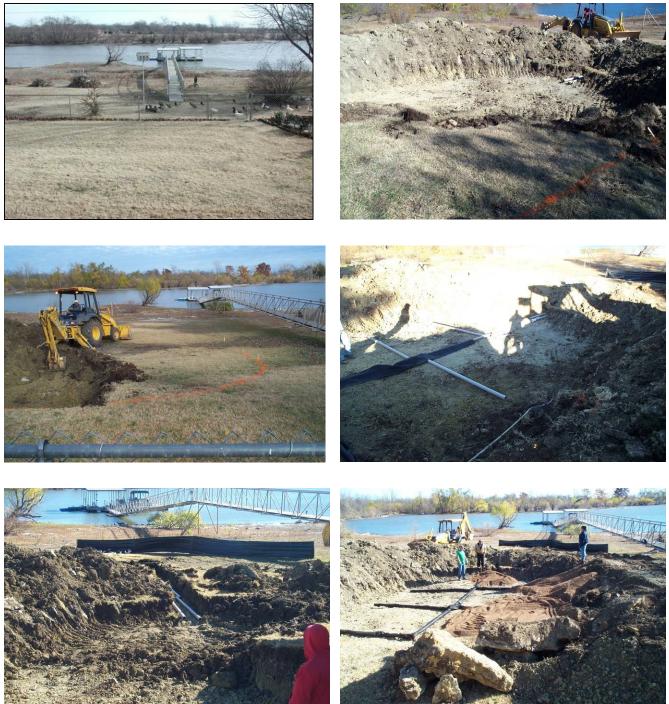
## **Spicer Residence**

**Top Left:** Site prior to cell construction. **Middle Left:** View of cell boundaries. **Bottom left:** Drainage outlet installation. **Top Right:** Cell excavation. **Middle Right:** Installation of drainage system. **Bottom Right:** Placement of filter layer lift.

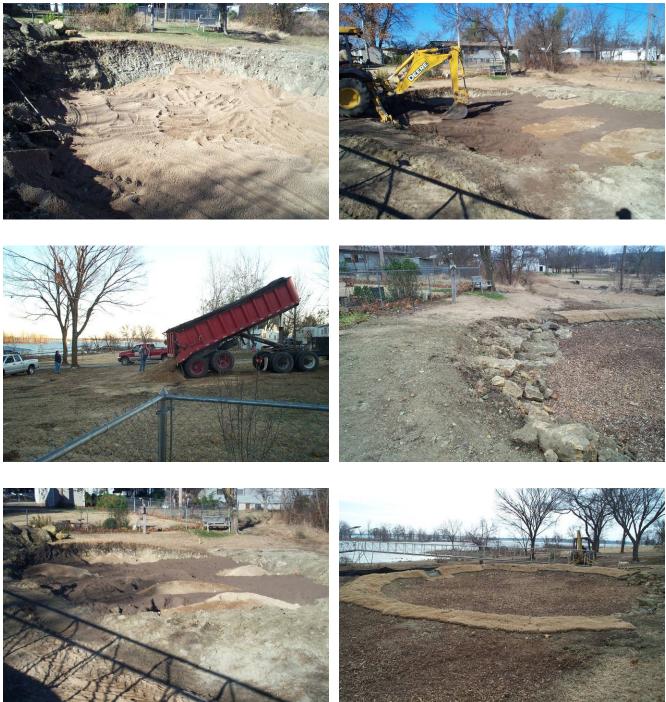
**Spicer Residence**

**Top Left:** View of filter layer lift. **Middle Left:** Receiving a truck load of sand. **Bottom left:** Placing top soil around sand plugs. **Top Right:** Leveling top soil/sand plug layer. **Middle Right:** View of rock inlet. **Bottom Right:** View of completed, unplanted cell.

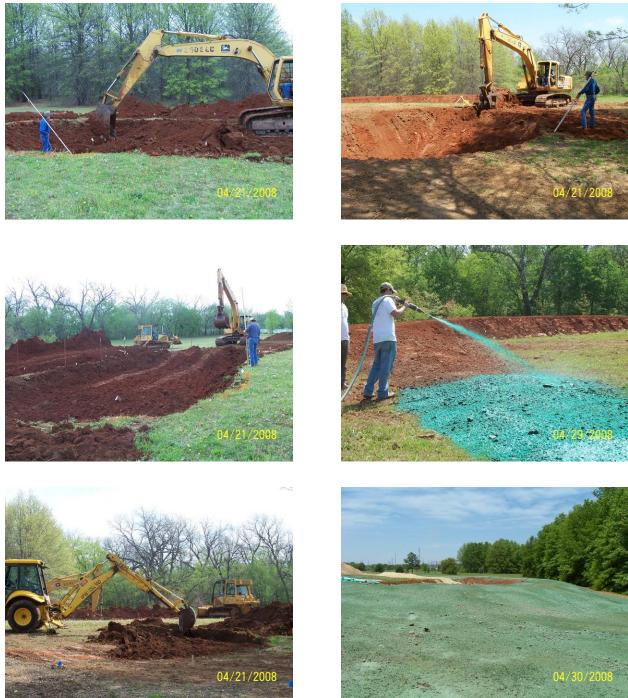
## Botanical Gardens (Cells A & B)

**Top Left:** Excavation of Cell B. **Middle Left:** Construction of berms for Cell B. **Bottom left:** Excavation of Cell A. **Top Right:** Excavation of drainage outlet for Cell B. **Middle Right:** Hydromulching cell berms. **Bottom Right:** View of hydromulched berm for Cell B.

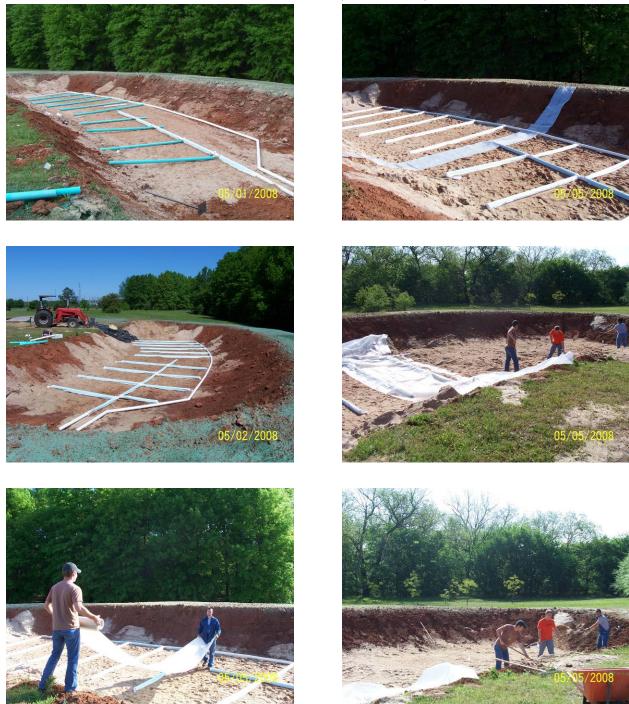
## Botanical Gardens (Cells A & B)

**Top Left:** Drainage layout for Cell B. **Middle Left:** Completed drainage system for Cell B. **Bottom left:** Measuring plastic barrier to hydraulically separate Cell B. **Top Right:** Placement of plastic barrier in Cell B. **Middle Right:** Securing the bottom of the plastic barrier under a layer of sand. **Bottom Right:** Spreading sand for filter layer in Cell B.

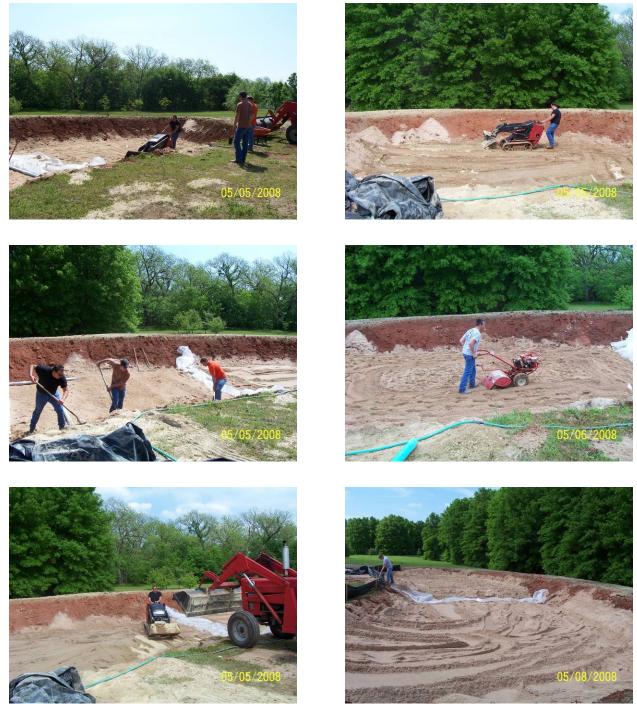
## Botanical Gardens (Cells A & B)

**Top Left:** Dingo leveling sand lift. **Middle Left:** Adding fly ash to sand. **Bottom left:** Dingo spreading fly ash evenly over sand lift. **Top Right:** Spreading fly ash over sand lift. **Middle Right:** Tilling fly ash into sand lift. **Bottom Right:** Completed filter layer.

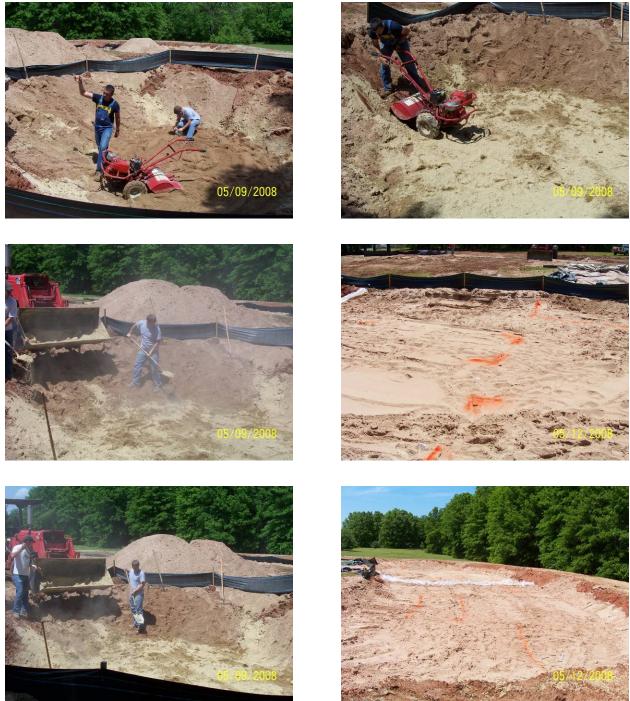
## Botanical Gardens (Cell A & B)

**Top Left:** Collecting samples from tilled filter layer lift in Cell A. **Middle Left:** Manually spreading fly ash over sand lift. **Bottom left:** Adding fly ash to sand lift. **Top Right:** Tilling fly ash into sand lift. **Middle Right:** Sand plug locations. **Bottom Right:** View of sand plug placement.
