TRAILWOODS NEIGHBORHOOD BEST MANAGEMENT PRACTICES

FY 2011 §319(h) CA # C9-996100-16 Project 5 (Task 5.2.6c)

For
United States Environmental Protection Agency (Regional 6) and
Oklahoma Conservation Commission

Prepared by
Reid Coffman, Associate Professor, Kent State University

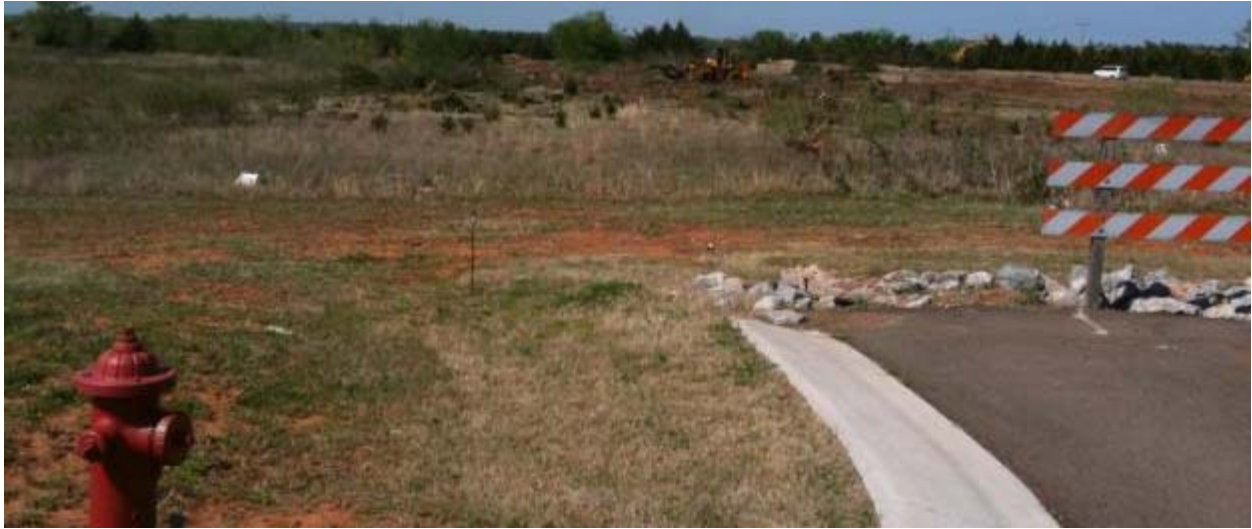
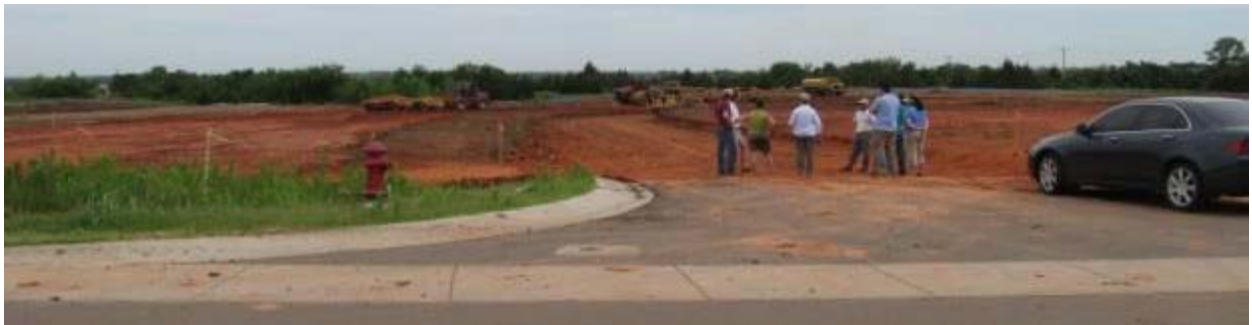
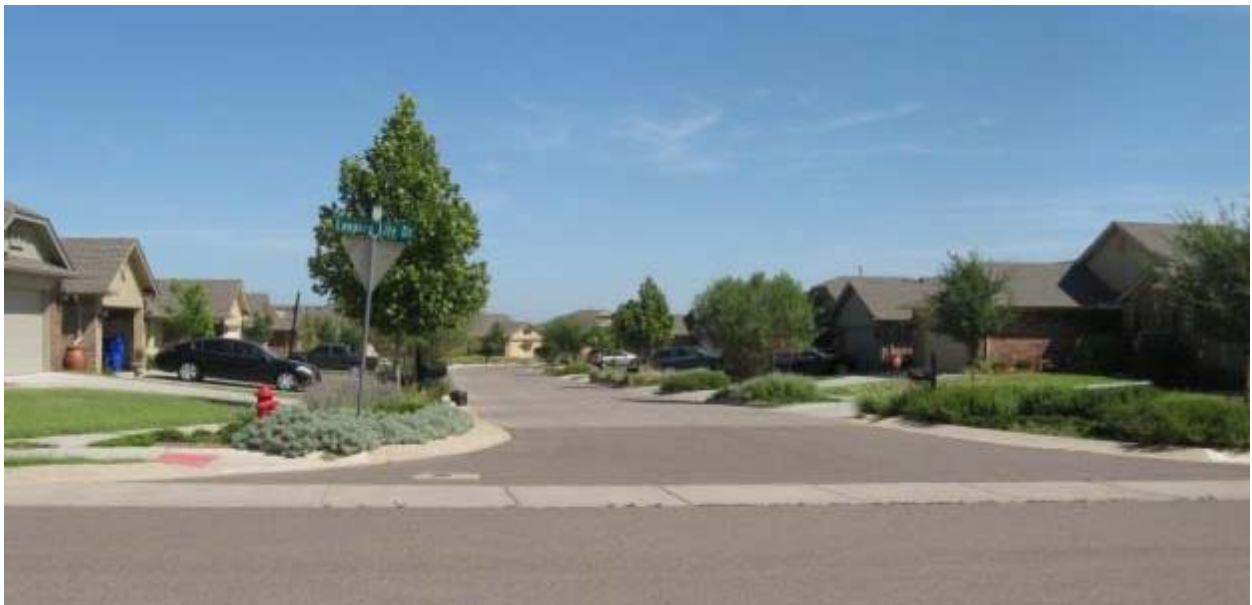
Figure 2: Site predevelopment condition (Top), the site under development September 2010 (Middle), and the site upon completion in 2013 (Bottom).

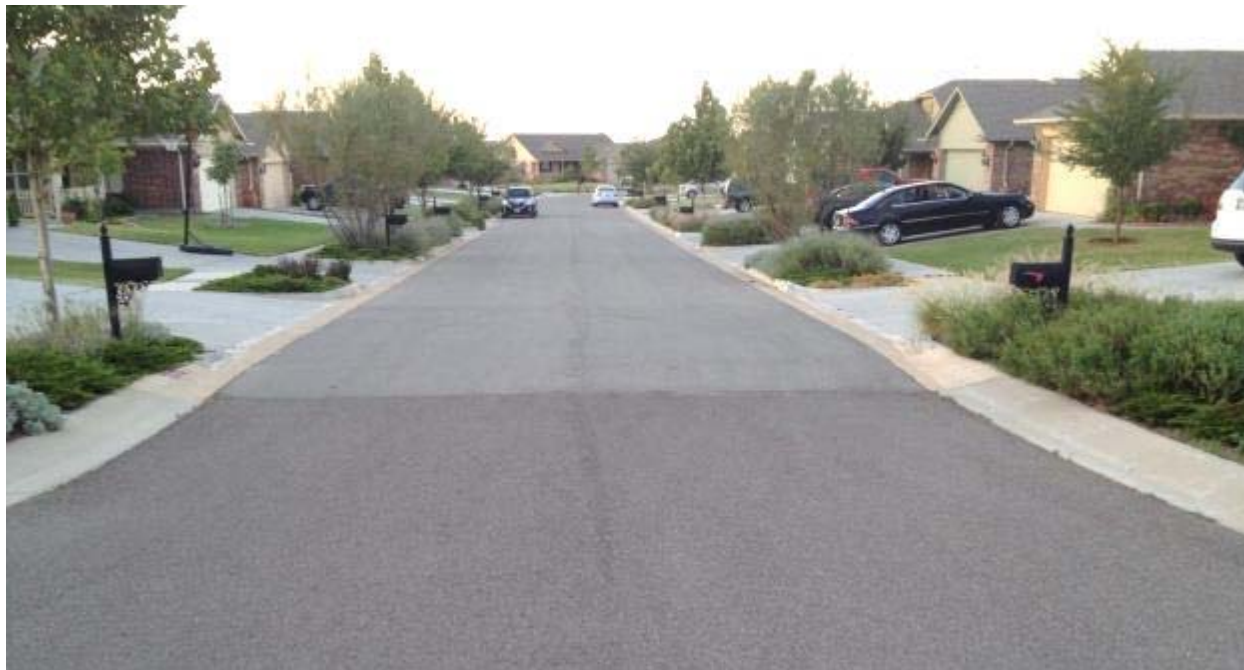
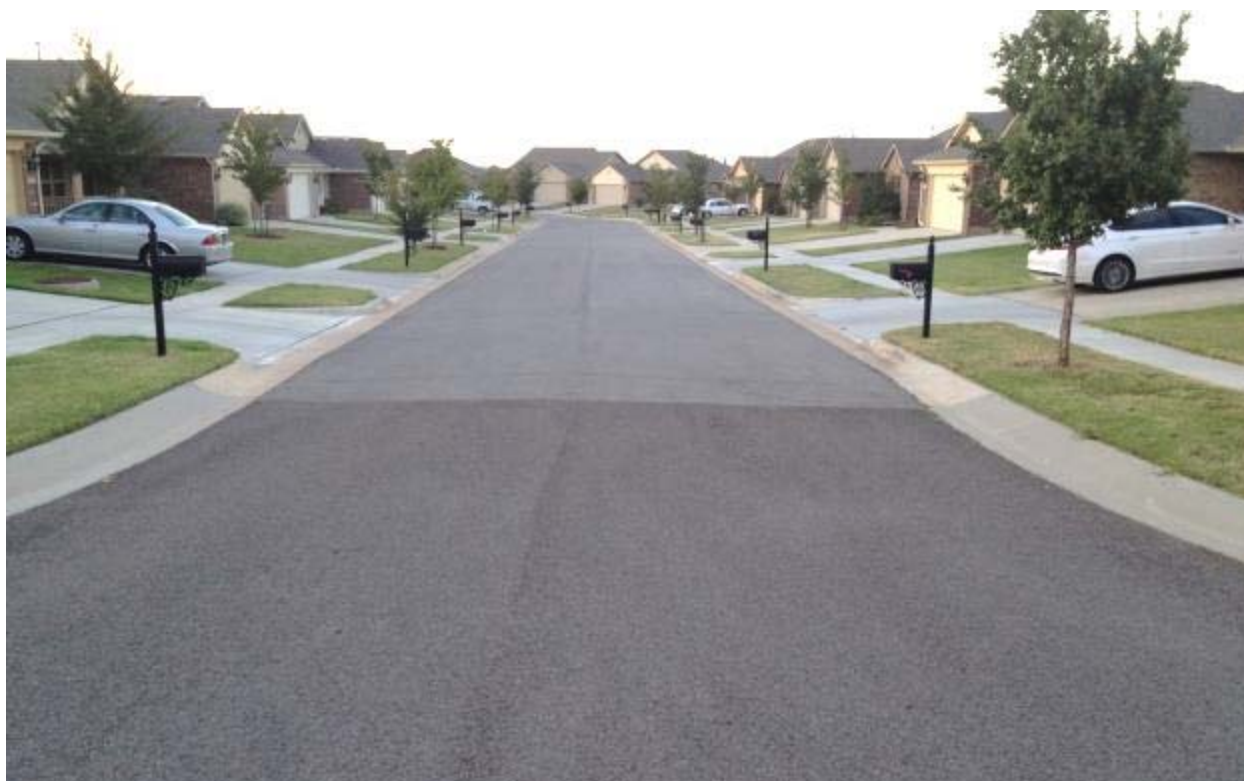
Figure 4: The demonstration basin (Top) and the conventional basin (Bottom) September 2014.

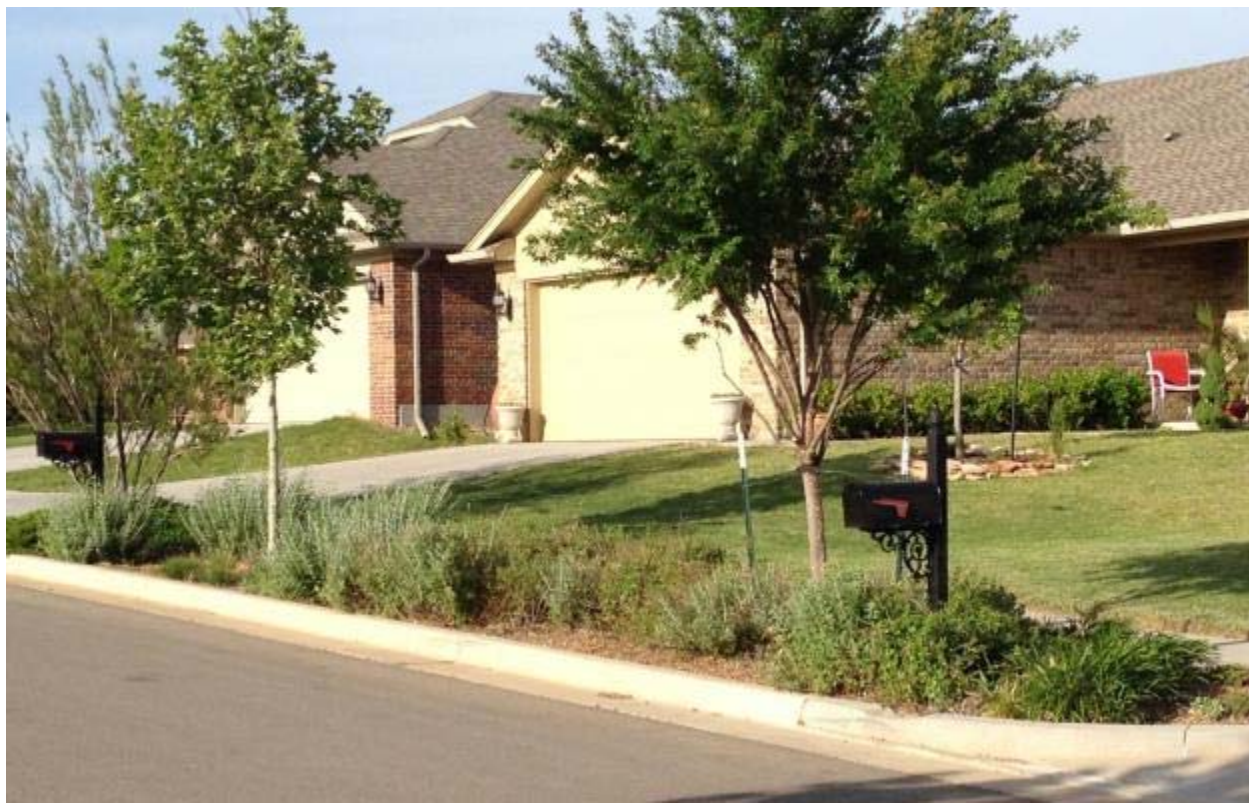
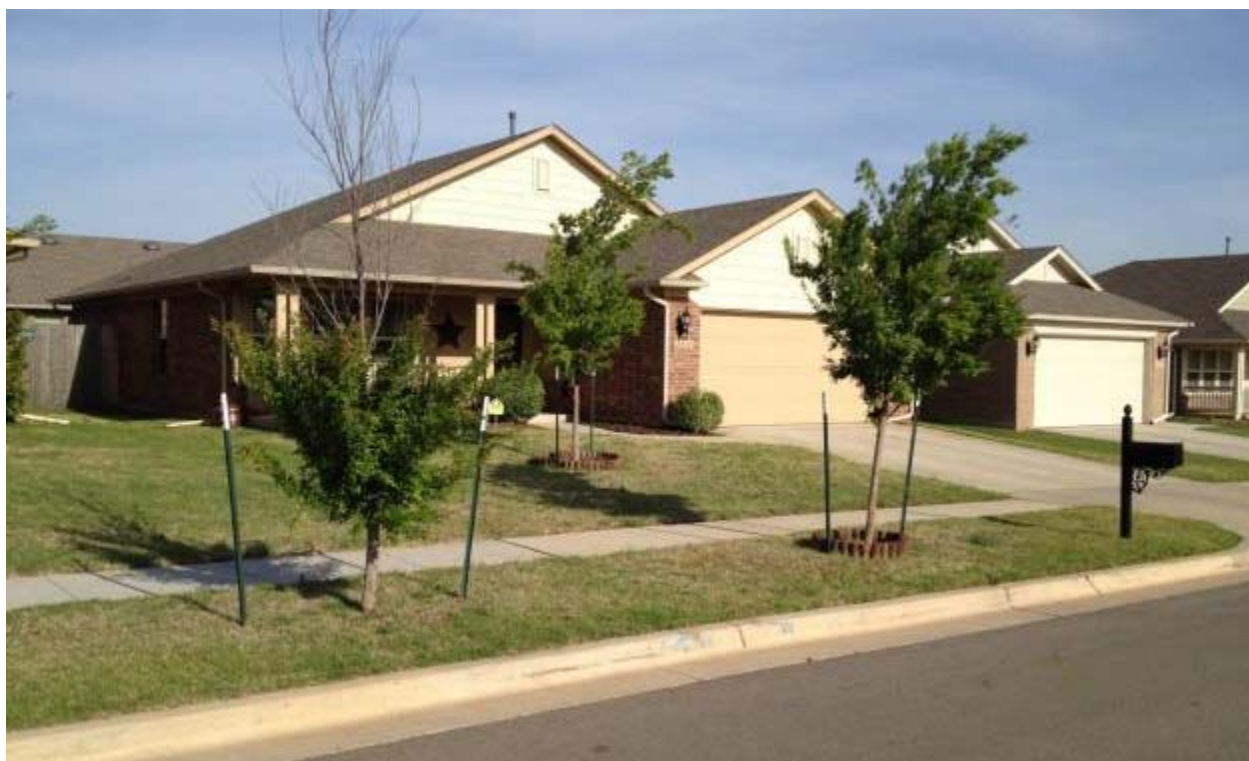
Figure 5: Photos of the demonstration basin (Top) and the conventional basin (Bottom) September 2014.

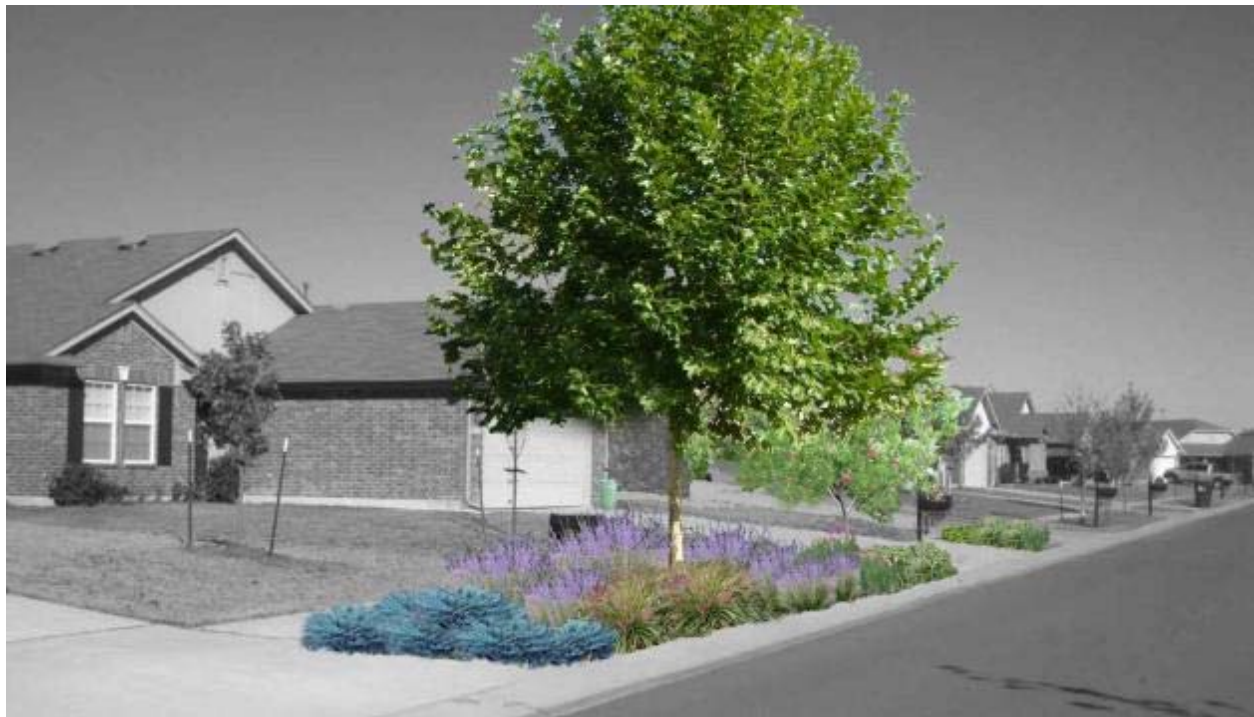
Figure 7: Imagery of the rain garden aesthetics depicting the conceptual vegetation community (Top) and a mid-iteration of a cross section of the street side rain garden studying the drain pipe and gas and water utility locations (Bottom).

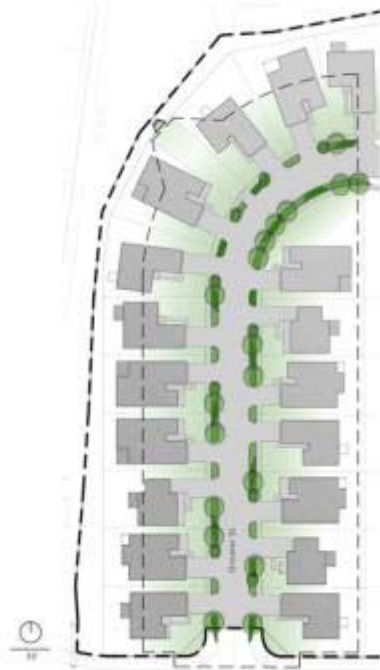
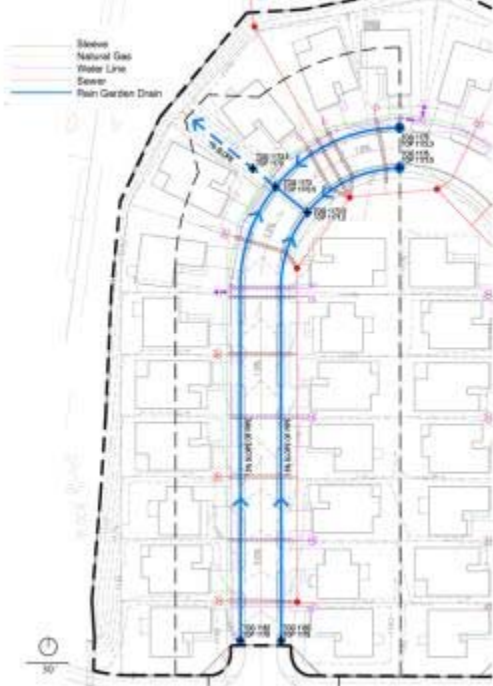
Figure 8: Series of schematic drawings street side rain garden illustration (Top left); micro-basin analysis which removed curb cuts and focused on parcel capture (Top right); utilities coordination plan (Bottom left); and lot illustration of rain gardens, rain barrels and surface flow (Bottom right).

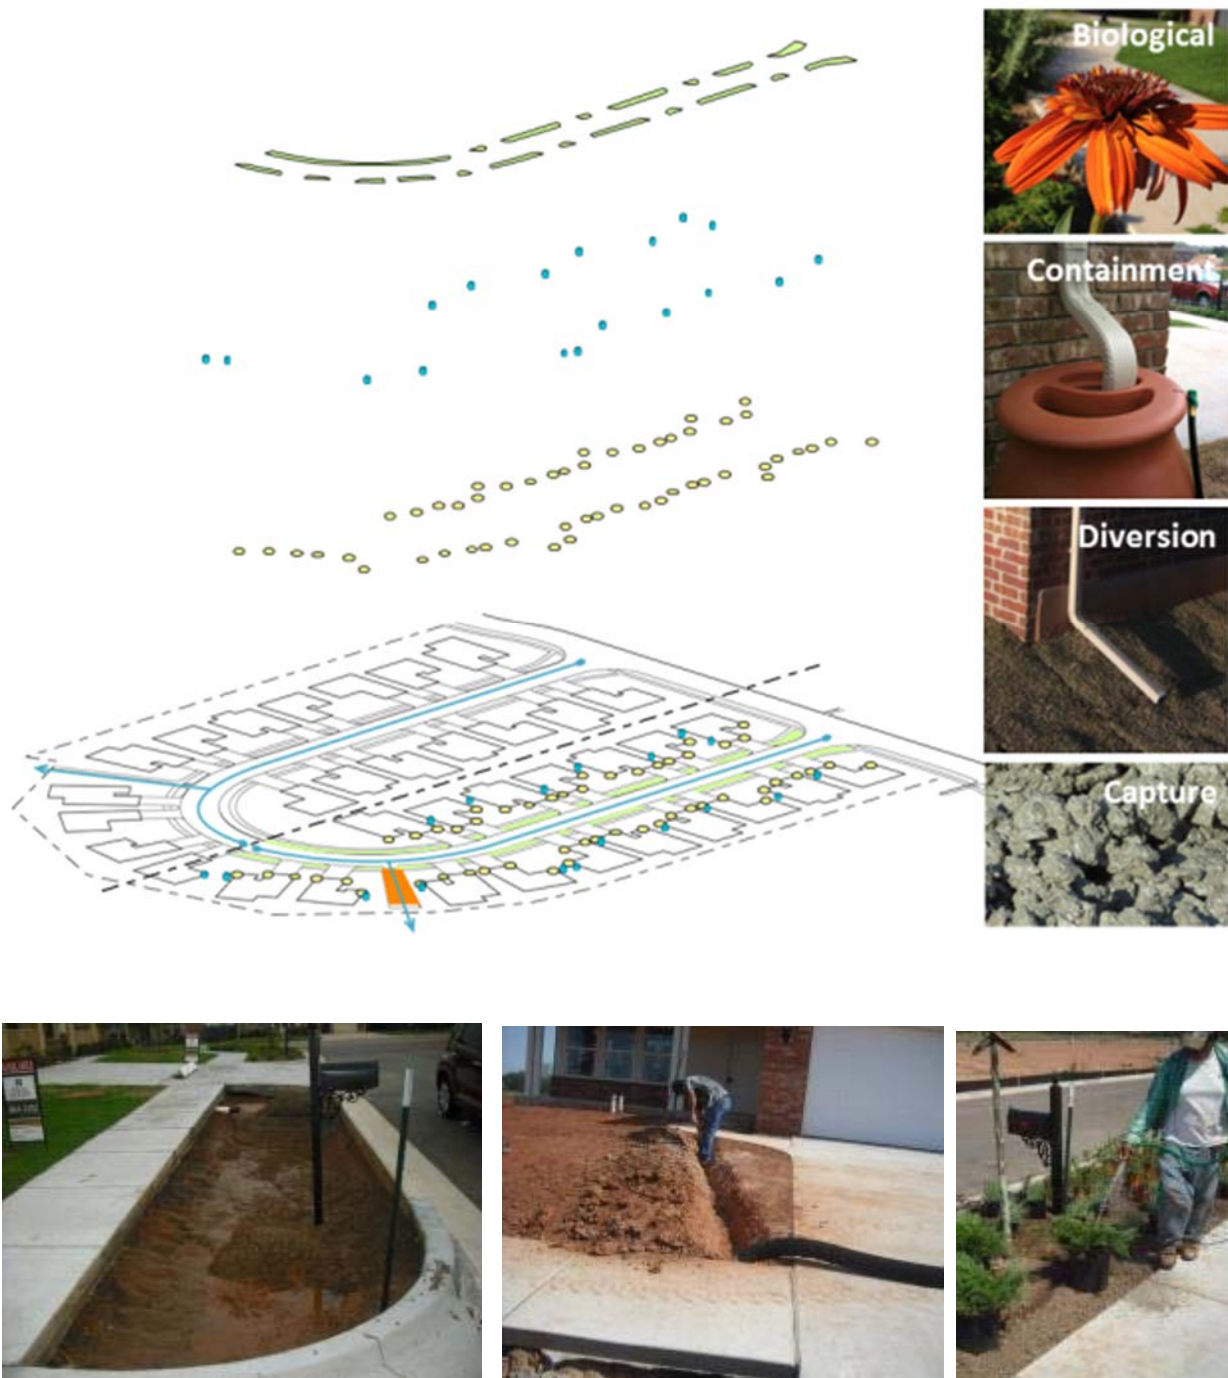
Figure 11: Shows the four BMPs per lot: Biological (rain garden), Containment (rain barrel), Diversion (downspouts), and Capture (a small section of porous pavement). Below (left) is a lot with rain garden in mid construction, a downspout diversion (middle), and plant installation (right).

The project installed four best management practices in the neighborhood by deploying four strategies: 1) biological (rain gardens), 2) containment (rain barrels), 3) diversion (downspouts), and 4) capture (porous concrete) (Figure 11).

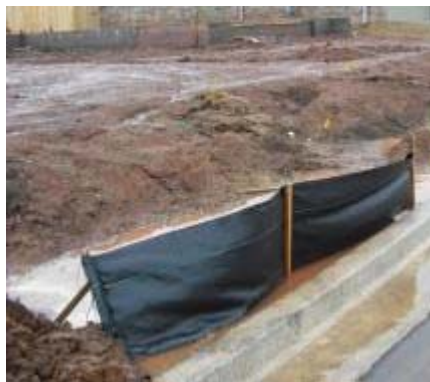
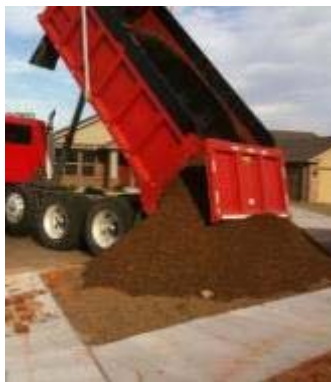
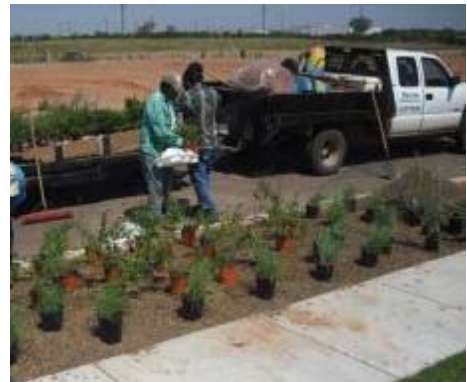
Figure 13: Shows the rain garden sub drain pipe installation with aggregate, fabric and sand (Top) and during parcel development as a mini catch basin (Bottom left), once completed the garden was excavated, filled with substrate (Bottom middle) and planted in the same day (Bottom right).

Each experimental lot was installed with 265 sq.ft. (mean) of rain garden. A 6" perforated flexible pipe, required by the City of Norman to dewater the road, was surrounded by 5/8" limestone aggregate, enclosed with landscape fabric, and topped with a 4" layer of sand (Figure 12). The pipes ran parallel to the curb line at 3' offset and were joined with a T intersect at the low point so they could daylight into the test flume. The outlet elevation had to rise in the field to accommodate downstream invert elevations. This resulted in 18-24" deep gardens in the lots surrounding the test flume (see below). The last house constructed was in the experimental basin in July 2013.

The garden installation went through a construction sequence aimed to protect water quality. After sub-drain installation, the gardens were used as mini-catch basins to trap sediment during lot development (Figure 13). When each house was sold, the sediment was excavated, the area was filled with substrate, and plants were installed within one day to prevent soil exposure. The installation of vegetation was required for issuance of the City Occupancy permit.

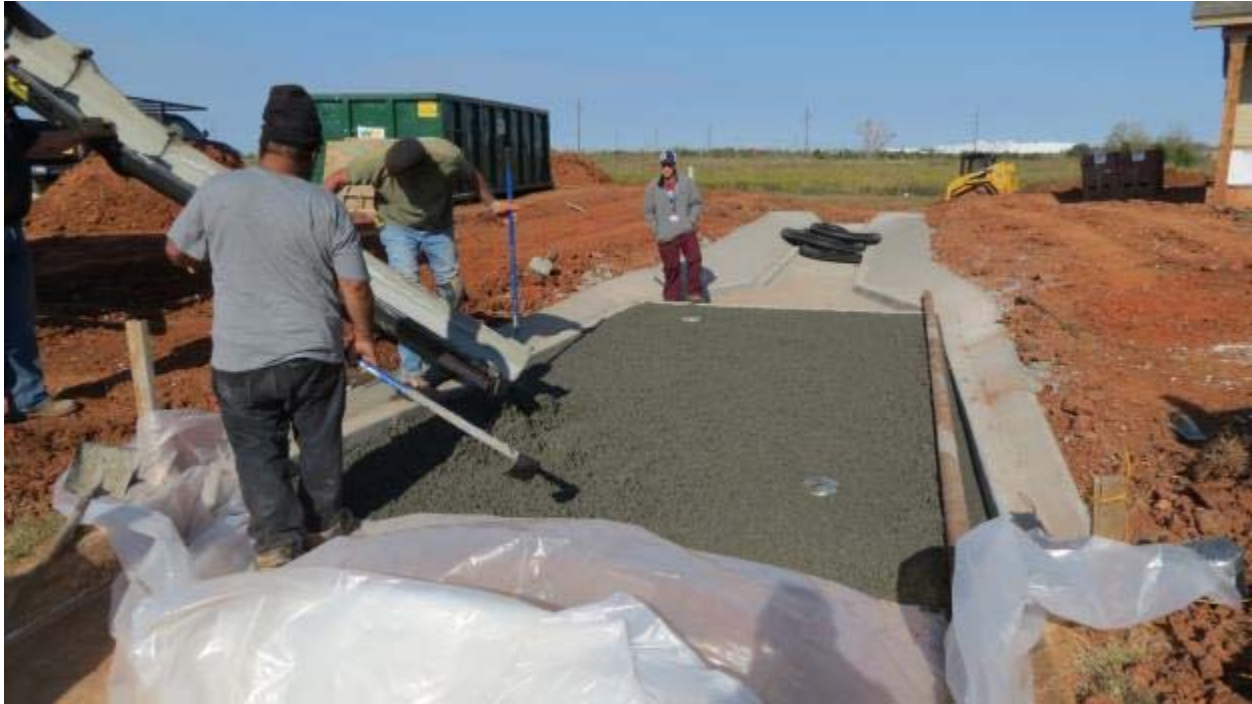
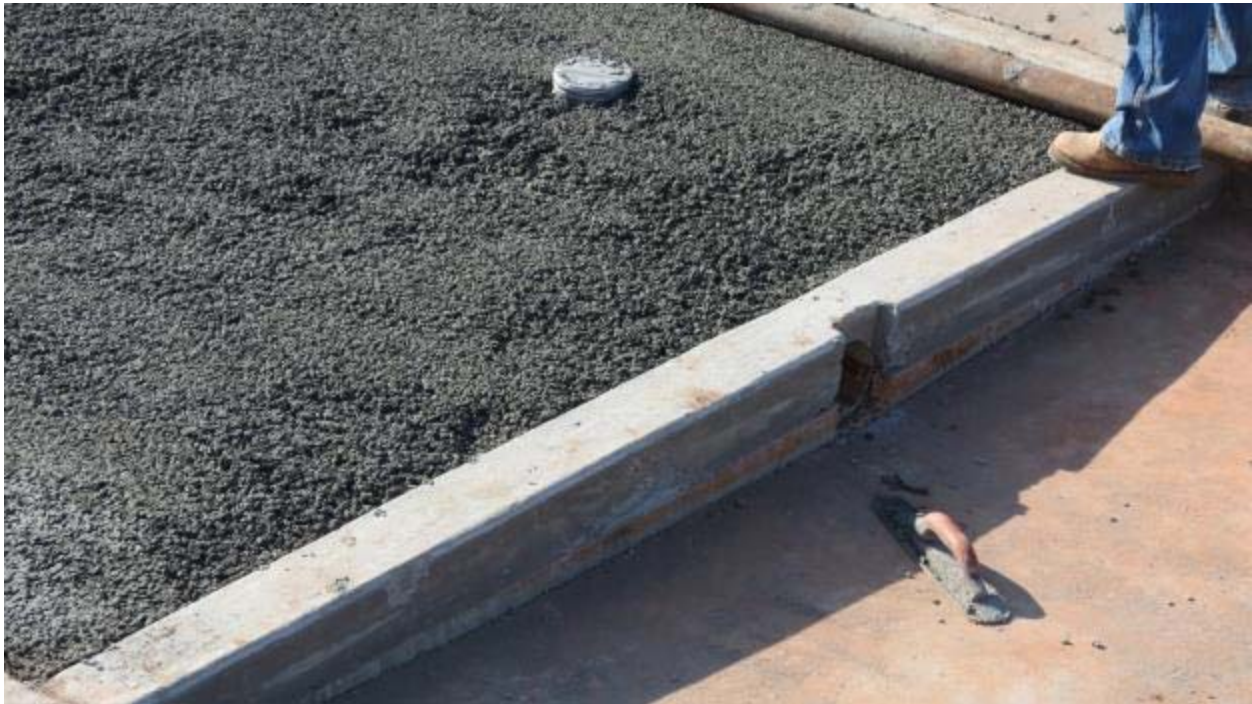
Figure 15: A small pad of porous concrete (120 s.f.) was placed over 36" of aggregate in the stormwater flume of the demonstration basin (Top). The pad accommodates both high flows to prevent flooding and the rain garden sub-drain pipe which daylights prior to the downstream test flume (Bottom). Wells were installed monitor sub-grade infiltration.

The use of porous paving in the area is in an early experimental stage and, due to the technical challenges of qualified mixers and installers, there were concerns about durability of the material and the homeowner/homebuyer acceptance, so large public and private paving areas were treated conventionally. However, a small section of porous concrete was installed in the stormwater flume, just before the test flume, of the demonstration basin. During the project, the contractor received classroom and field training in Tulsa, OK to order and install porous concrete. A 120 sq.ft. pad of 8" thick concrete was installed over 36" of aggregate. The pad was set level and elevation was set to accommodate high stormwater flows preventing flooding. The pad was aimed to capture first flush events. The rain garden sub-drain daylights just after the pad.

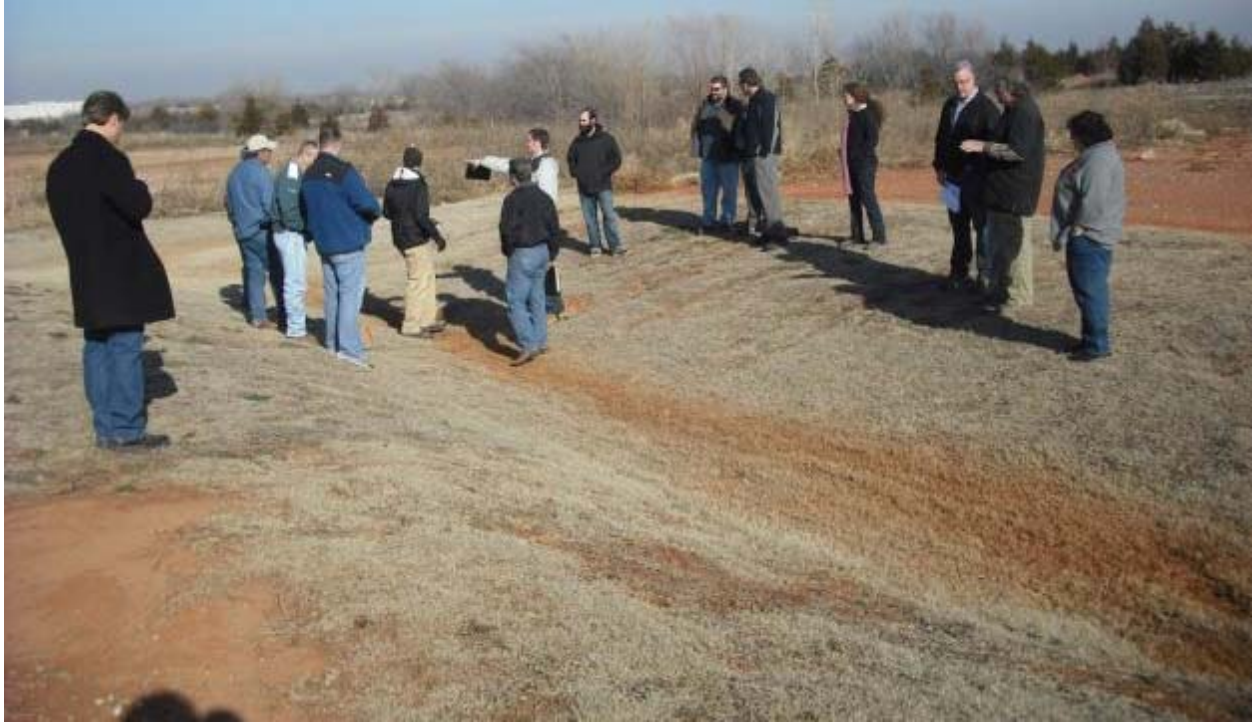
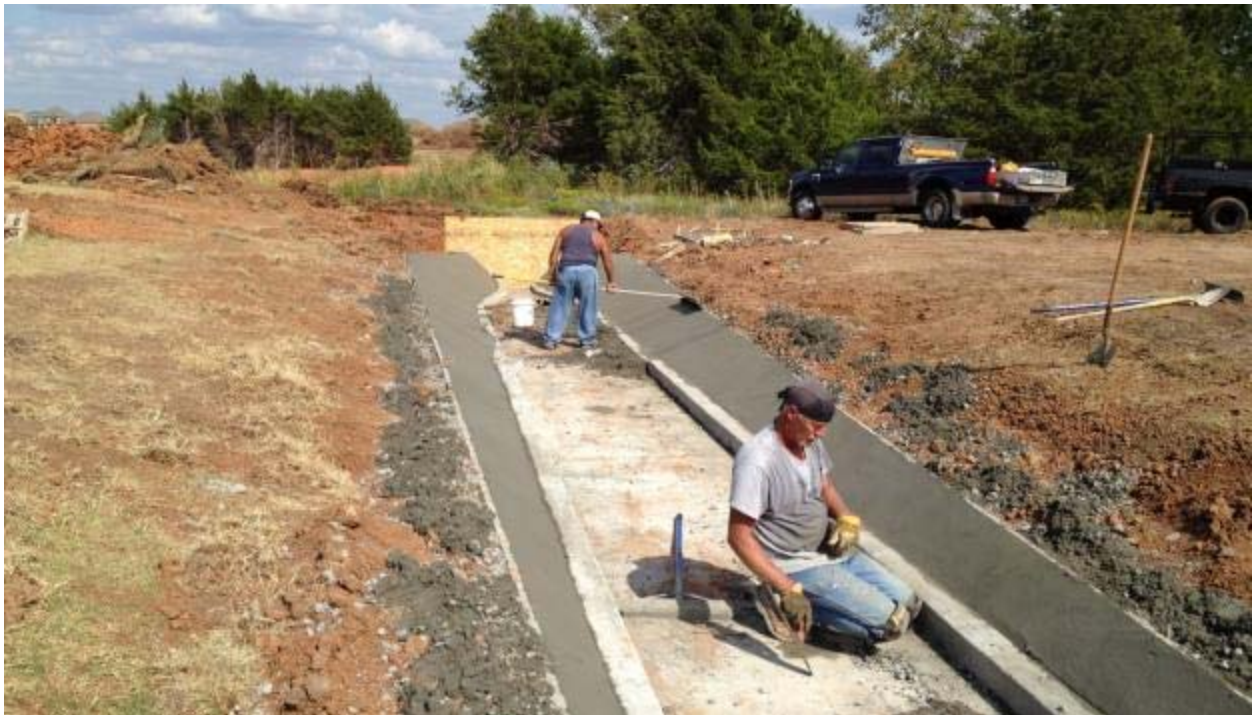
Figure 16: Photo of the team of scientists, engineers, landscape architects, client representatives, city officials and contractor locating the west stormwater and test flumes (Top). Photo of the east stormwater flume under construction (Bottom).

Concrete flumes were built to carry runoff away from the streets and prevent backflow into traffic (Figure 16). Plasti-fab test flumes were manufactured off site and shipped for installation. Sampling equipment specified to meet EPA regulated quality assurance [was](#) set in place by OU's Dr. Nairn and Dr. Strevett. Volumetric discharge data is being generated using a trapezoidal flume, bubbler/automated water sampler system, and datalogger (Figure 17). Stormwater quality samples will be collected using a flow-triggered automatic composite sampler. Upon completion of sample collection, physical parameters (pH, temperature, specific conductance, and related parameters) will be measured using properly calibrated multi-parameter data sondes. Collected samples will be analyzed for total suspended solids, biochemical oxygen demand, total and dissolved reactive phosphorus, nitrate-nitrogen, and ammonia-nitrogen at OU CREW laboratories.

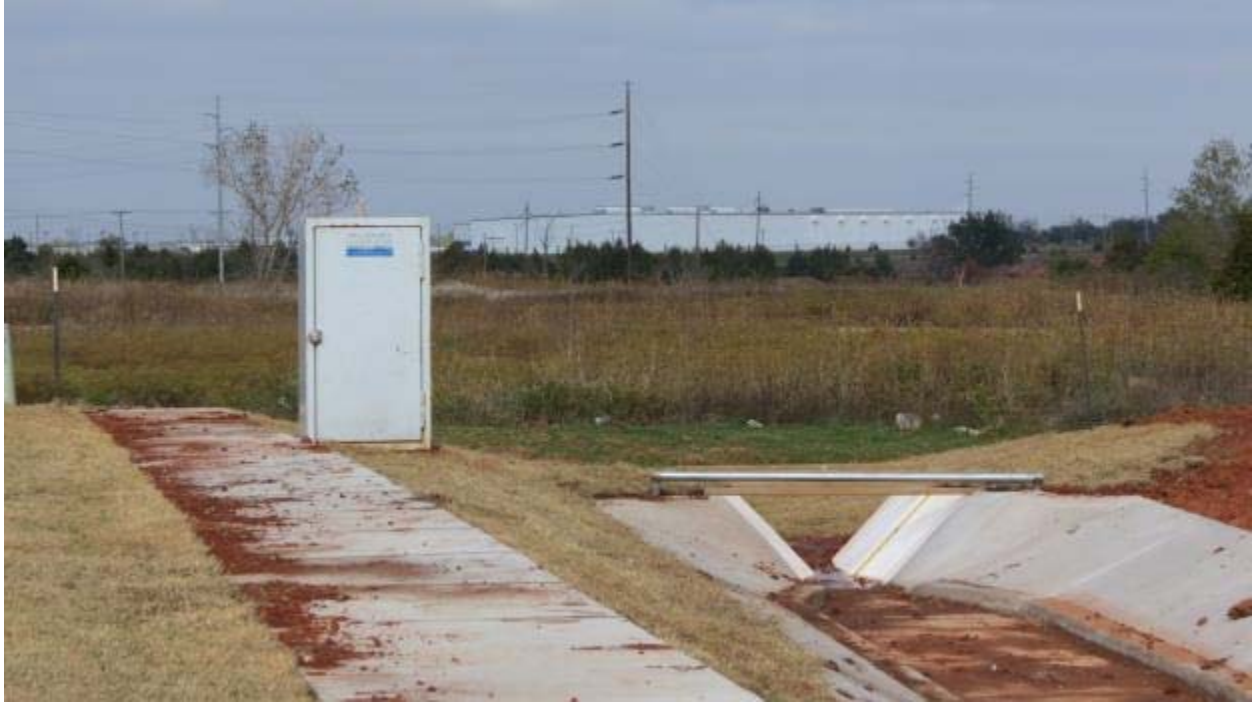
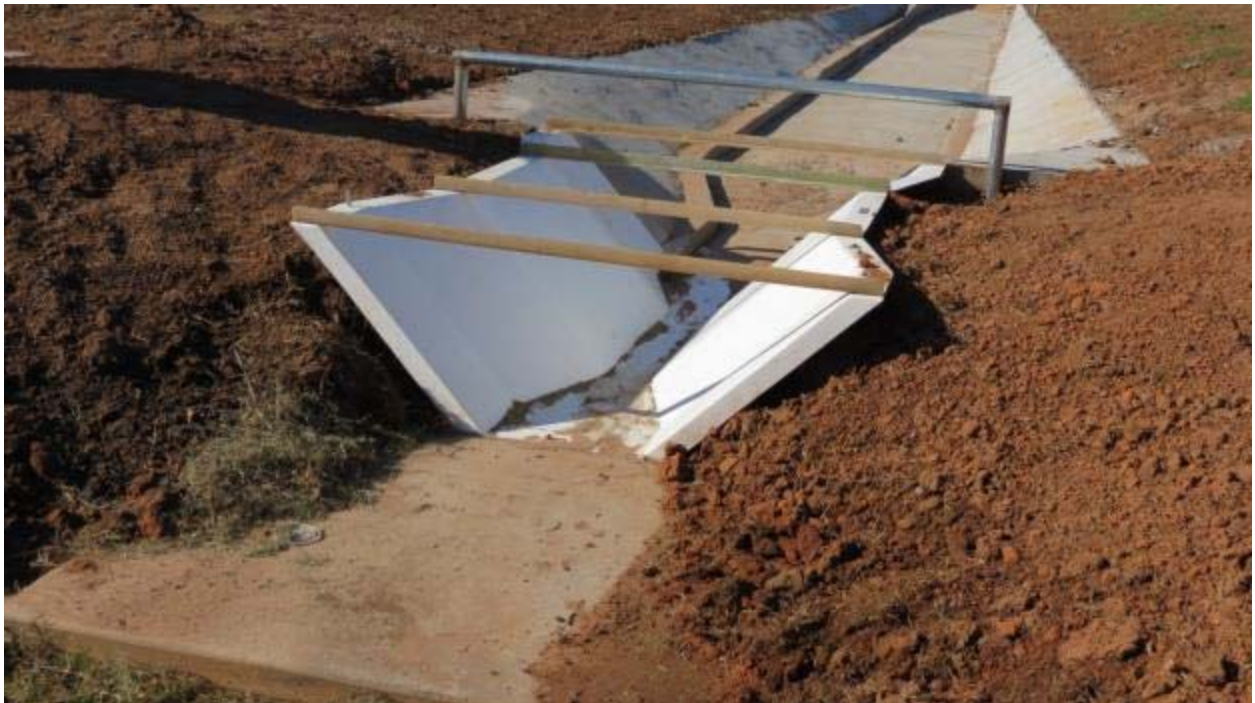
Figure 17: Photo of Plasti-fab test flumes were installed at the end of the concrete stormwater flumes and equipment closets were set adjacently on the top of bank west flume (Top) and east (Bottom).

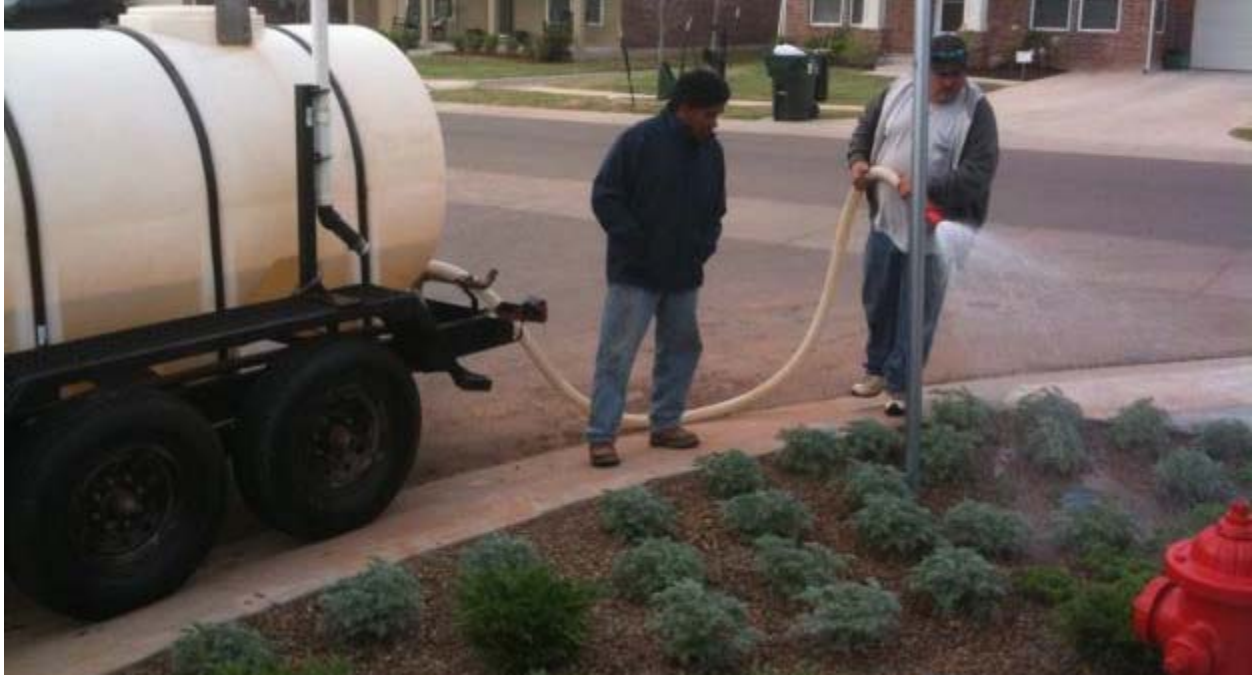
Figure 18: Photo of supplemental irrigation in April 2011. Irrigation was required in 2011 and 2012 due to severe drought and summer heat.

The weather conditions influenced establishment throughout the project. The site experienced severe drought in three of the five years and record setting summer temperatures in 2011 and 2012. This demanded extensive supplemental irrigation for the full years of 2011 and 2012 including weekly irrigation through the growing period (Figure 18). In 2013 an ice storm and severe cold temperatures damaged many trees.

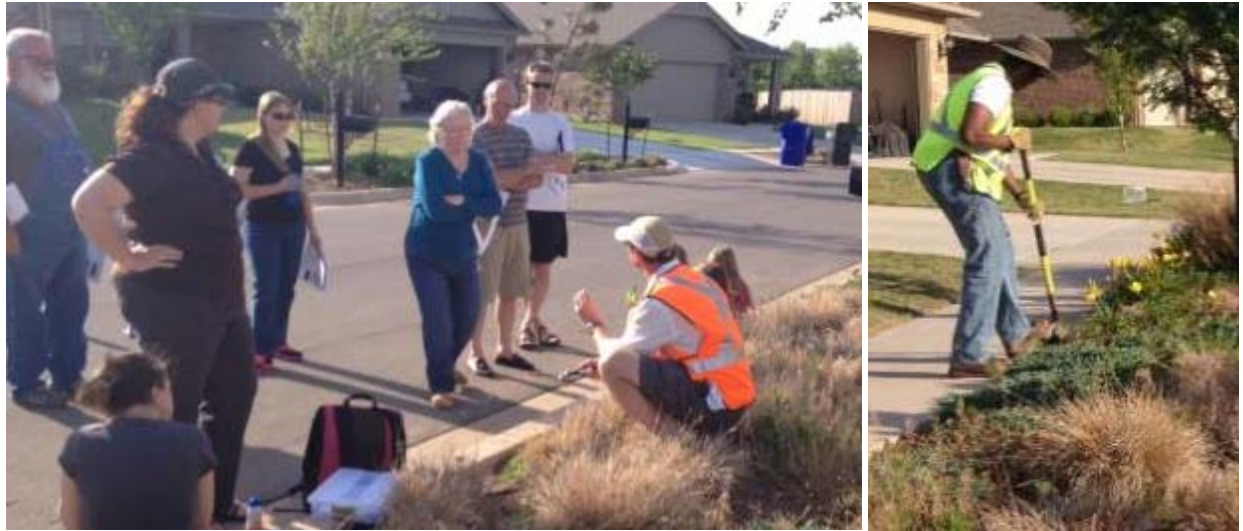
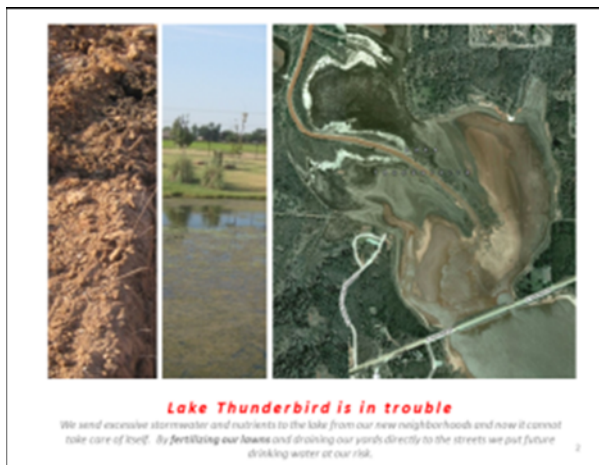
Figure 20: Images of the Homeowner Stewardship workshop (top) and selected images of the Stewardship Manual provided to each homeowner.

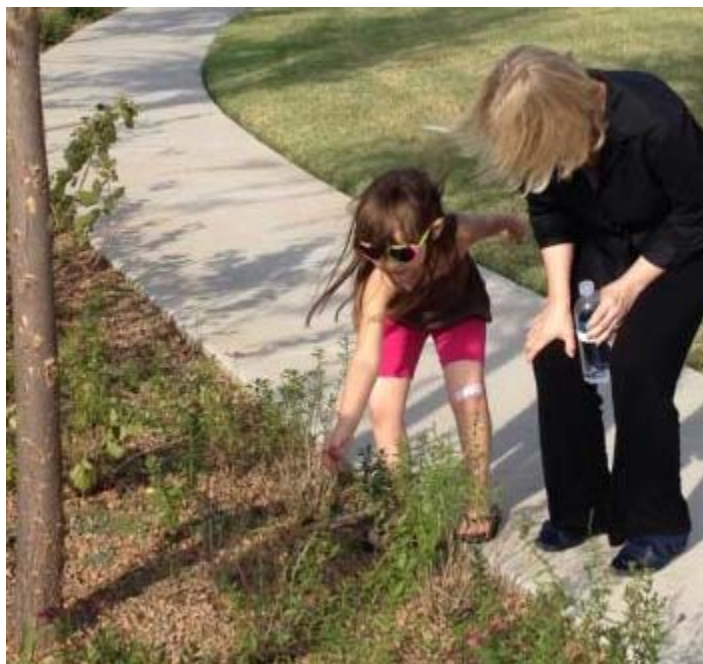
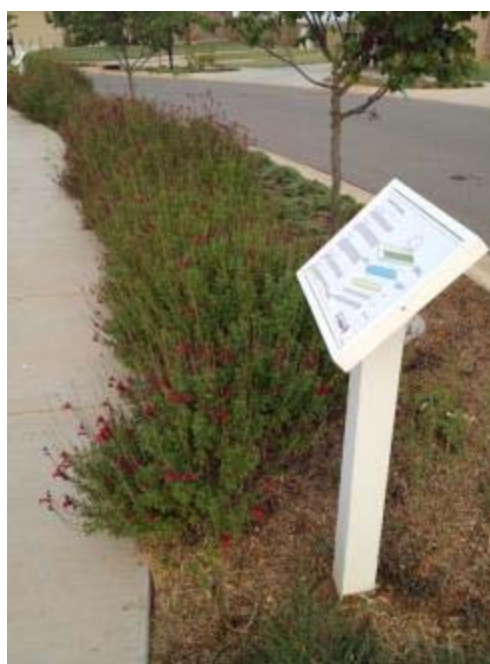
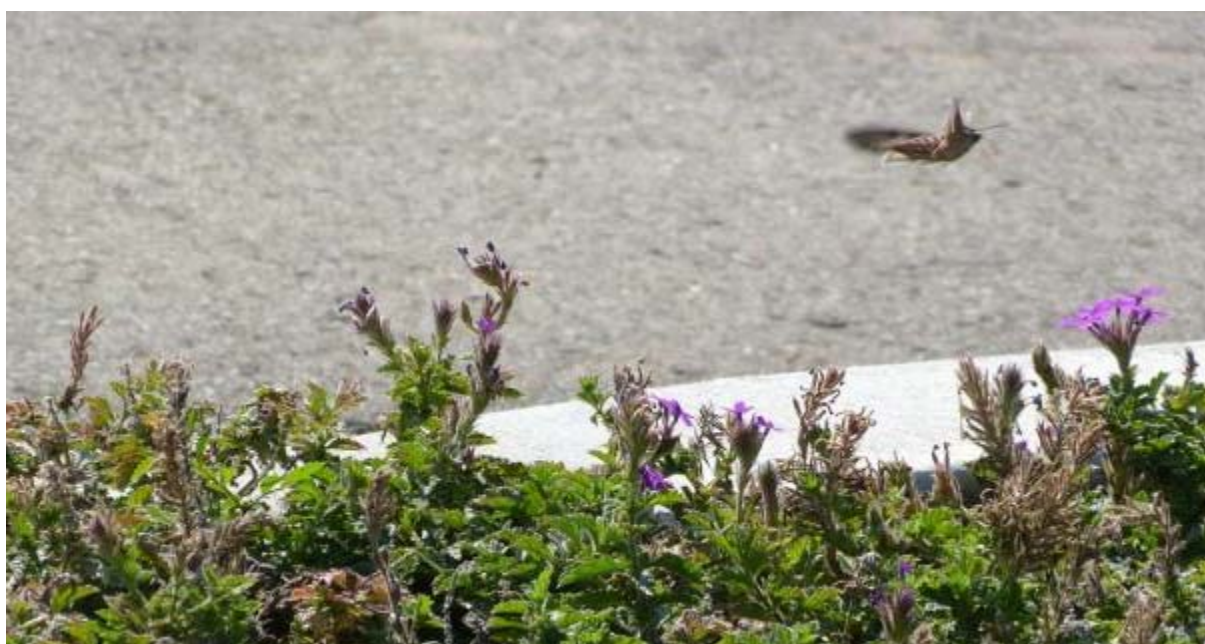
Figure 21: Neighborhood children show visitors the flowers in the rain garden (Top left) and citizens can learn from educational signage. Homeowners document wildlife visiting the rain gardens such as this hummingbird moth (Bottom).

Most importantly, it has impacted the citizens of Trailwoods. Children living on the street recognize their street is unique, and they take pride in the gardens (Figure 21). They pick flowers and talk about the birds and butterflies that visit their gardens. Most interestingly, a few homeowners are using the gardens as a place for wildlife photography. Butterflies, birds, and bees are commonly observed during flowering season.

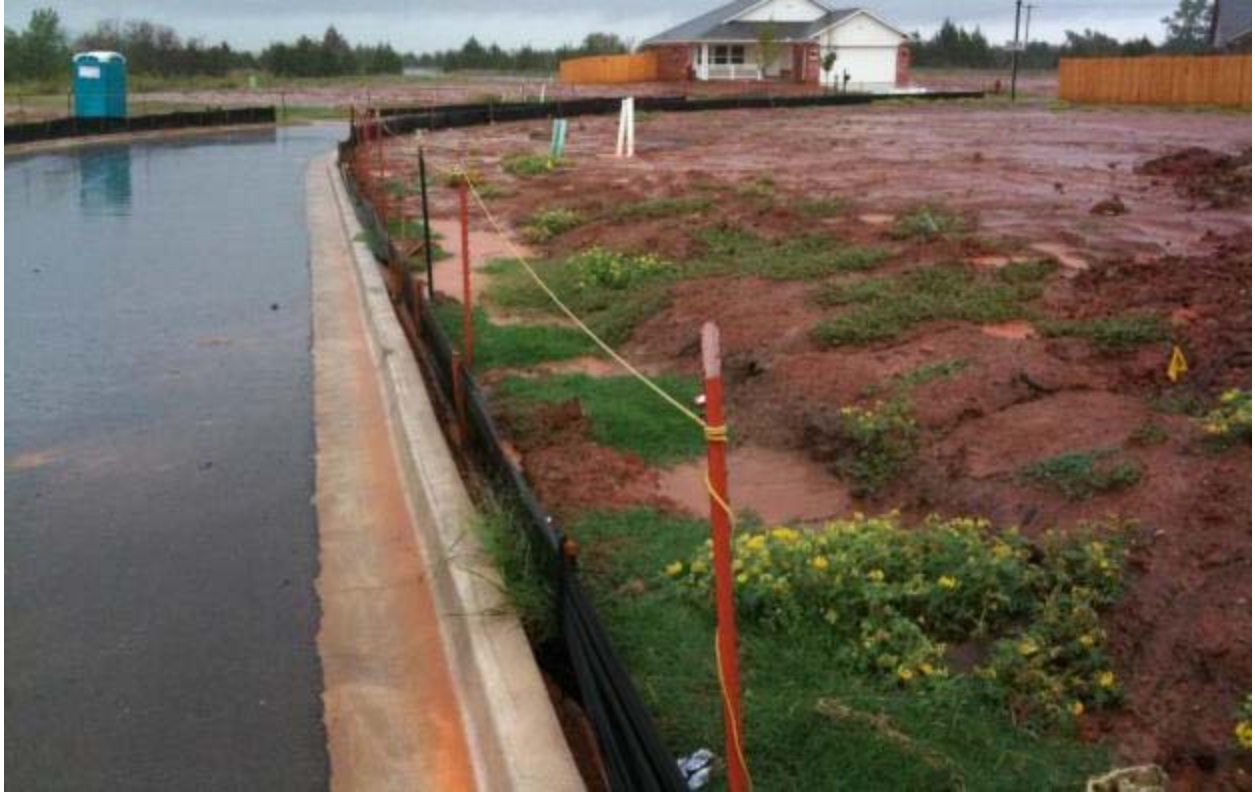
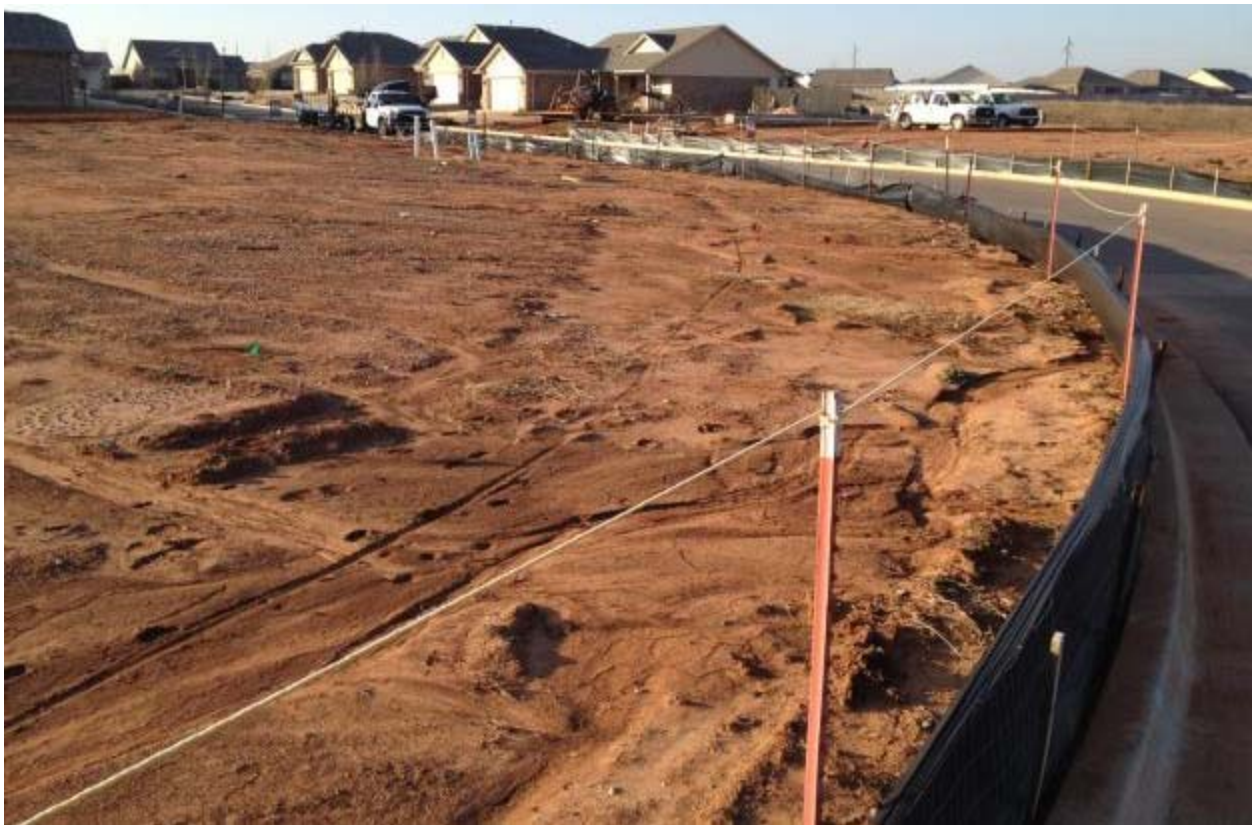
Figure 22: Photo of the rain gardens functioning as a mini sediment catch basin during construction.

7. The use of a pre-excavated rain gardens constructed as sediment catch basins functioned very well as a construction BMP. Although the data is anecdotal, this project cost the developer significantly less in clean-up costs after rain events compared to other projects.
