EROSION CONTROL AND ABATEMENT PRACTICES FOR COUNTY ROAD SYSTEMS

Final Report
FY 1995 319(h)
EPA (CFDA 66.460)
TASK #900: OCC TASK #73

Gerald A. Miller

July 2001

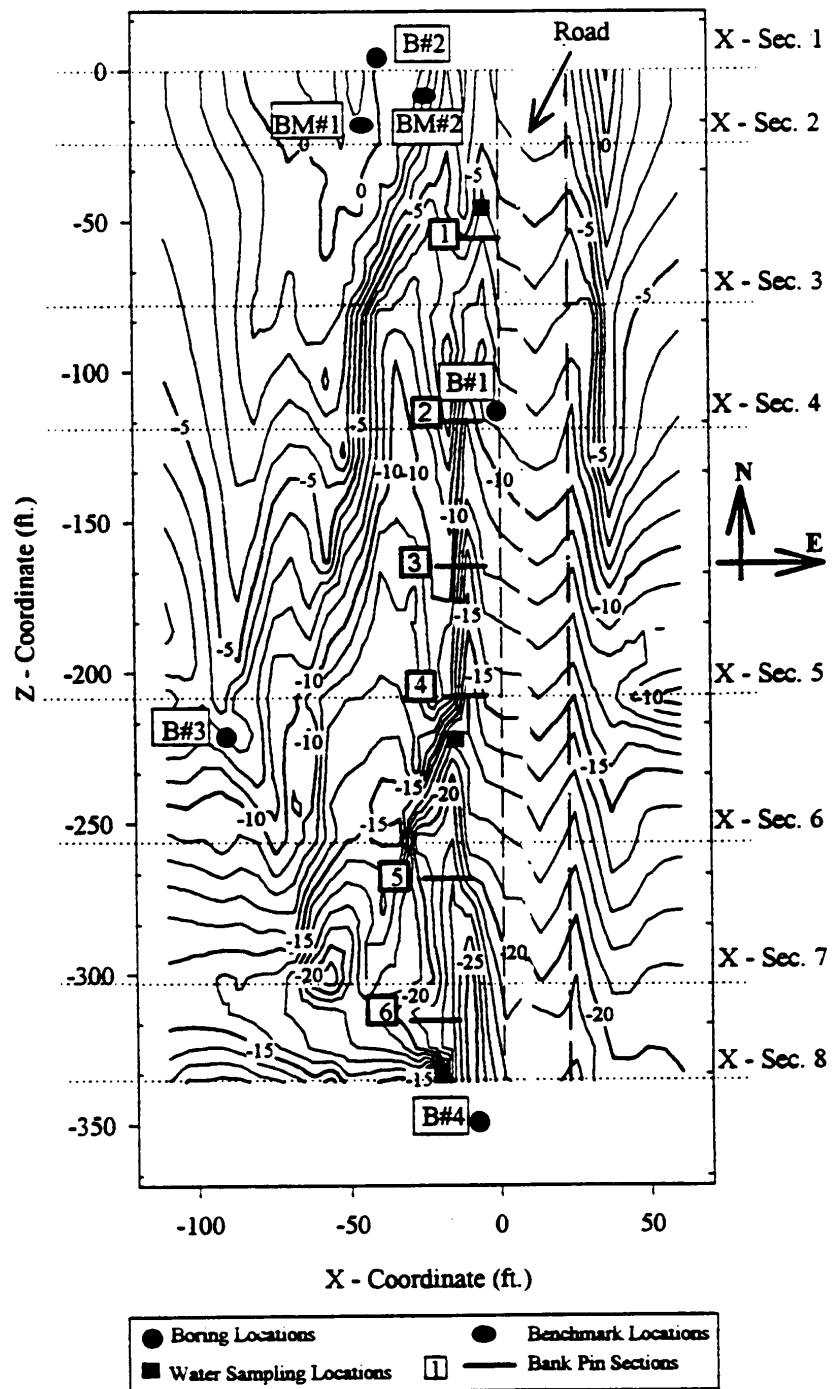
Figure 2.5 Topographic Map of Site 1.

At Site 1, bank pins were installed at six locations in the roadside gully as indicated on Fig. 2.5. Bank pins consisted of 2- or 4-foot long sections of #4 reinforcing steel bars that were either driven vertically or horizontally in the channel bank. The pins were driven so that the end was nearly flush with the soil surface. Coincident with bank pin installation, the cross-section of the gully at each pin-section was determined by optical surveying. After rainfall events, measurements of the protrusion of each bar were made to determine how much soil had been eroded. The change in channel cross-section at pin locations was then determined by subtracting the protrusion of each pin from either the initial

In Figure 4.7 are shown results of optical survey measurements at cross-section 4 located as shown in Fig. 2.5. The gully was surveyed on October 18, 1996 and then again on November 15, 1997 and June 10, 1997. During the first 65 days of this time frame approximately 11 inches of rainfall were recorded. As shown in Fig. 4.7, in one month a volume of soil with a width and depth of about six feet was eroded from the channel.

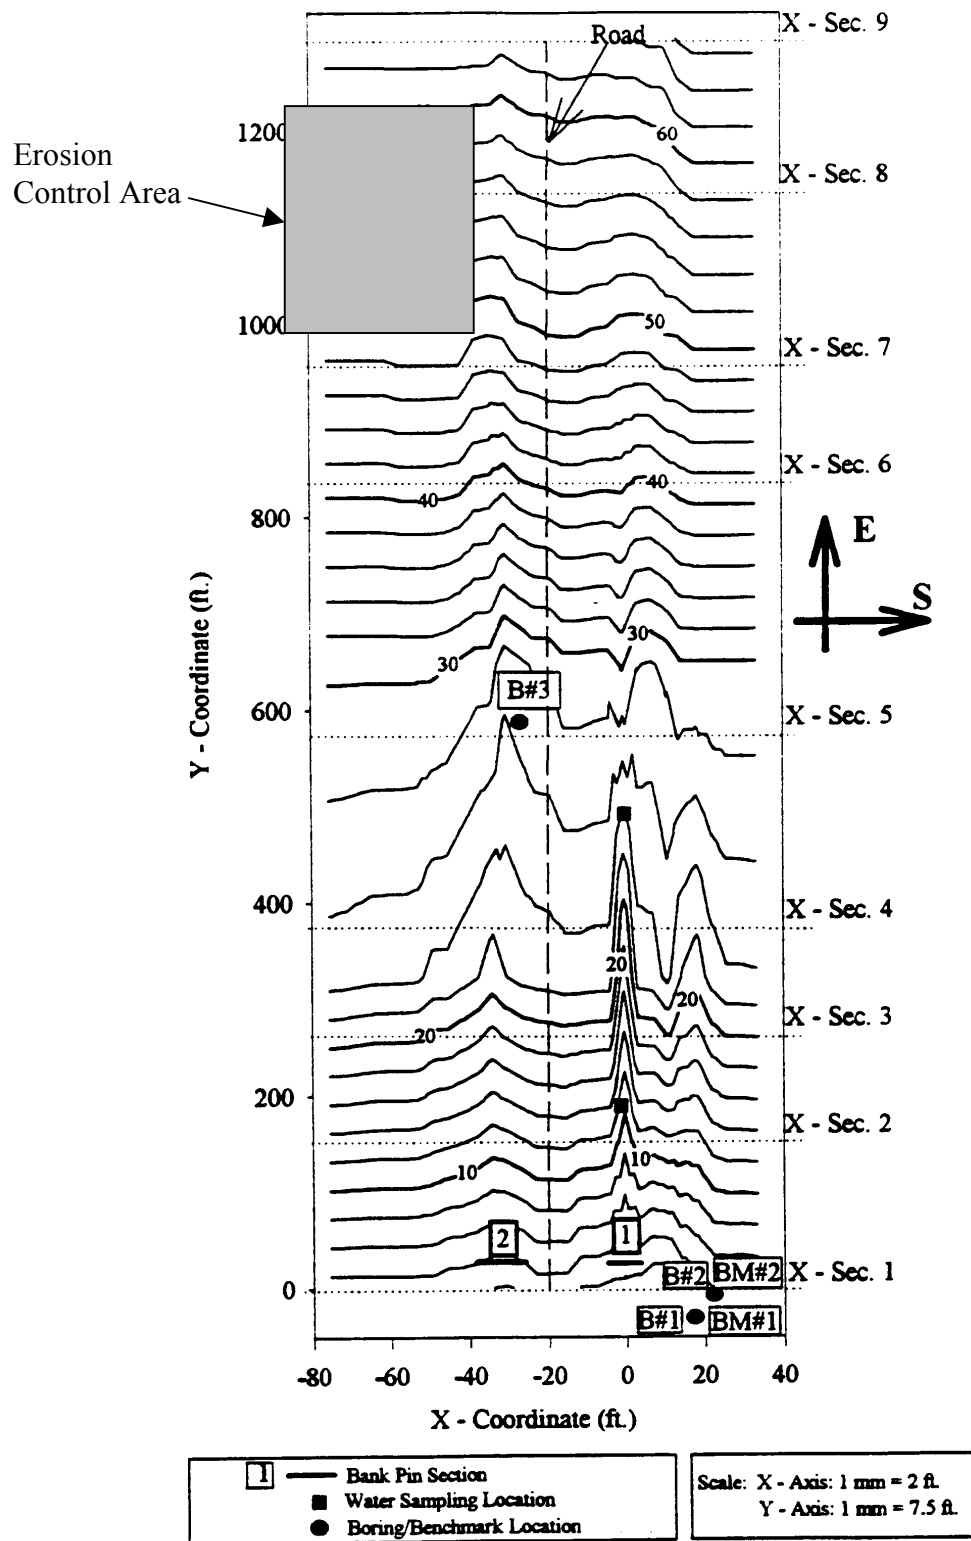
Figure 2.6 Topographic Map of Site 2.

A portion of the area indicated in Fig. 2.6 was covered with mulch (cotton burrs), fertilized and seeded with Bermuda grass. Portions not covered with mulch were fertilized and seeded with Bermuda grass to assess the effectiveness of the mulch, versus no mulch, in establishing vegetation.

The bank pin measurements and cross-section survey are dramatic examples of the rate of erosion at Site 1. At Site 2, little change was observed in the bank-pin cross-sections located as shown in Fig. 2.6.

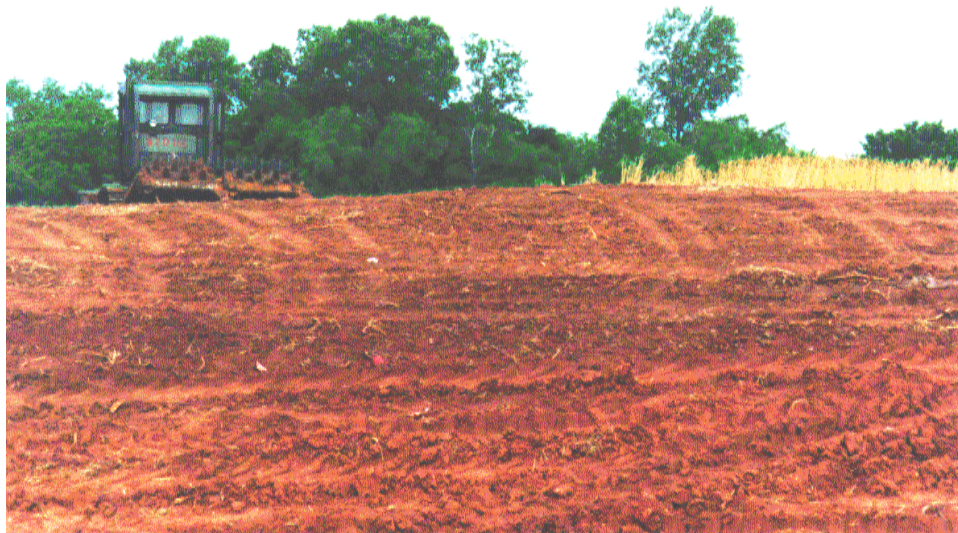
Figure 3.2 Compaction at Site 1 with Bulldozer and Sheepfoot Roller.

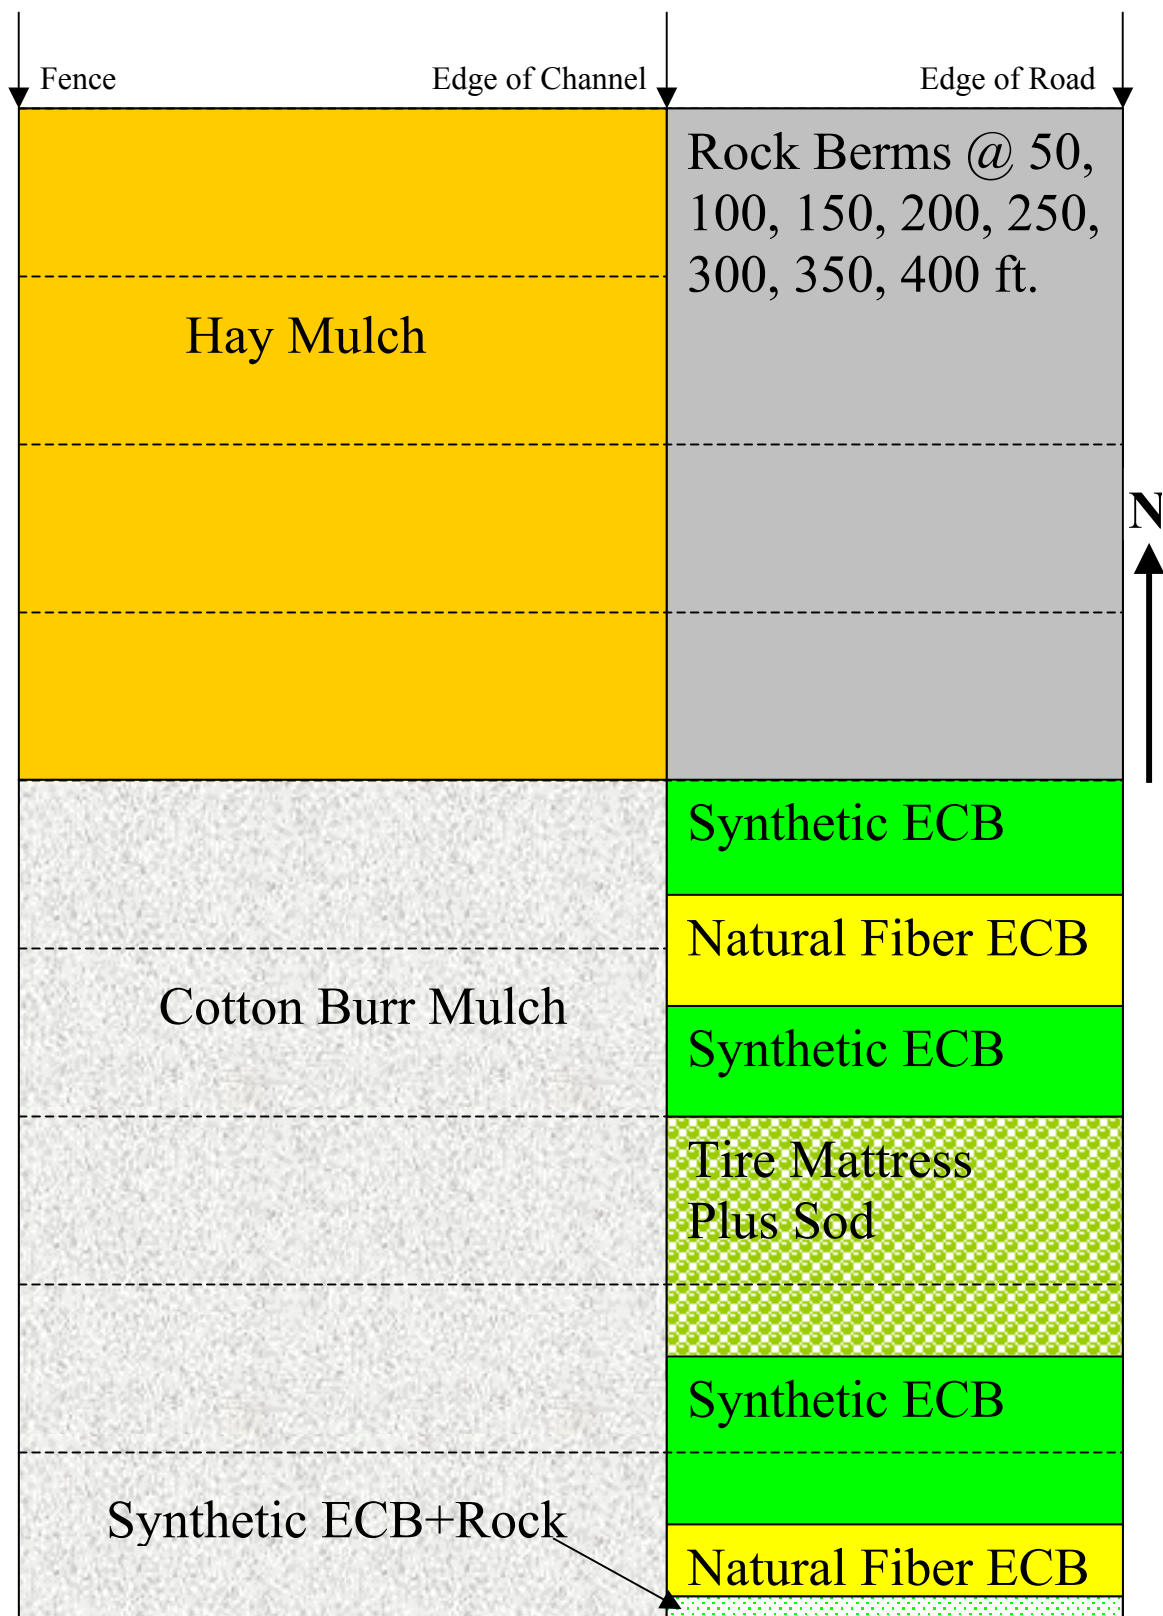
Figure 3.5 Schematic Showing Layout of Site 1 Erosion Control.

Of critical importance in preventing severe erosion of bar ditches is to provide adequate protection for exposed soil. To protect the drainage channel at Site 1 different strategies were used including rock structures, erosion control blankets, a tire mattress, and sod cover. The relative position of each of these features on the site is shown in Fig. 3.5

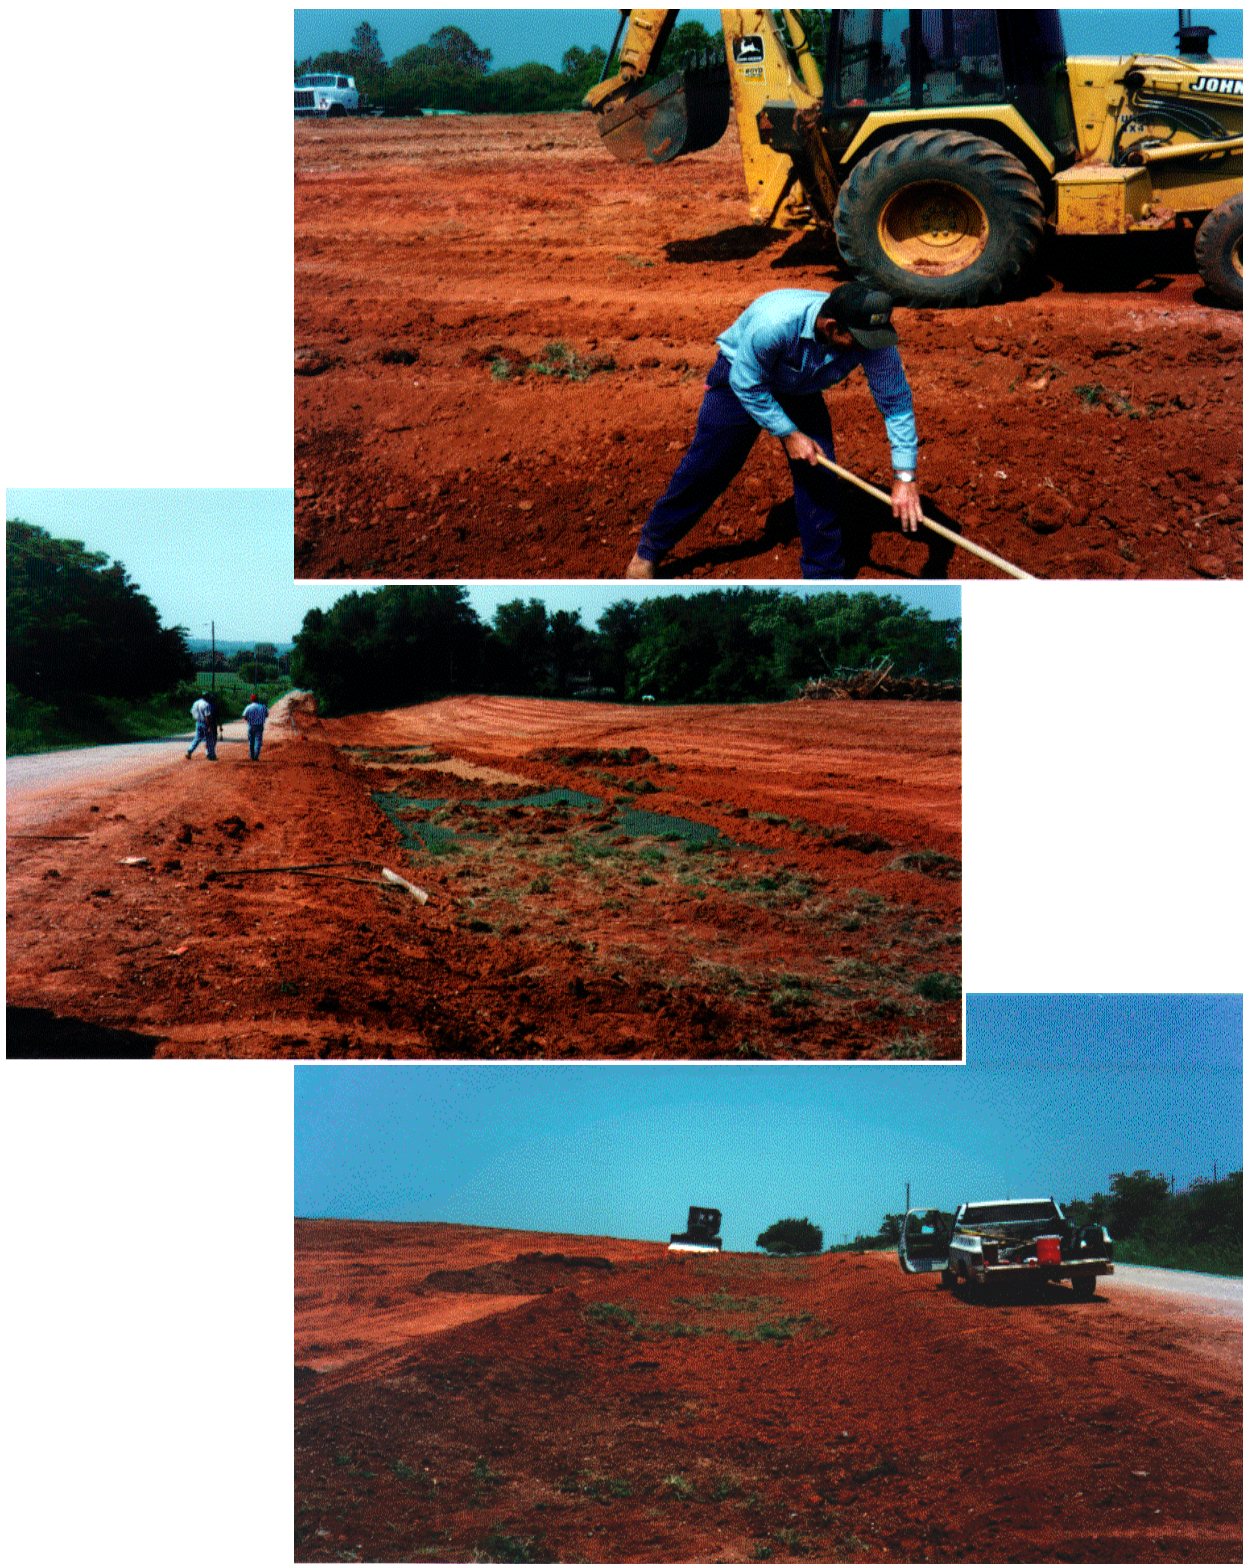
Figure 3.9 Soil Cover Placed Over Erosion Control Blankets.

Three different erosion control blankets were used at the site, two composed primarily of natural fibers (one coconut and one straw) and the other composed of synthetic fibers (green polypropylene fiber mesh). The natural fiber blankets had a synthetic monofilament woven mesh (forming approximately 1 inch squares) that provided some stability. In Fig. 3.8, the polypropylene and coconut fiber mats are shown. Approximately 350 linear feet of the channel was covered by erosion control blankets, which were delivered in rolls 10 feet wide. After shaping the channel, anchor trenches at the top of each side of the channel were cut using a motorgrader and an anchor trench at the upstream end of the blankets was cut with a backhoe. Blankets were rolled out parallel to the longitudinal axis of the channel, three abreast, with an overlap of at least one foot. After compacting soil in the anchor trenches, metal pins were used to stake the overlapping portions of the blankets per the manufacturer's recommendations. To complete the installation, a thin layer of soil was spread over the top of the blankets. In Fig. 3.9 are photographs depicting the placement of soil cover over erosion control blankets.

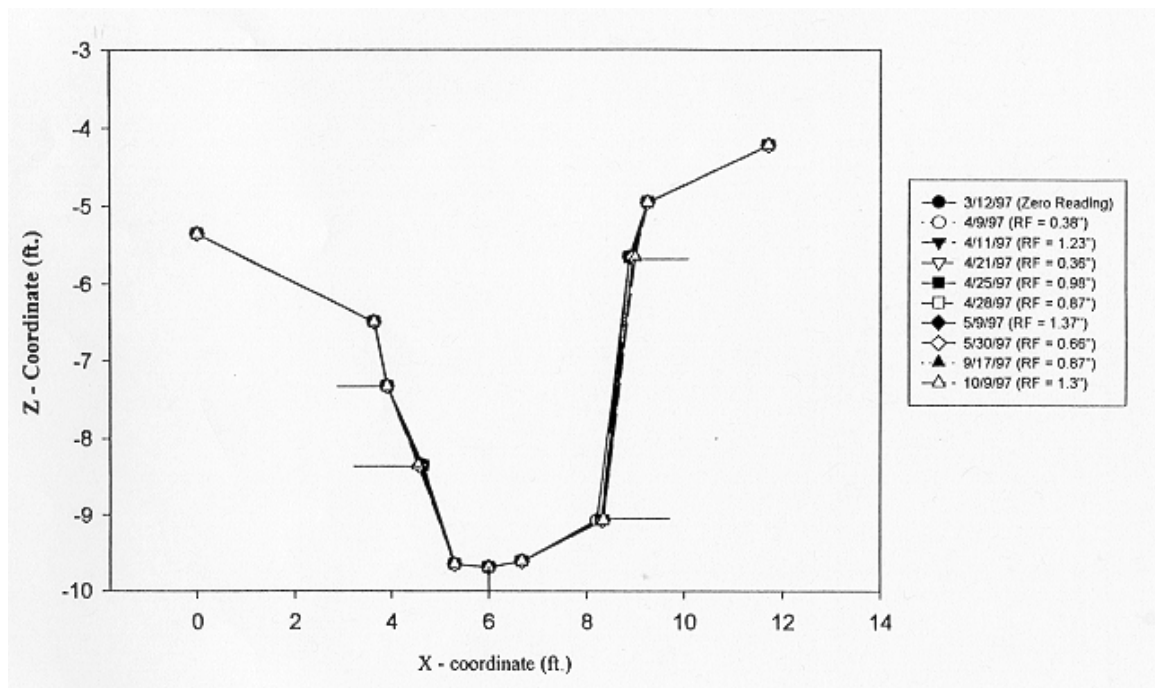
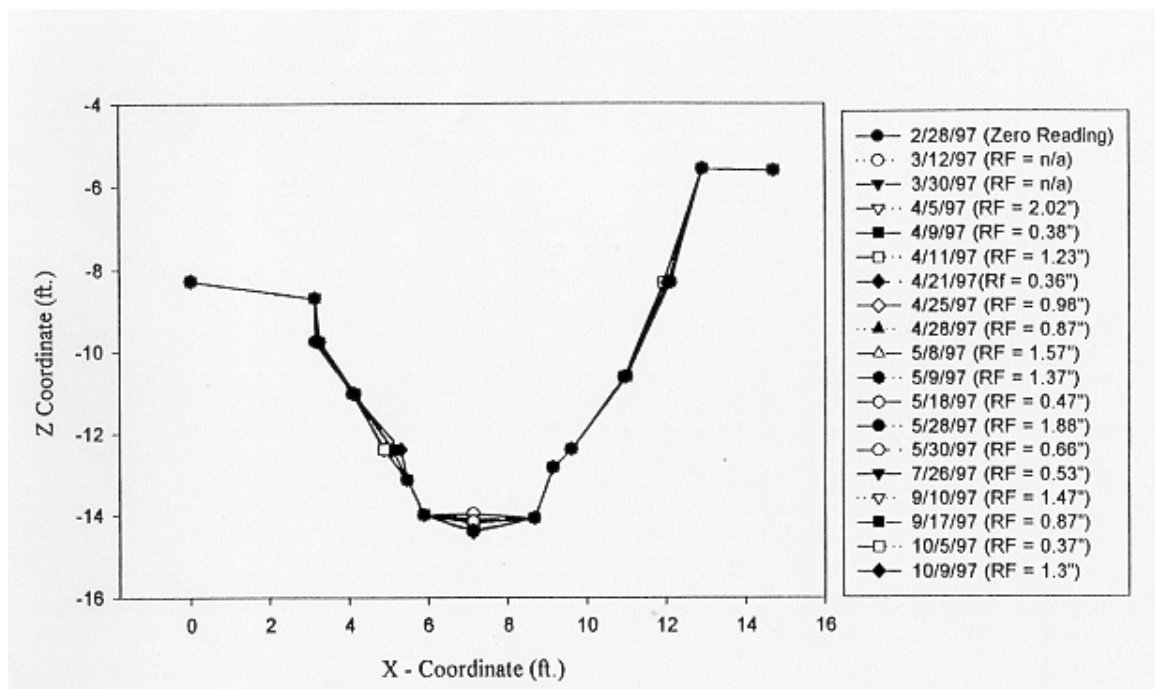
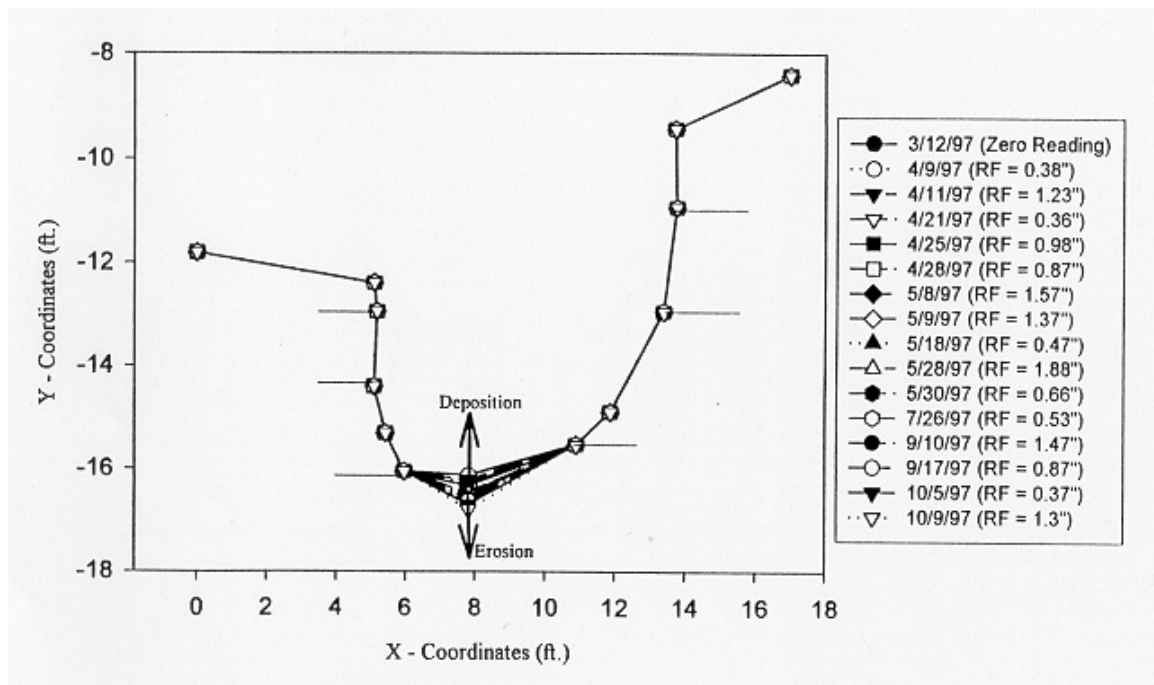
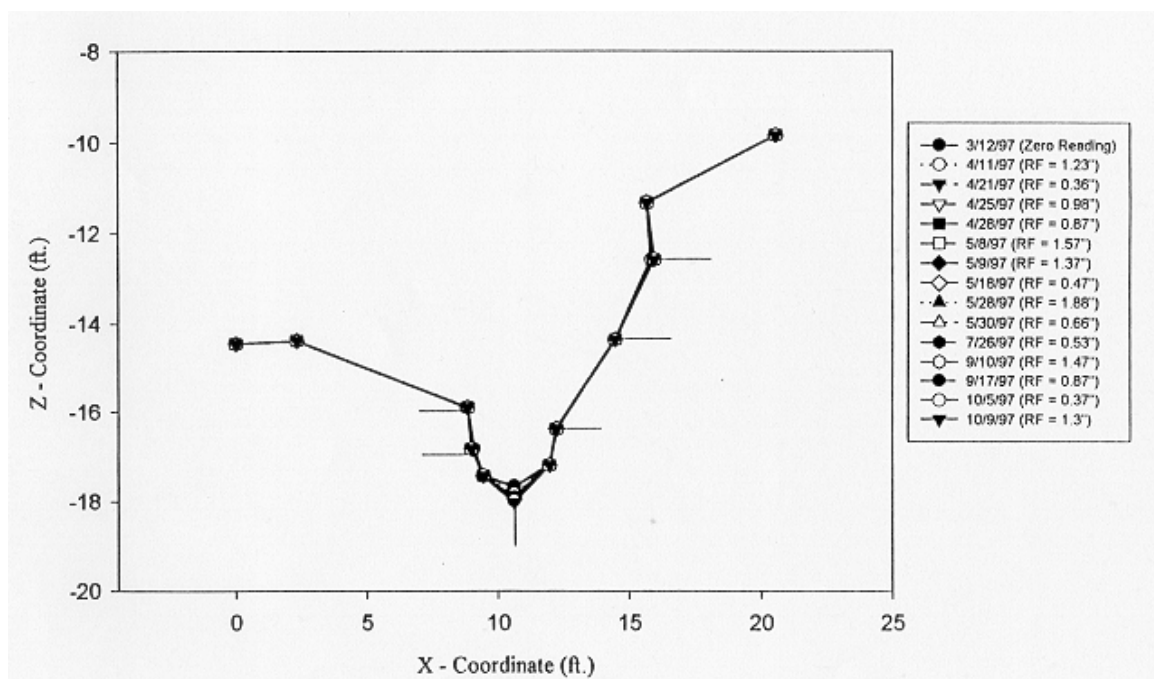
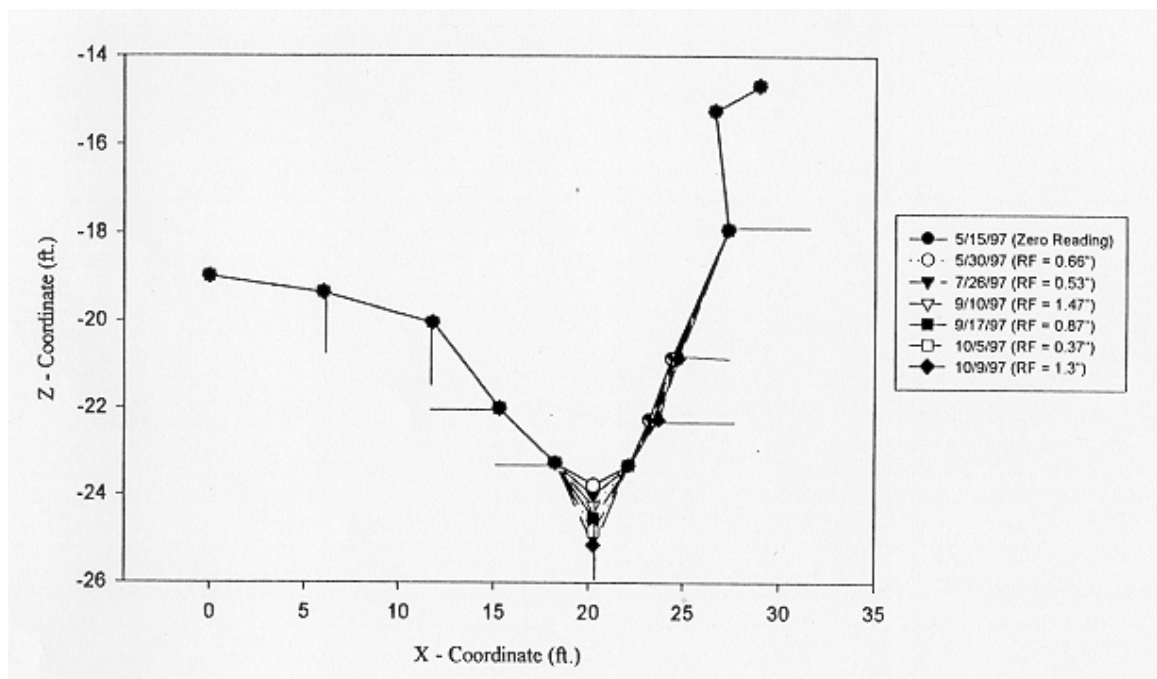
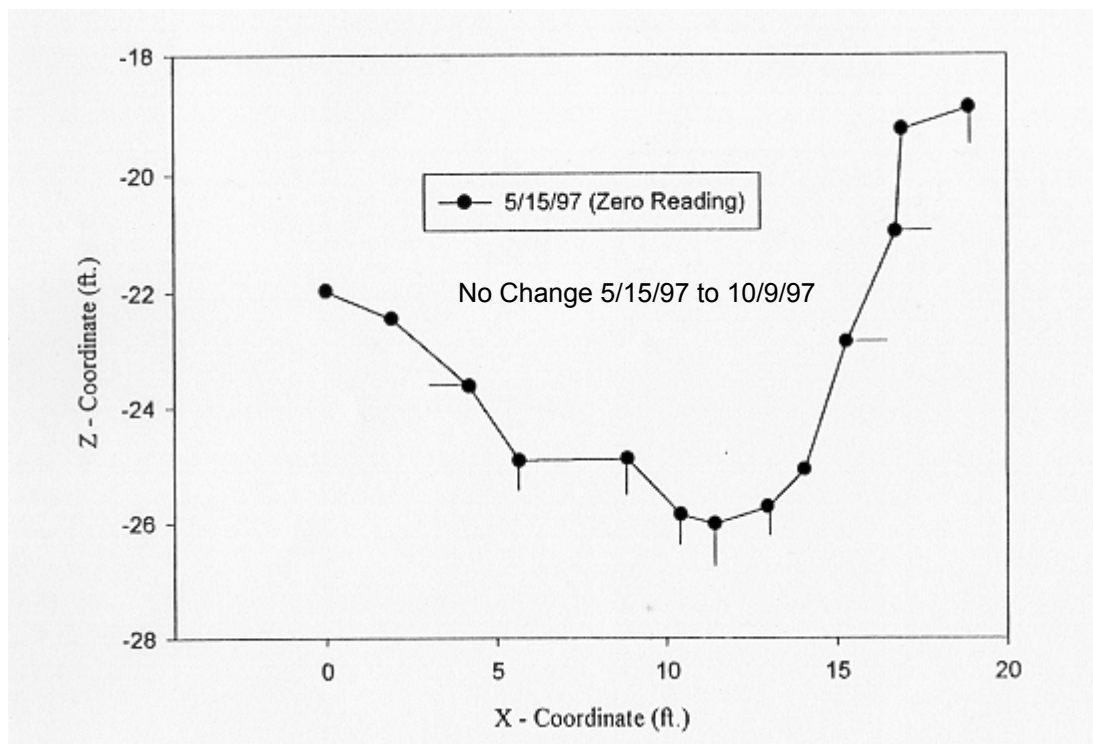
horizontal or vertical coordinate determined by optical surveying. Bank pin cross-sections corresponding to dates on which measurements were made are presented in Figs. 4.1-4.6.

Figure 4.1 Bank Pin-Section 1 at Site 1.

Figure 4.2 Bank Pin-Section 2 at Site 1.

Figure 4.3 Bank Pin-Section 3 at Site 1.

Figure 4.4 Bank Pin-Section 4 at Site 1.

Figure 4.5 Bank Pin-Section 5 at Site 1.

Figure 4.6 Bank Pin-Section 6 at Site 1.

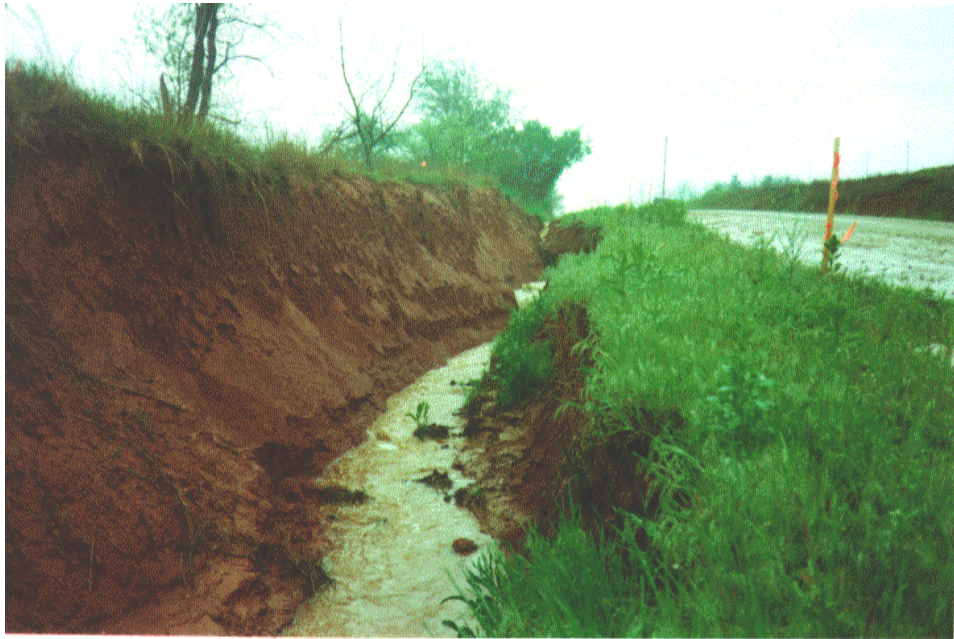
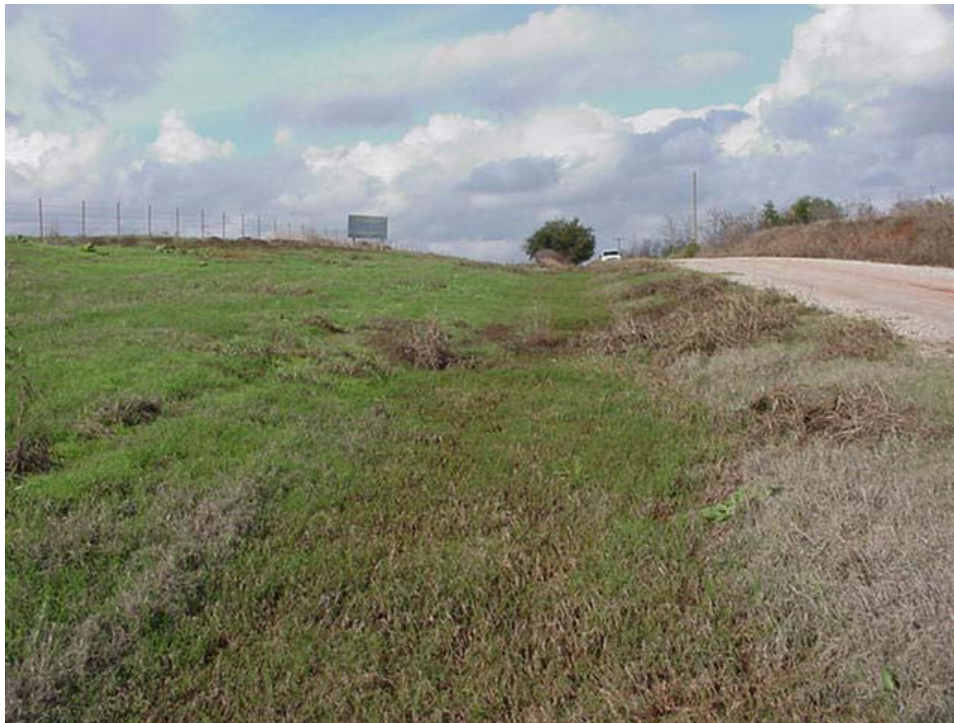
Figure 4.17 Site 1 Looking North from Similar Positions a) Before (Spring 97) and b) After Erosion Control (Fall 2000) [note position of telephone pole].

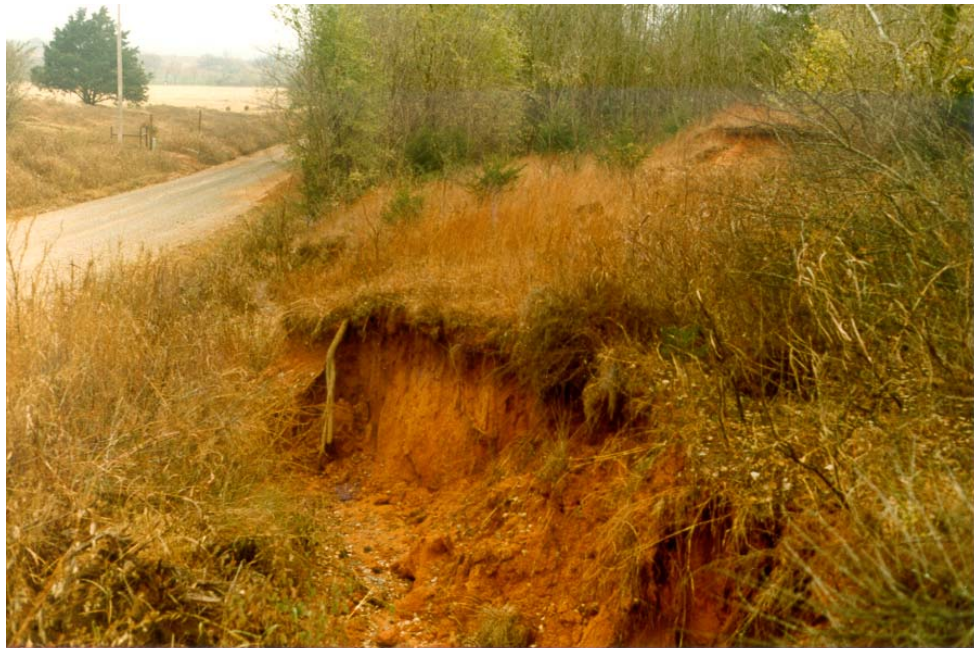
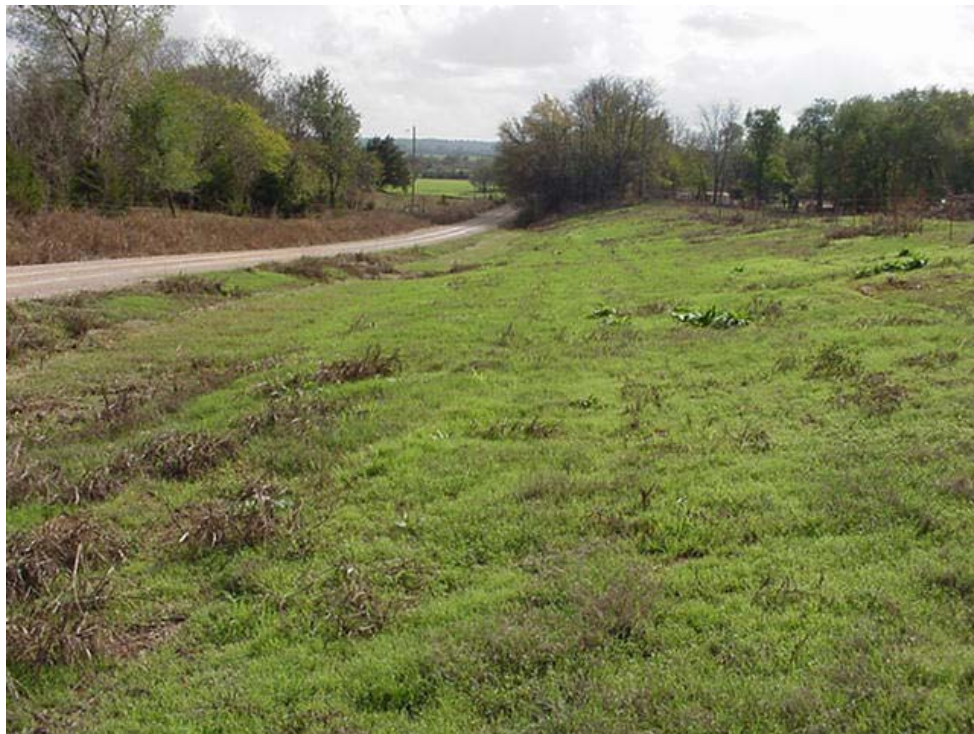
Figure 4.18 Site 1 Looking South a) Before (Fall 1996) and b) After Erosion Control (Fall 2000) [note position of pine tree in upper left corner of a)].

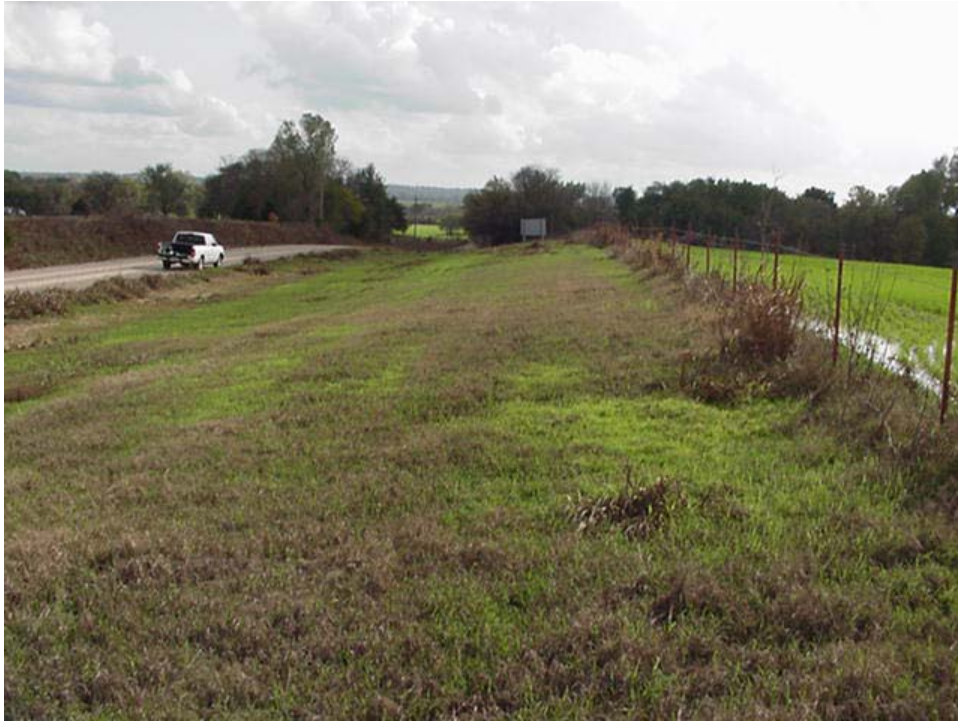
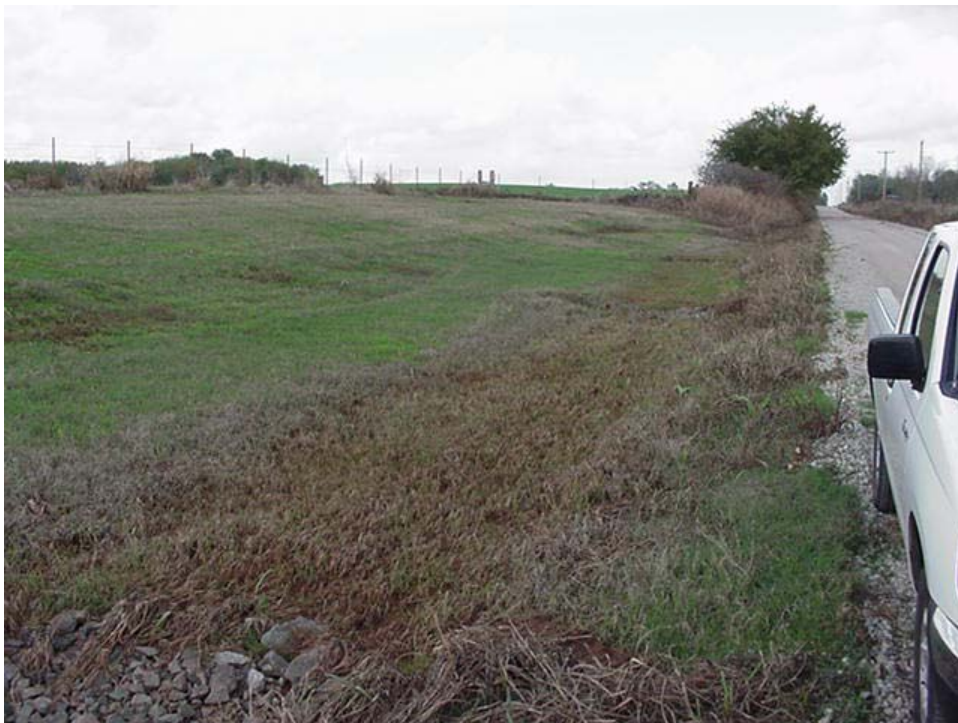
Figure 4.19 View from North End of Site 1 after Erosion Control (Fall 2000): a) Looking South, b) Looking North.
