# Honey Creek Restoration Project

*...restoration of wetland, stream  
& riparian habitat*

**EPA Grant C9-996100-10, Project 9**

**FINAL REPORT**

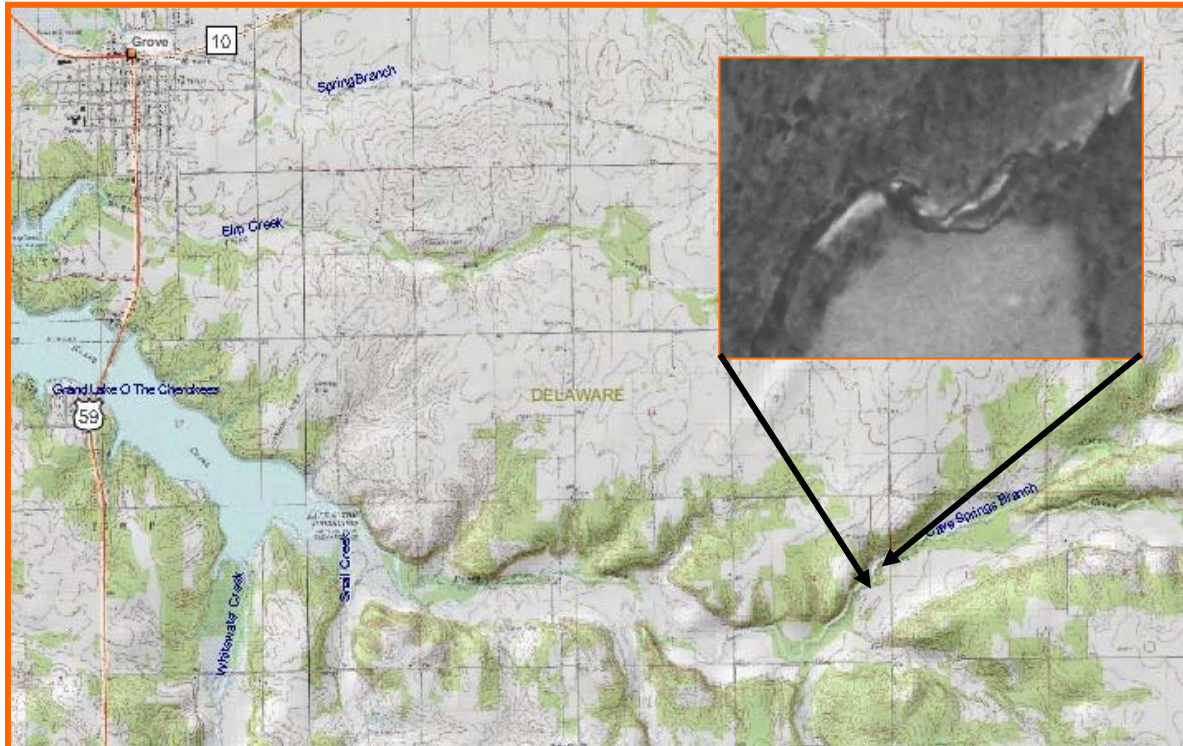
**Figure 1: Phase I restoration site**

The project area is an approximately 400-foot long reach of Honey Creek located in Delaware County (SE1/4 of S24, T24N, R24E; **Figure 1**) near Grove, Oklahoma owned by Tom Steen.

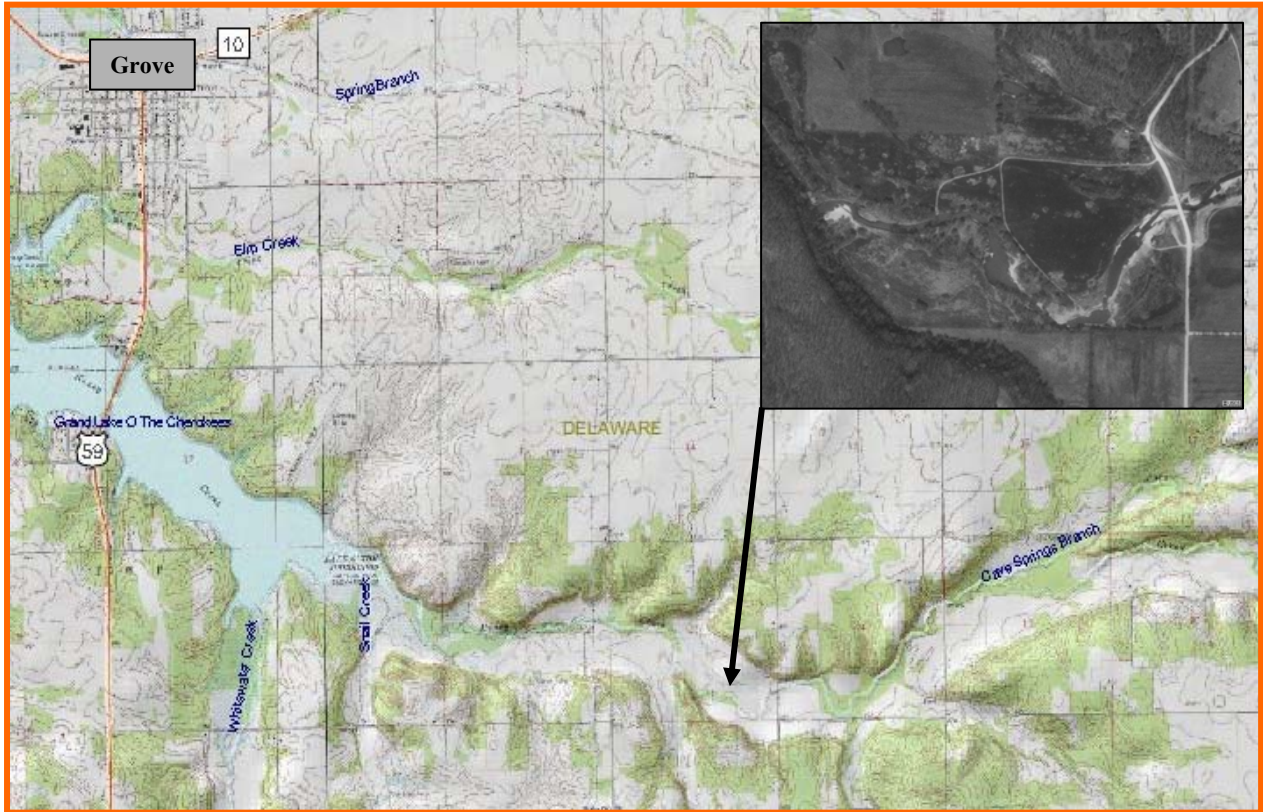
**Figure 17: Phase II restoration site**

The project area is an approximately 3200-foot long reach of Honey Creek located in Delaware County (SE1/4 of S23, T24N, R24E; **Figure 1**) near Grove, Oklahoma owned by Bill Berry. The area is characteristic of a slowly rebuilding C stream type, and occurs inside a relic F channel, with slight entrenchment, meandering pattern and a riffle/pool sequence. Floodplain development is moderate to low. Channel morphology consists of a relatively low gradient (range = 0.001 to 0.005) and the gravel dominated substrate includes a significant burden of fine-grained particles causing localized encumberedness. Approximately one-half of the site-length
