Demonstration Project: *Mitigation of NPS Impact to Littoral Zone of Lake Thunderbird Cleveland County, Oklahoma*

Lake Thunderbird FY- 00 319

October 24, 2005

Agency: Oklahoma Water Resources Board (OWRB)

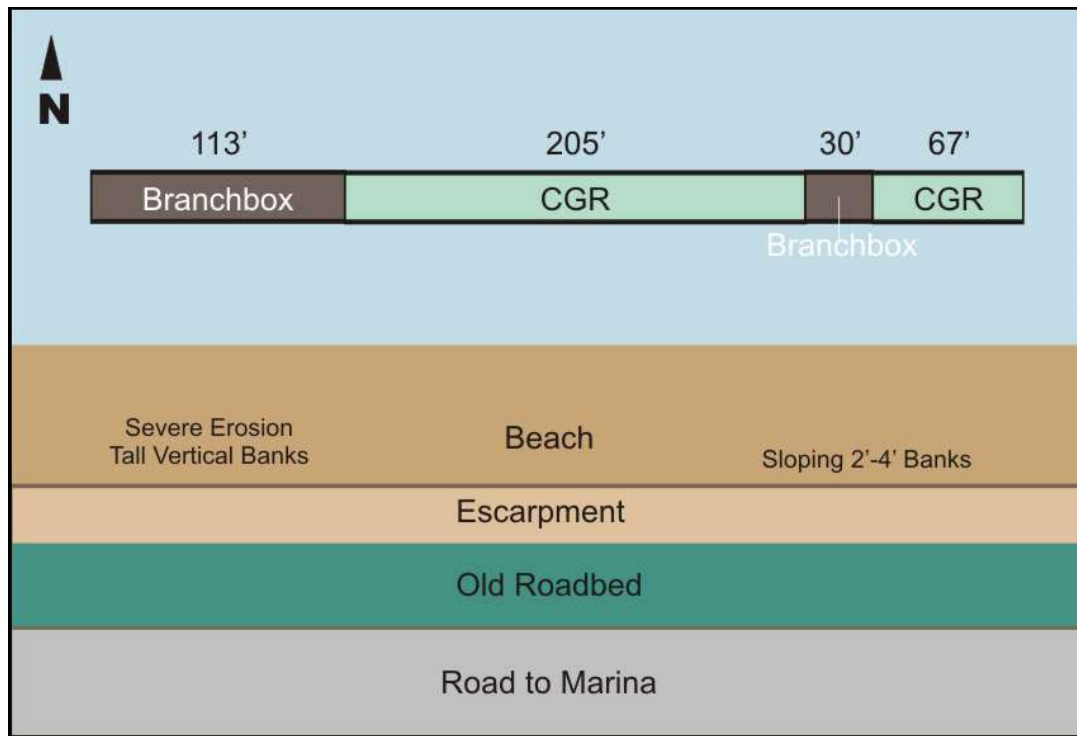
Figure 5: Breakwater Layout.

In August of 2003, with the water level approximately 1.5 ft. down below the conservation pool of 1039' (1,037.5'), 415 feet of breakwater were installed using 272' of coir geotextile rolls (CGR) and 143' of t-posts and wattle branchboxes (Figure 5, Figure 6, Figure 7). Branchboxes, which were taller, were installed where erosion was deemed most severe. Breakwater treatments were installed at the water line with the expectation that the normal pool would rise near the top of the coir rolls.

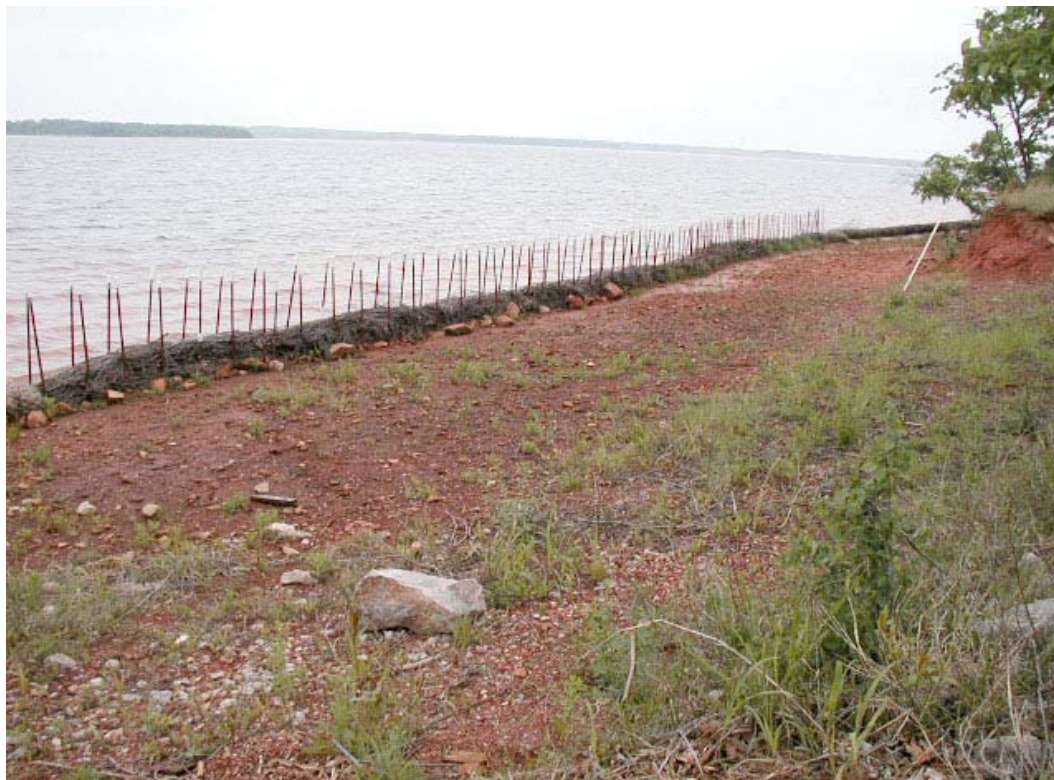
Figure 6: Branch box at west end - Zone 1.

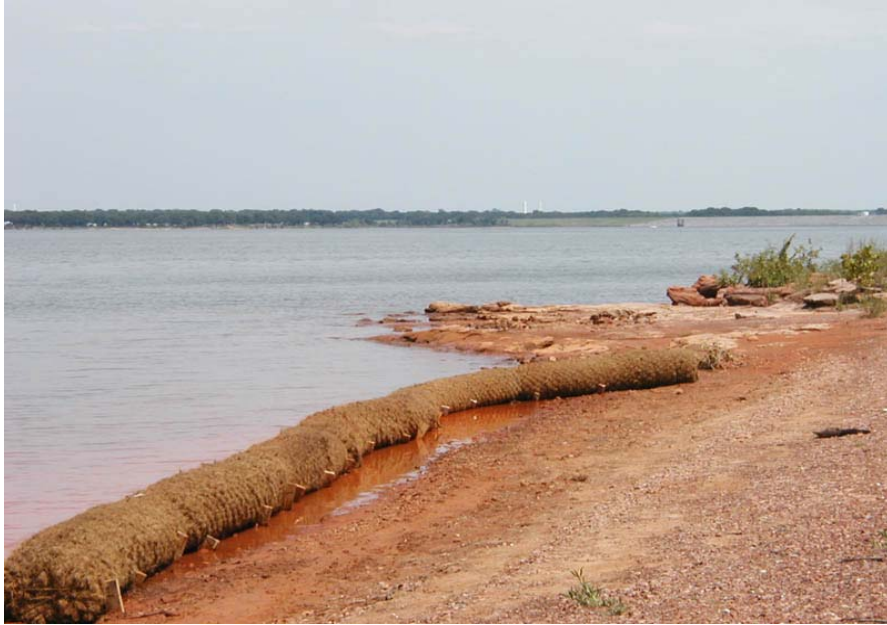
Figure 7: CGR at east end - Zone 2.

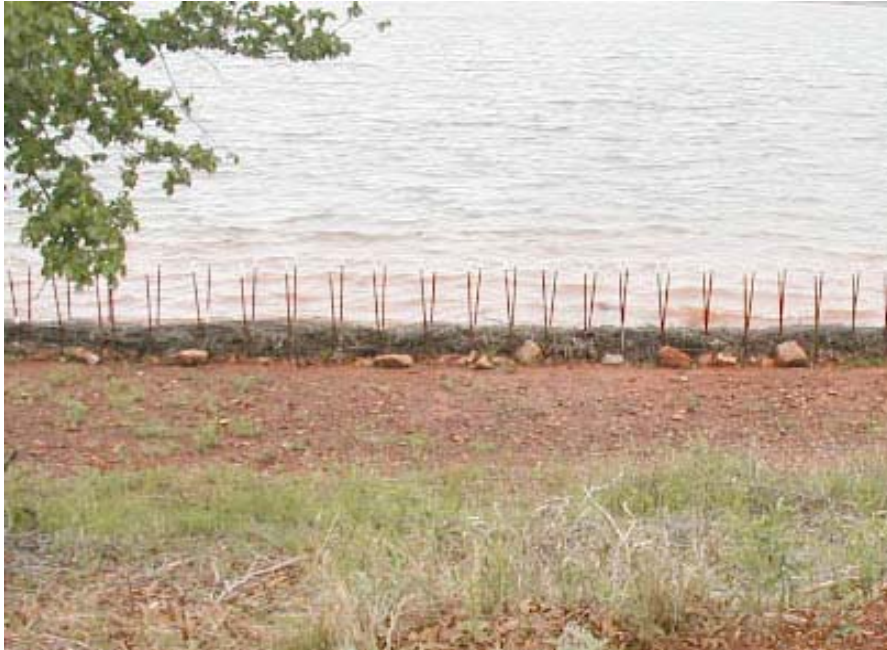
Figure 11: Completed branchbox (1.5 ft. below conservation pool).

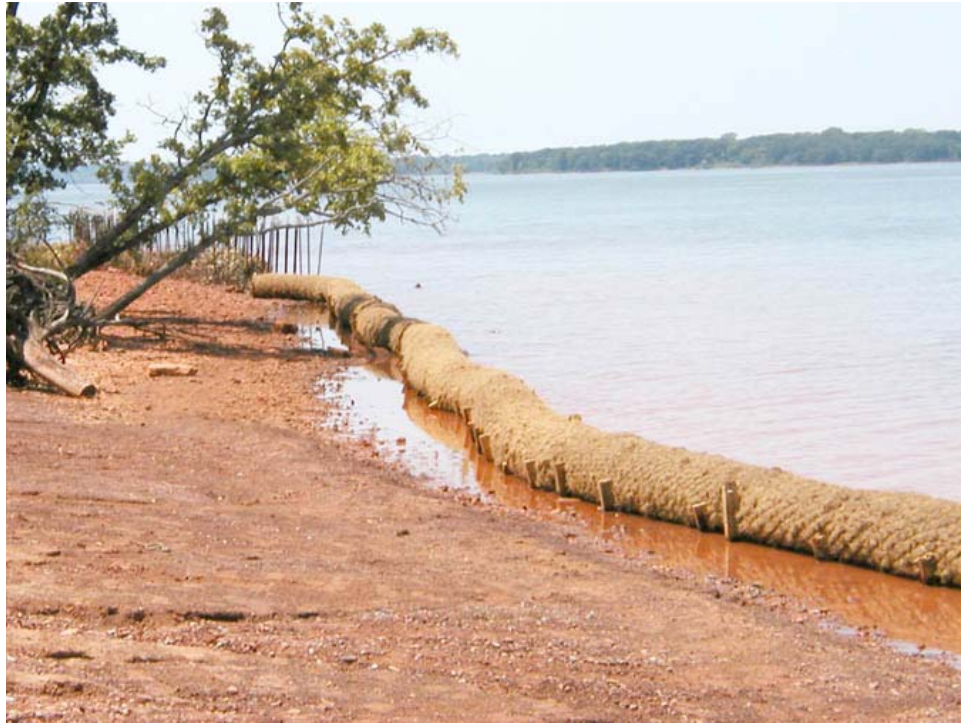
CGR breakwaters are more suitable for low-energy areas and their diameter limits them to 20" depths (Figure 12, Figure 13). CGRs are relatively expensive, approximately \$13 / ft. but are much less labor intensive to install and will naturally disintegrate over time unlike the t-posts in the branchbox. The CGRs were held in place using baling wire tied to 2" x 4" x 24" wooden wedges. The CGRs are extremely heavy when wet as well and form a good barrier. They are also capable of collecting sediment and working as a direct media for vegetative expansion.

Figure 13: CGRs installed.

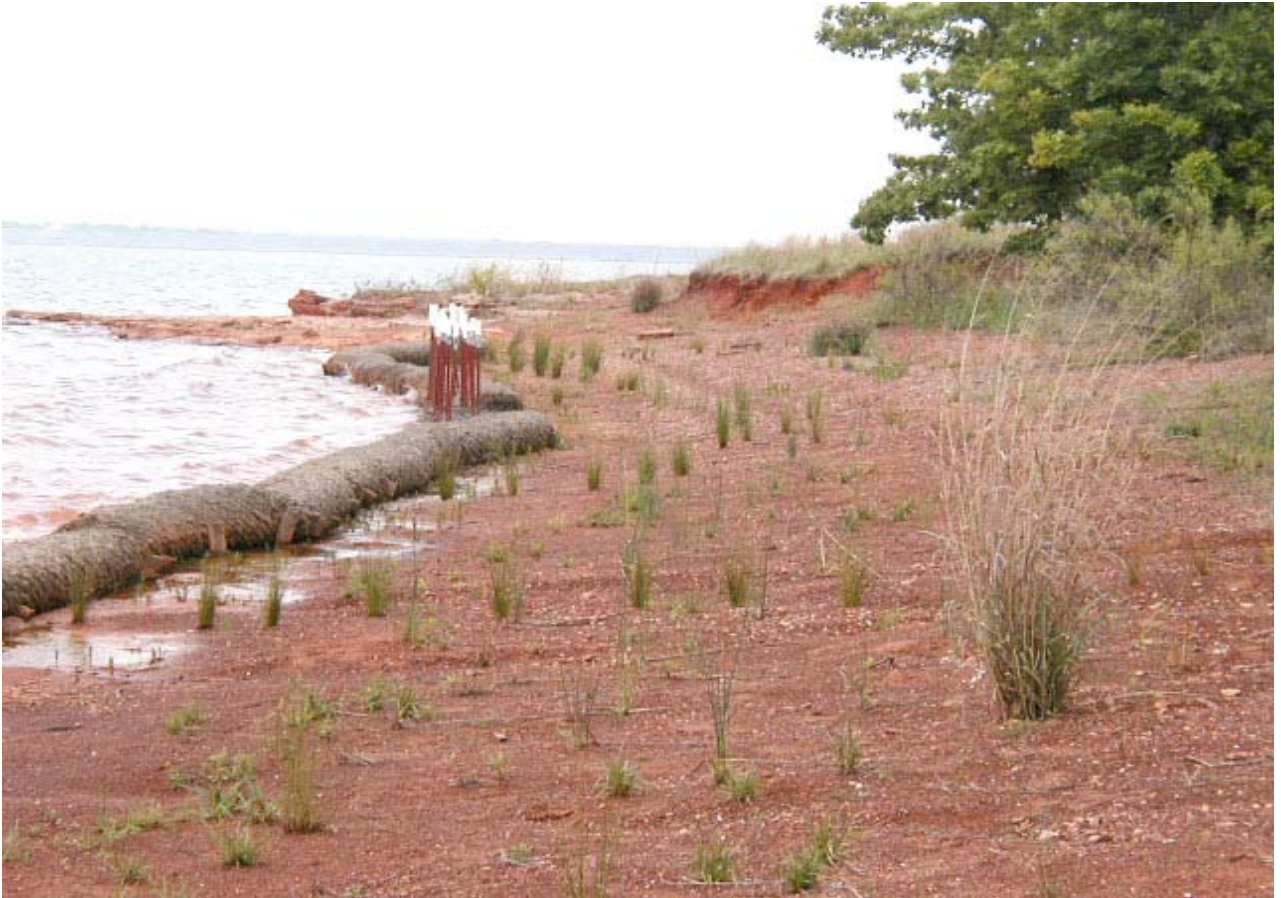
On September 1st through 5th of 2003, behind and parallel to the breakwater, a 30' to 40' strip of emergent aquatic vegetation was planted at and above the waterline (Figure 14). 500 plugs of assorted rushes, sedges and spikerush were supplied by Sanctuary Water Gardens of Blanchard, Oklahoma. In addition, the project purchased 175 softstem bulrush plugs and transplanted 500 plants from around the lake consisting primarily of common bulrush. Some sprigs of water willow and horsetail were intermixed with the transplanted bulrush. Several small willows and panicum grass were transplanted to mark transition areas from one zone to the other. For instance the panicum grass in the foreground of Figure 14 demarks the transition from primarily plug plantings (eastward) to lake transplants (westward).

Daytime high temperatures were above 100° F at the time of planting. The upper gravel and clay substrate was very dry. Subsequently the site was watered with an irrigation pump on two occasions soon after planting. Initially the plugs fared much better than the transplants most probably due to poor soil conditions.

Water levels were expected to rise as the summer turned to fall and the plants would be in saturated soil. Further, as the water entered in behind the protective breakwater sediment was to drop out and build up on the planted area creating a more hospitable substrate for the plants. Unfortunately the lake level did not reach conservation pool until almost a full year following breakwater completion. Consequently the plants did not have sufficiently saturated soils nor did the breakwaters have the opportunity to trap the finer silts and solids required to improve sediment structure.

Figure 14: Plugs after planting.

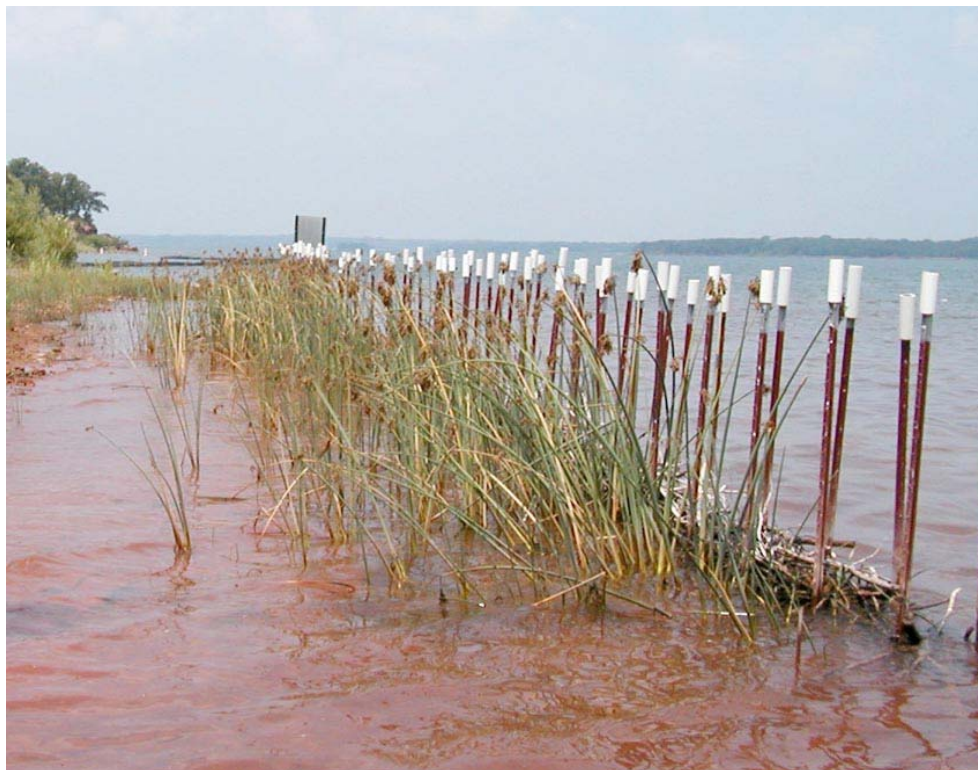
The final plant counts and densities for the entire site and for the area behind the remaining breakwaters are shown in Table 2 & Table 3. While site-wide survival was poor the remaining plants protected behind the extant breakwater are vigorous and expanding exponentially (Figure 24). There were approximately 1,175 assorted macrophyte plugs and sprigs planted at a density of 0.1 plants per sqft. The calculated density by project end for the site was 0.48 plants per sqft.; an increased density of 480%. The final estimated number of shoots behind the breakwaters is over 6,300; a density of 1.5 shoots per sqft. (primarily bulrush and waterwillow); an increased density of 1,500%.

Figure 24: Softstem bulrush stand looking west, July 2005, grows towards the shoreline.

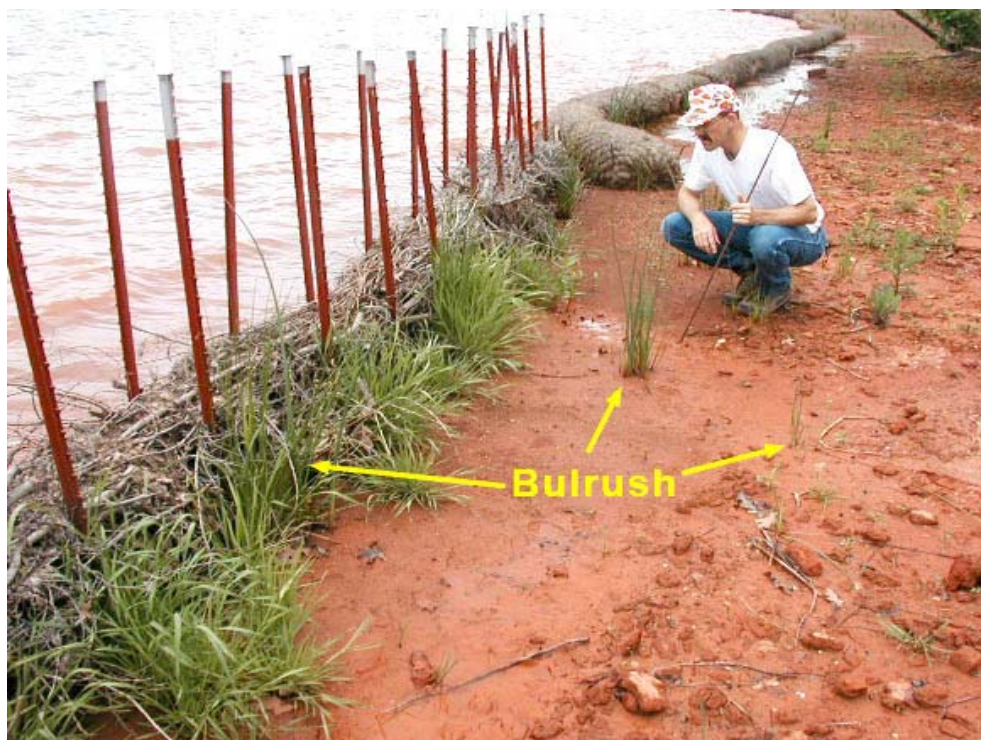
Before lake levels came up, the bulrush was small and mainly grew close to the breakwater within the saturated sediment (Figure 25). There were few shoots and very little vegetative reproduction. Once lake levels returned to the conservation pool elevation (near 1,039') the still-protected bulrush spread exponentially behind the breakwater (Figure 24). This is evidence of the demonstration's real potential when water and a firm breakwater are present. The vigorous growth indicates the potential for initial low plant density to effect a long-term change in physical structure. Barring other disaster or herbivory, the worst of this site will eventually be covered by bulrush, both *americanus* and *tabernaemontani*.

Figure 25: The same softstem bulrush stand looking east, April 2004 8 months after planting and before lake levels rose.

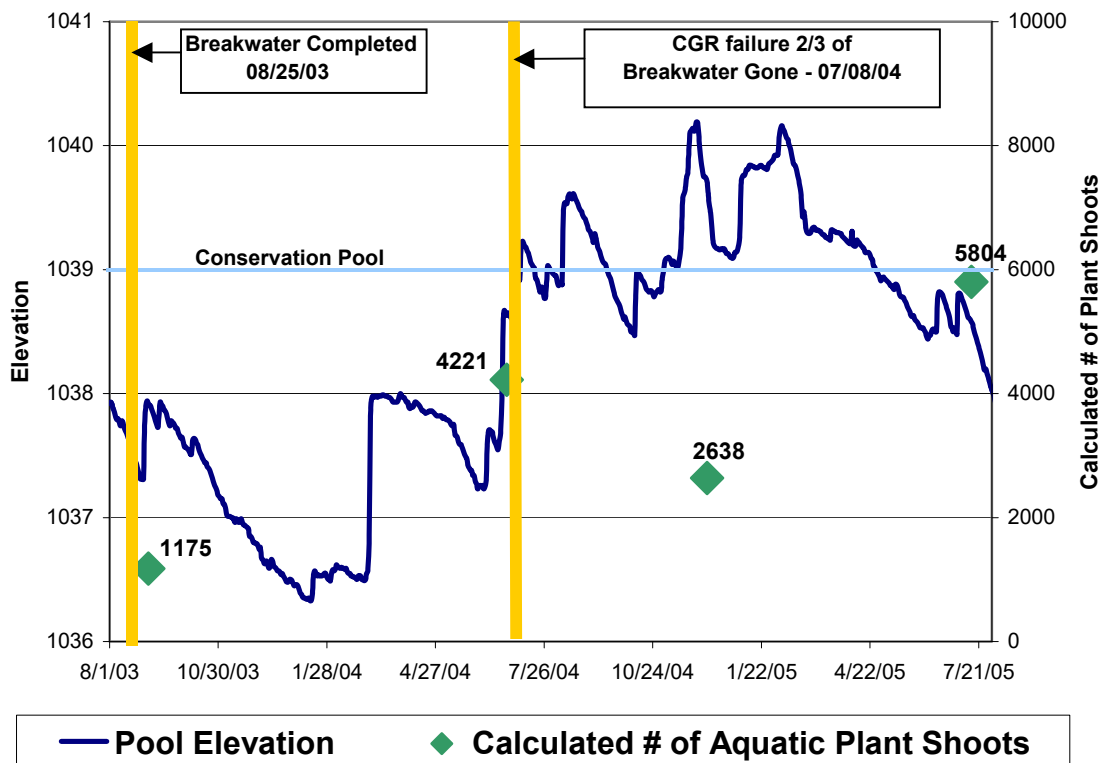
Figure 26: Graph - Plant counts and pool elevations

The potential for this site to establish a dense stand of emergent aquatic macrophytes has been shown in this demonstration. That potential can be expressed as a function of time and water levels combined with the presence of a working breakwater as shown in Figure 26. This graph shows a calculated increased plant population of 360% over the first year even though water levels were well under the 1,039' conservation pool level. This supports that aquatic plants can do well on the site even under harsh relatively dry conditions. In the following year, with only one-third of the site area still protected by the breakwater, counts still showed a 137% increase in overall shoot population once the water levels rose above 1,039' and saturated the plants. The plants counted were almost entirely behind the branchbox breakwaters. Extrapolating the number of plants calculated* behind the remaining branchboxes over the entire site would give a 450% increase for the year. This extrapolation can only be used as an indicator that there is potential to rapidly populate this site with water willow, softstem bulrush and common bulrush given a steady breakwater and enough growing seasons to allow for water level fluctuations.
